STATE OF VERMONT
PUBLIC UTILITIES COMMISSION

Petition of Vermont Gas Systems, Inc., for a)
certificate of public good, pursuant to 30)
V.S.A. § 248 , authorizing the construction of)
the “Addison Natural Gas Project” consisting)
of approximately 43 miles of new natural gas) Case No. 17-3550-INV
transmission pipeline in Chittenden and)
Addison Counties, approximately 5 miles of)
new distribution mainlines in Addison County,)
together with three new gate stations in)
Williston, New Haven and Middlebury,)
Vermont)

INTERVENORS’ MOTION TO BROADEN SCOPE OF INVESTIGATION
(CORRECTED)

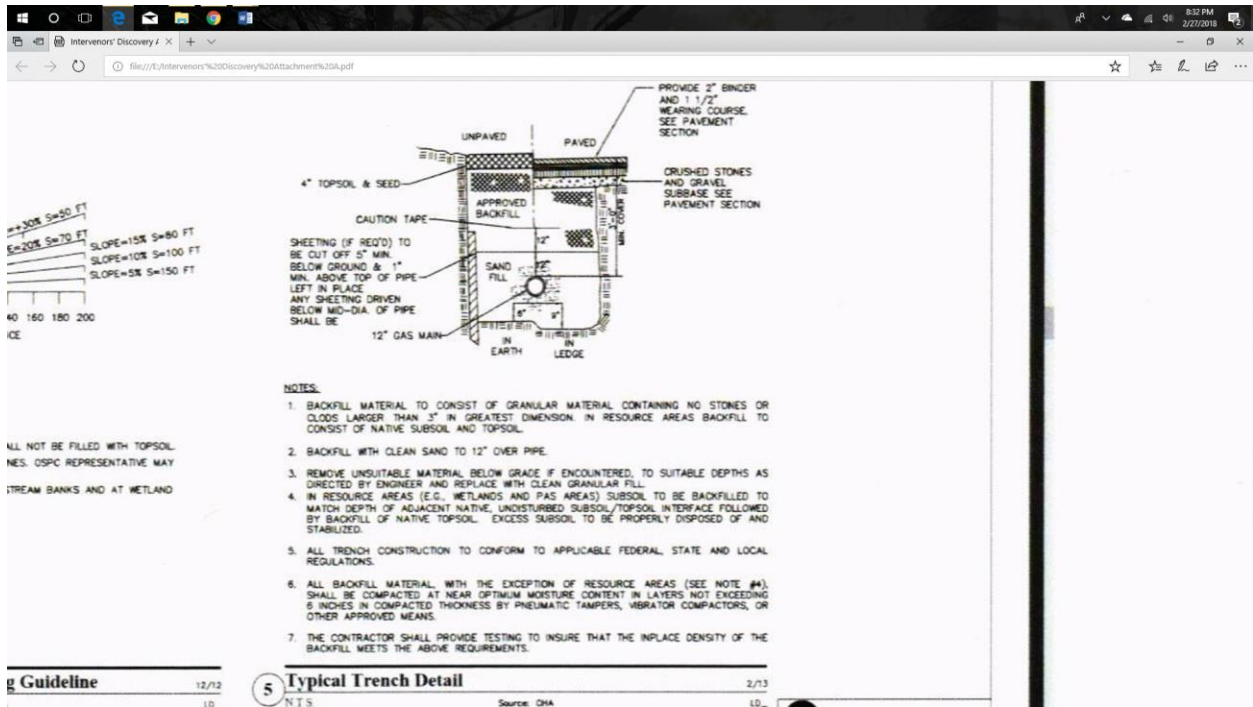
The trench detail plans submitted to the Commission prior to issuance of the CPG are set forth in Discovery Attachment A and Answer to Request to Discovery Question 1-12 (Agreeing that Attachment A was the trench construction detail plan submitted to the Commission to obtain the CPG.) The details from Attachment A are reproduced here:

The diagram shows the pipe entirely surrounded by “SAND FILL.” It shows a minimum depth of sand fill of 6” on earth trench bottom and 9” on ledge trench bottom. It shows 12” of SAND FILL above the pipe. Above the SAND FILL its shows “APPROVED BACKFILL.”

Note 1 states: “BACKFILL MATERIAL TO CONSIST OF GRANULAR MATERIAL CONTAINING NO STONES OR CLODS LARGER THAN 3” IN GREATEST DIMENSION. IN RESOURCE AREAS BACKFILL TO CONSIST OF NATIVE SUBSOIL AND TOPSOIL.”

Note 6 states: “ALL BACKFILL MATERIAL, WITH THE EXCEPTION OF RESOURCES AREAS (SEE NOTE #4) SHALL BE COMPACTED AT NEAR OPTIMUM MOISTURE CONTENT TO LAYERS NOT EXCEEDING 6 INCHES IN COMPACTED

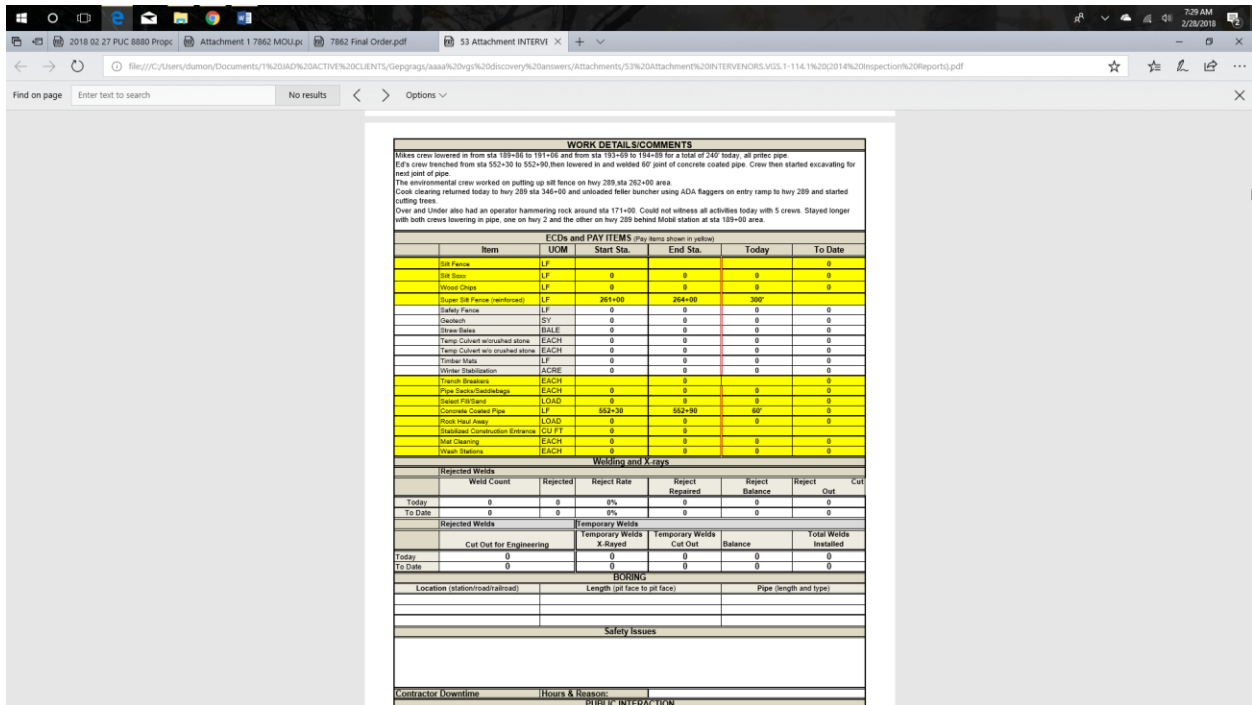
Violation 2(b). In 2014, in those locations where the pipe was not placed directly on trench bottom, there is no record that clean sand or other select fill was placed under and over the pipeline.

The company's daily inspection records in 2014 contained columns for stating the number of loads of “select fill/sand” used in each location. These records reveal that all of the pipeline construction which occurred in 2014 lacked sand or substitute select fill; if sand or substitute select fill in fact was used, there is no record of its use. The daily records state “0” in this category every day. The following, from September 9, 2014, by Inspector J.R. Kelch, is a typical example:

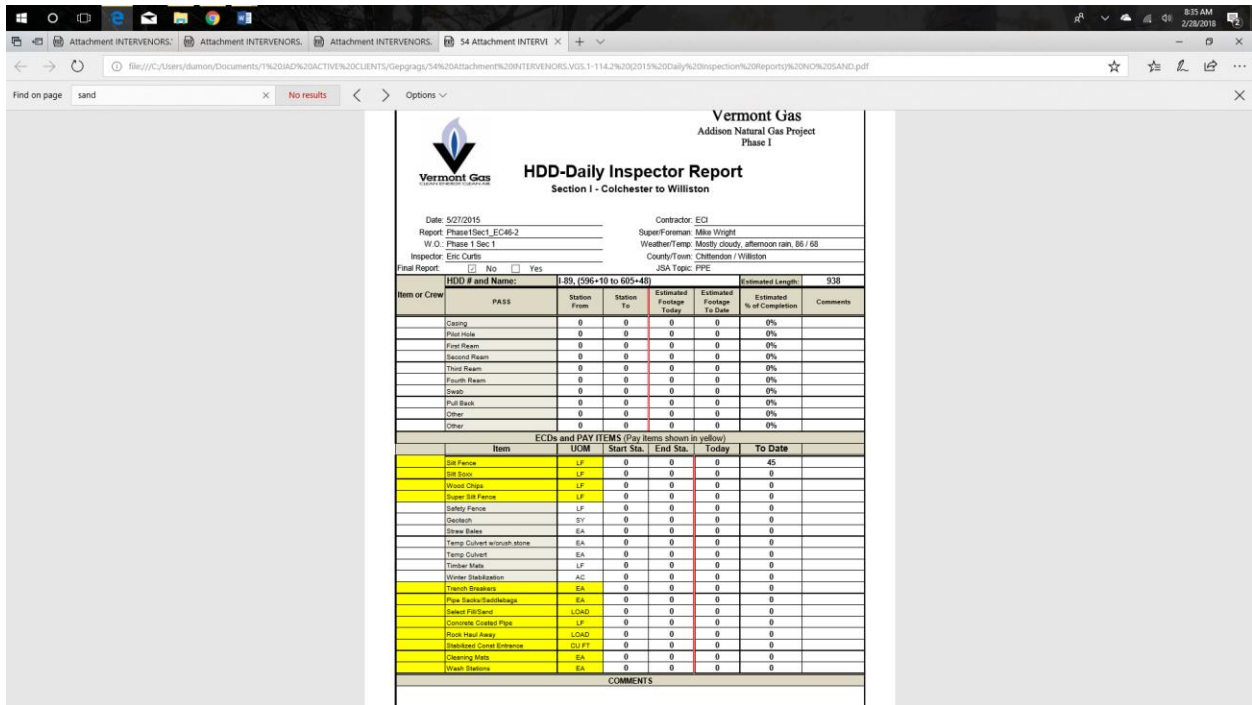
Violation 2(c). In 2015, there is no record of sand or substitute select fill under and over the pipeline.

By 2015, the company’s contractor specifications had been changed to require that backfill be placed under the pipe but left it to the contractor to decide not to use clean sand if the contractor believed other materials were adequate. Records for 2015, however, do not indicate that any sections of the pipeline received clean sand or received substitutes. The inspection reports for some of the year contain a column for indicating if “select fill/sand” was used. They are uniformly marked “0.” The May 27, 2017 report, for example, is copied here:

If sand was used, or a substitute for sand was used, there is no record of where either was used, or what the substitute was.

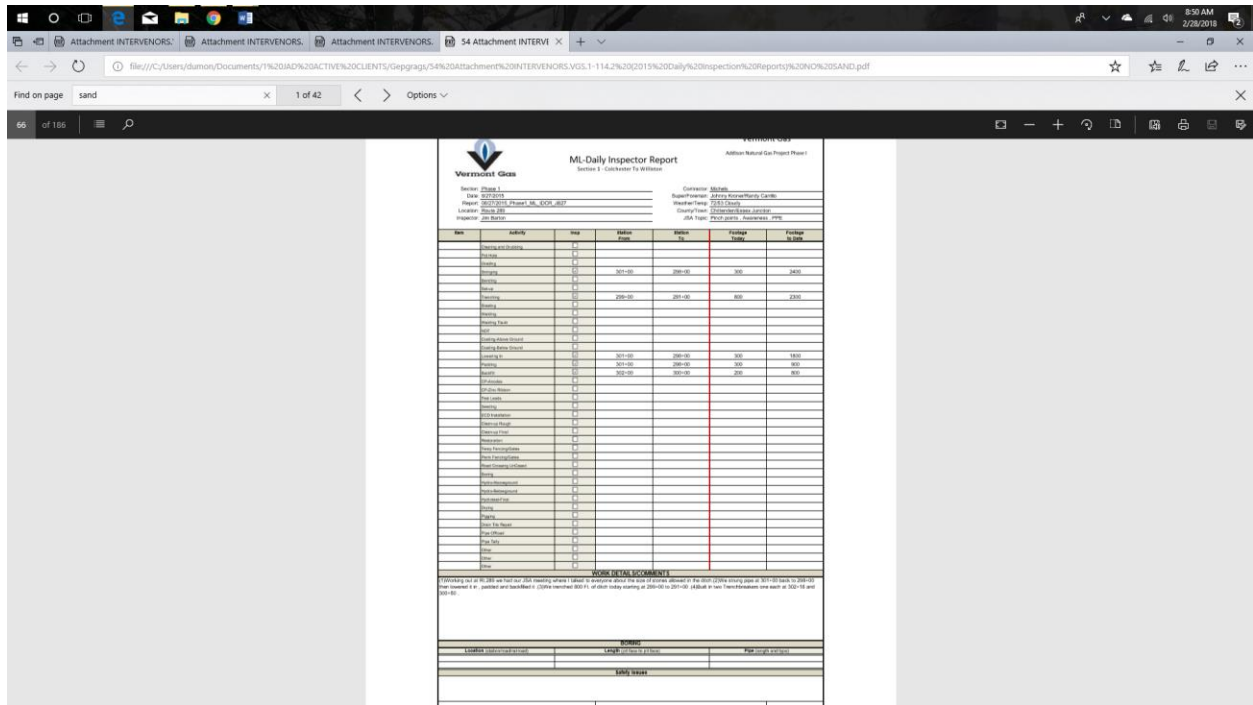
Violation 2(d). In late 2015 and 2016, the company ceased recording whether select backfill of any kind was being used.

The inspection reports for late 2015 and 2016 contained no place to record whether sand or select fill was used. The report of August 27, 2015, for example states that the crew discussed the size of stones allowed in the ditch and that pipe was laid down, padded and backfilled, but there is no mention of sand or select fill:

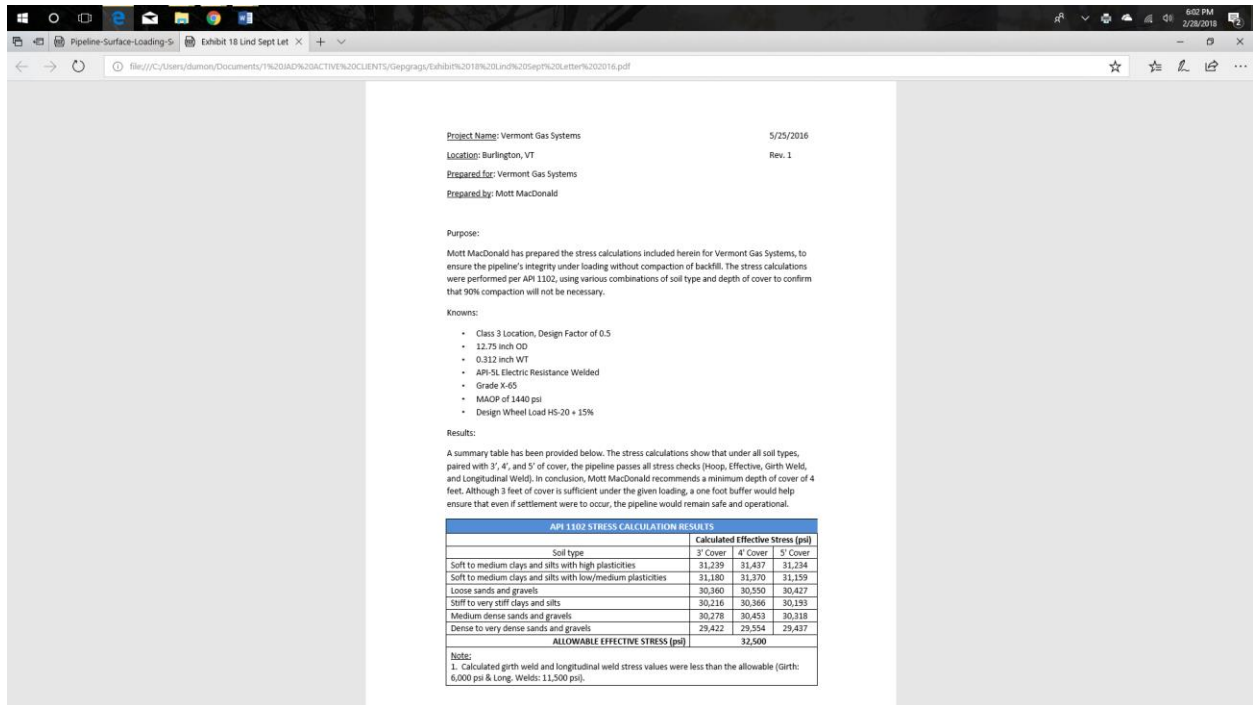
Properly inspected and compacted backfill is absolutely necessary for pipeline safety in the VELCO ROW because *load-bearing calculations were based on compacted soils*. The load-bearing calculations were from the industry standard, which is American Petroleum Institute (“API”) Recommended Practice (“RP”) 1102, “Steel Pipelines Crossing Railroads and Highways” (7th ed. 2007). This will be discussed in detail next. However, first it is important to note that properly inspected and compacted backfill is absolutely necessary to comply with the CPG as well as with safety, because the CPG required compliance with the VELCO MOU, and *the VELCO*

MOU was based upon the same API RP 1102 load-bearing calculations. See, e.g., the May 25, 2016 Mott MacDonald Report which the company relies upon:
