**VERMONT GAS SYSTEMS, INC.
TRANSMISSION LINE EXPOSURE REPORT**

VERMONT GAS SYSTEMS, INC.
TRANSMISSION LINE EXPOSURE REPORT
SUPPLEMENTAL FOR ASSESSMENT EXCAVATIONS

Date: 7/30/2019	Location: Excavation Site 1 - Breezy Valley Storage	Town: St. George
Project/Work Plan Date: 07/30/2019	Revision #: 0	Pipe Diameter: 12"
Length of Pipe Exposed & Inspected: Exposed 4' of Pipe, Removed Approx. 18" of Coating		
Pipe Condition: Good. Found Pritec coating (on pipe), Canusa shrink wrap (on weld), and wax tape over previous coating removal all in good shape.		
Jeeping Results: Good. Jeeped at 7000v, no coating anomalies found.		
Trench and Backfill Conditions (described area around pipe, note presence of rocks, sandbags, rockshield, etc.): Found clean, rock-free clay. Sand Bags under weld.		
Indication/Anomaly Found:	Wall Loss <input checked="" type="checkbox"/>	Dent <input type="checkbox"/>
	Manufacturing Anomaly <input type="checkbox"/>	Other: _____
	Ovality <input type="checkbox"/>	Weld Anomaly <input type="checkbox"/>
		N/A <input type="checkbox"/>
Dimension of Indication/Anomaly (if found):	Length = 0.768"	Width = 0.885"

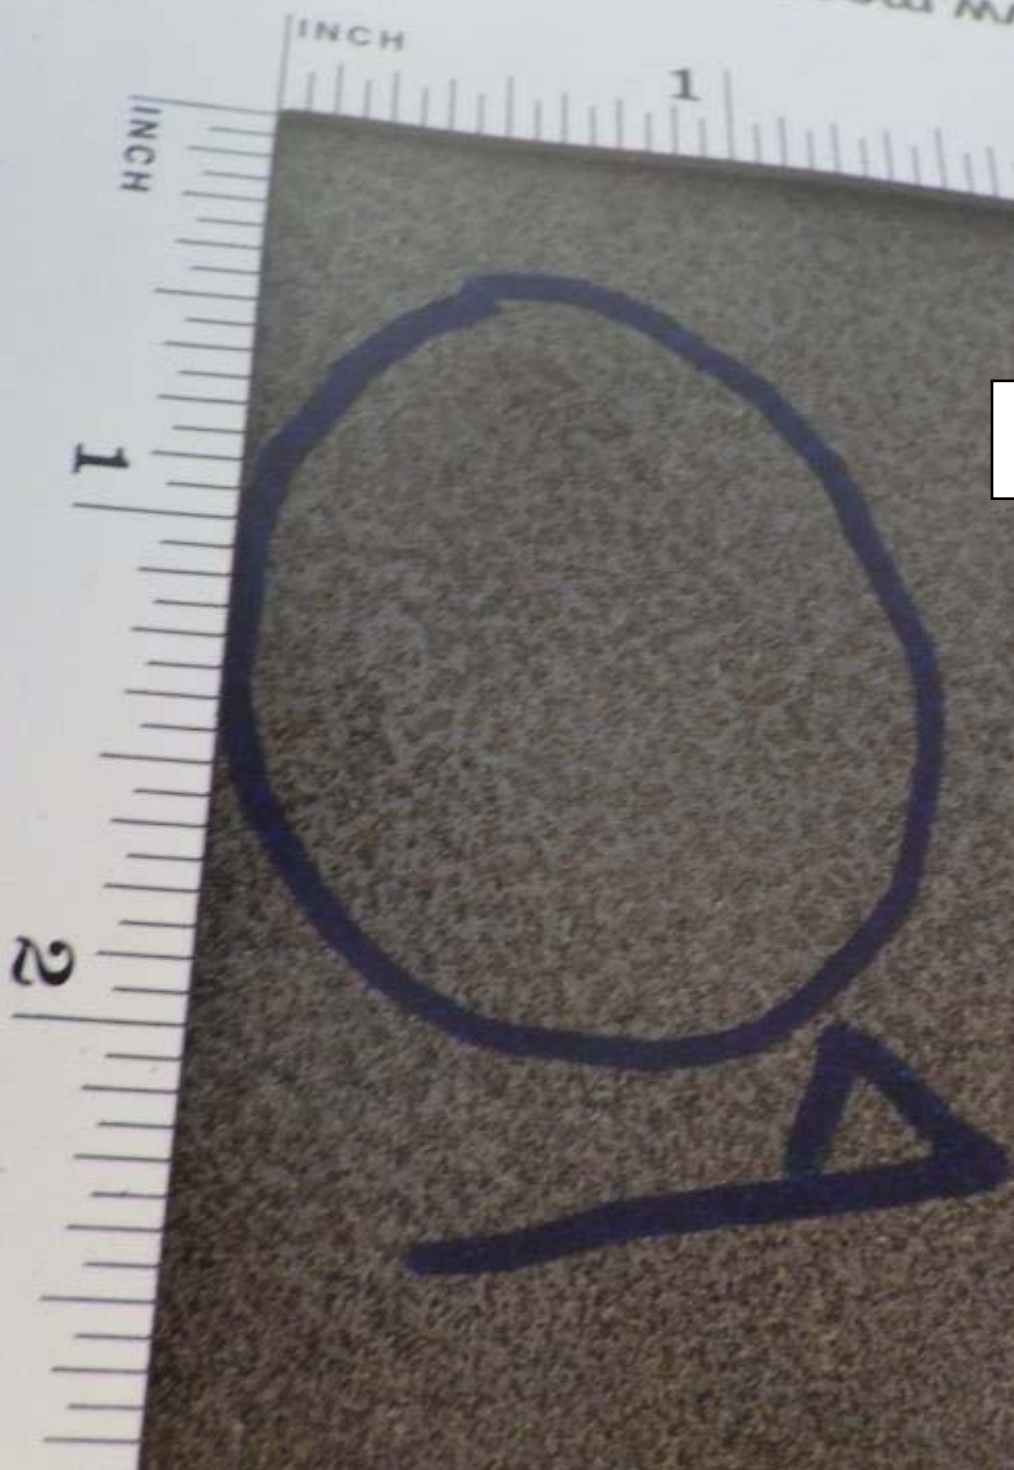
ANOMALY

Depth = 0.029"
Repair Made: Yes <input type="checkbox"/> No <input checked="" type="checkbox"/>	Length of Repair: <u>N/A</u>	
Repair Type (i.e. Clock Spring, Weld Sleeve, etc.): <u>N/A</u>		
Repair Notes: Anomaly was a smooth grind repair. See photos.		
ADDITIONAL COMMENTS: Used laser scanning mapping to measure anomaly LxWxD. The maximum depth of anomaly of 0.029" equates to 9.4% wall reduction.

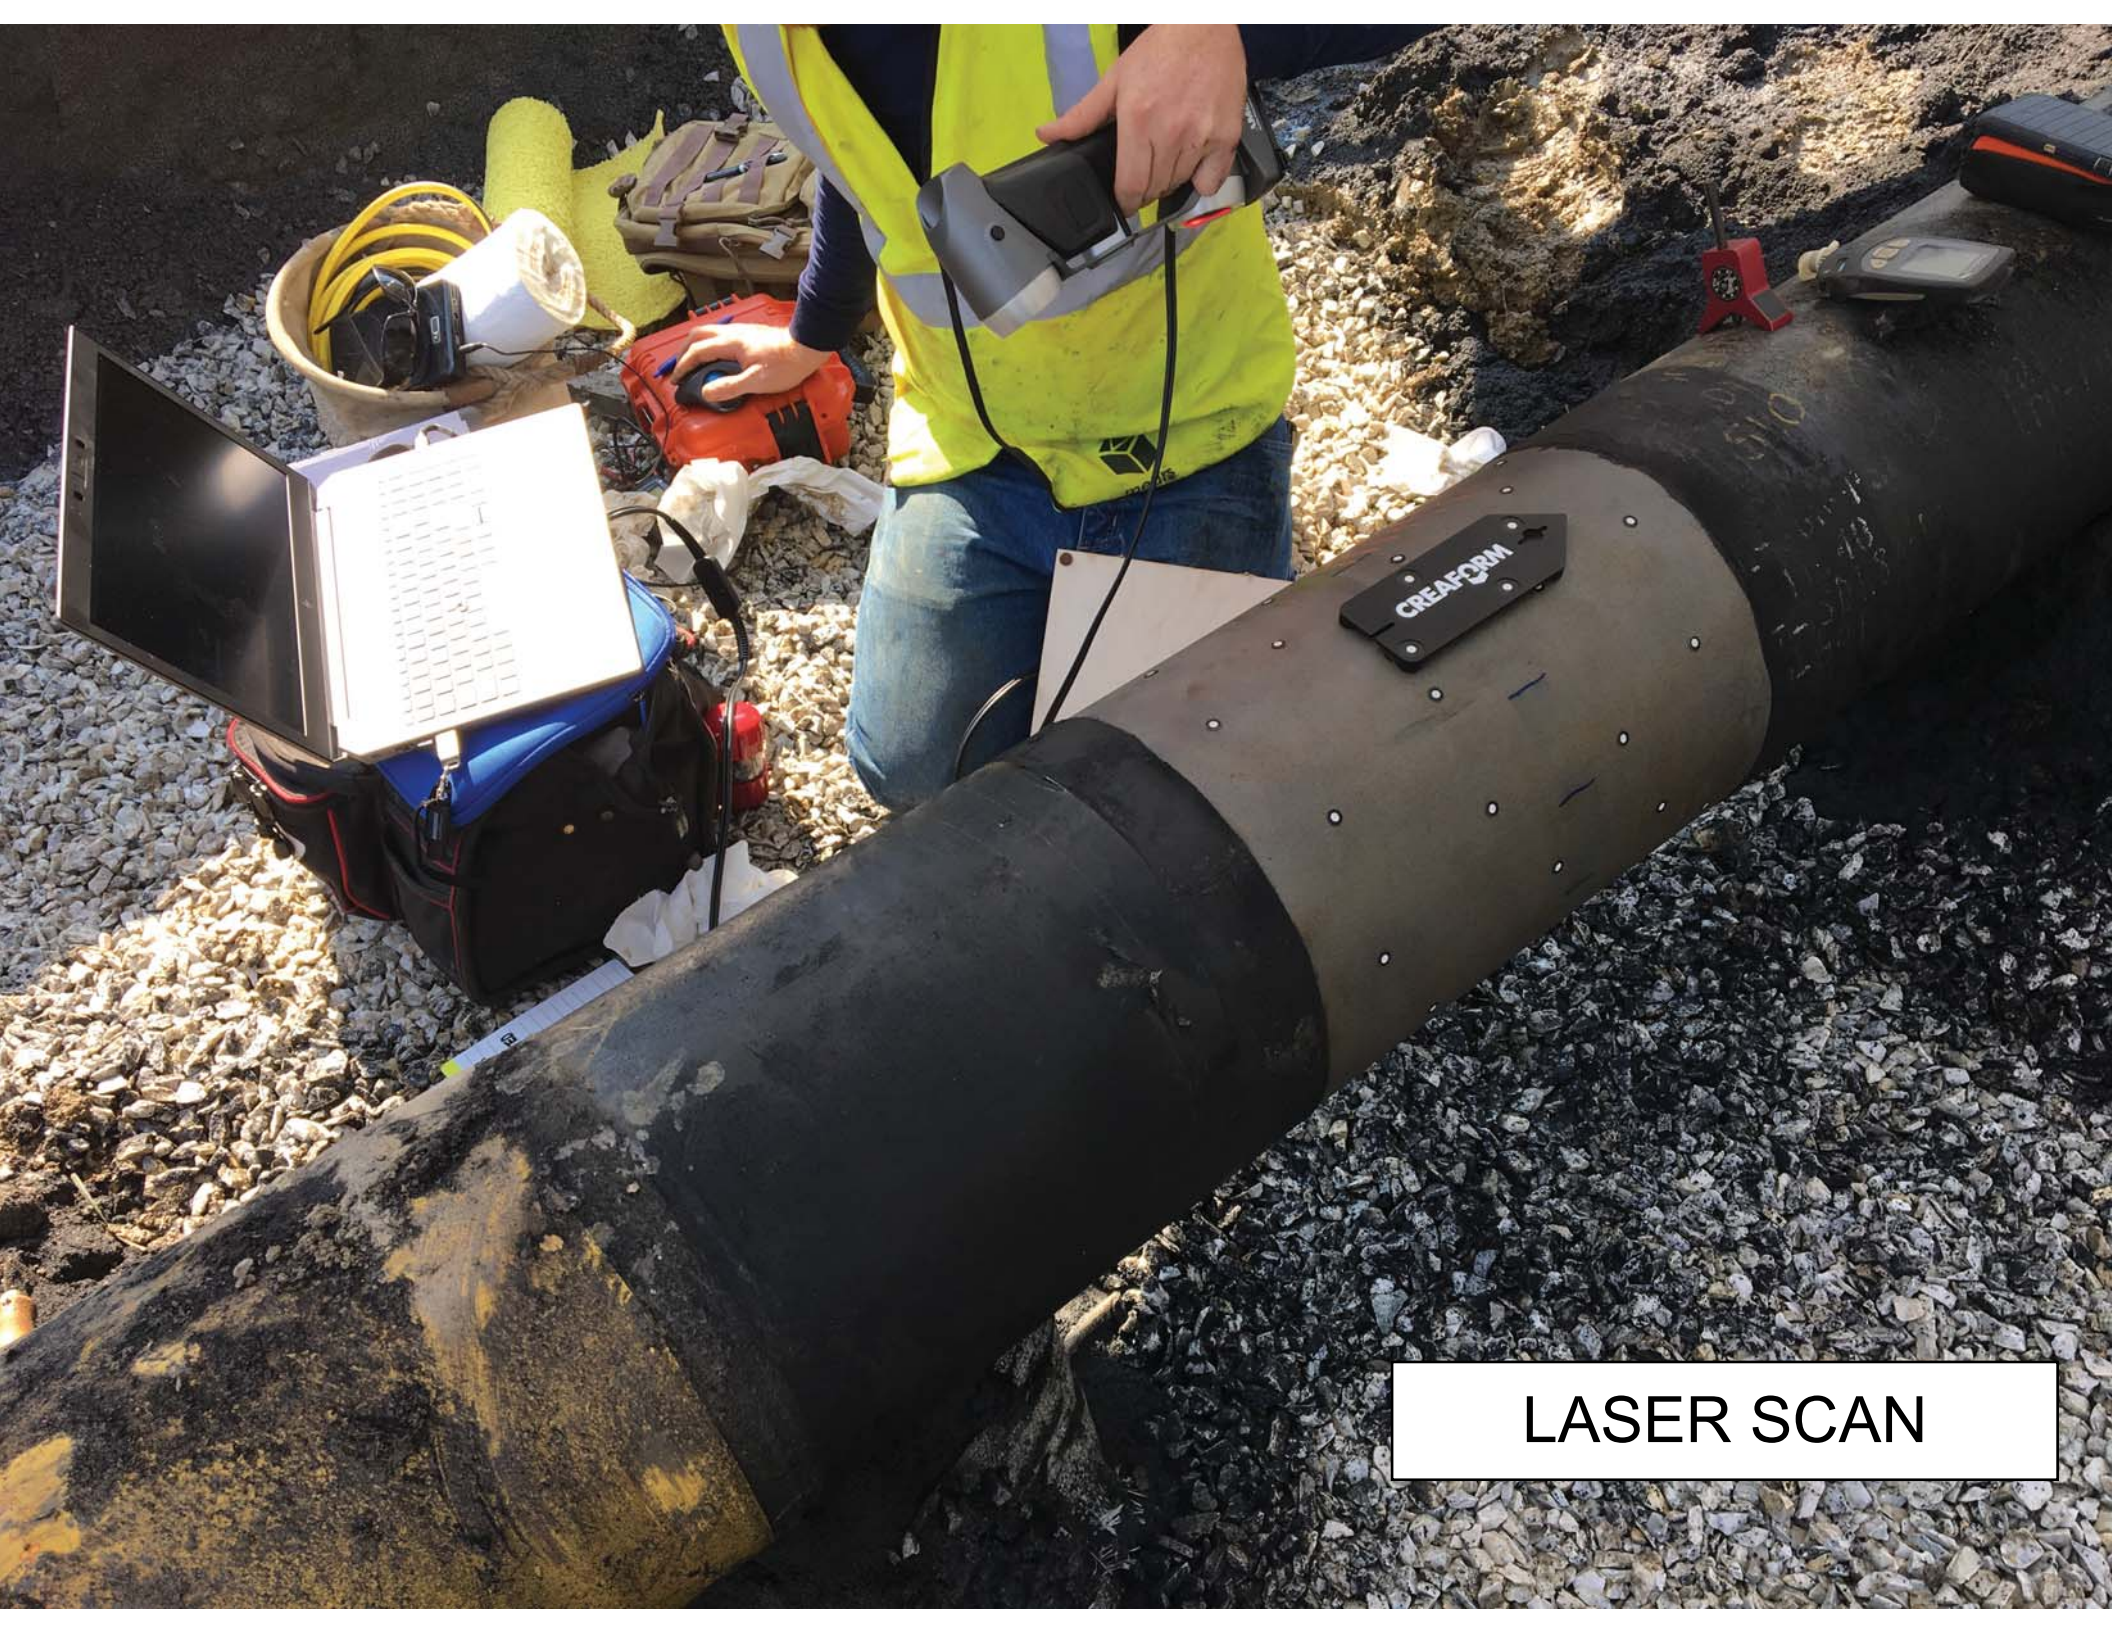
ANOMALY

Foreign Pipe crossing: Y <input type="checkbox"/> N <input checked="" type="checkbox"/>		Foreign Pipe crossing clearance: N/A		Foreign pipe crossing ties taken: Y <input type="checkbox"/> N <input checked="" type="checkbox"/>	
<p>Comments:</p> <ul style="list-style-type: none"> -Excavated for inspection on Wednesday, July 24, 2019. -Mears conducted coating inspection on Monday, July 29, 2019. -Mears returned on July 30, 2019 to continue with the inspections. -VGS removed coating and sand-blasted pipe. -Mears conducted UT gauge w.t. readings at 12 clock positions around the pipe. Found minimum thickness at 0.310". -Mears conducted laser scan of found anomaly. -Laser scan indicated a maximum anomaly depth of 0.029". -See Mears Report for more information.

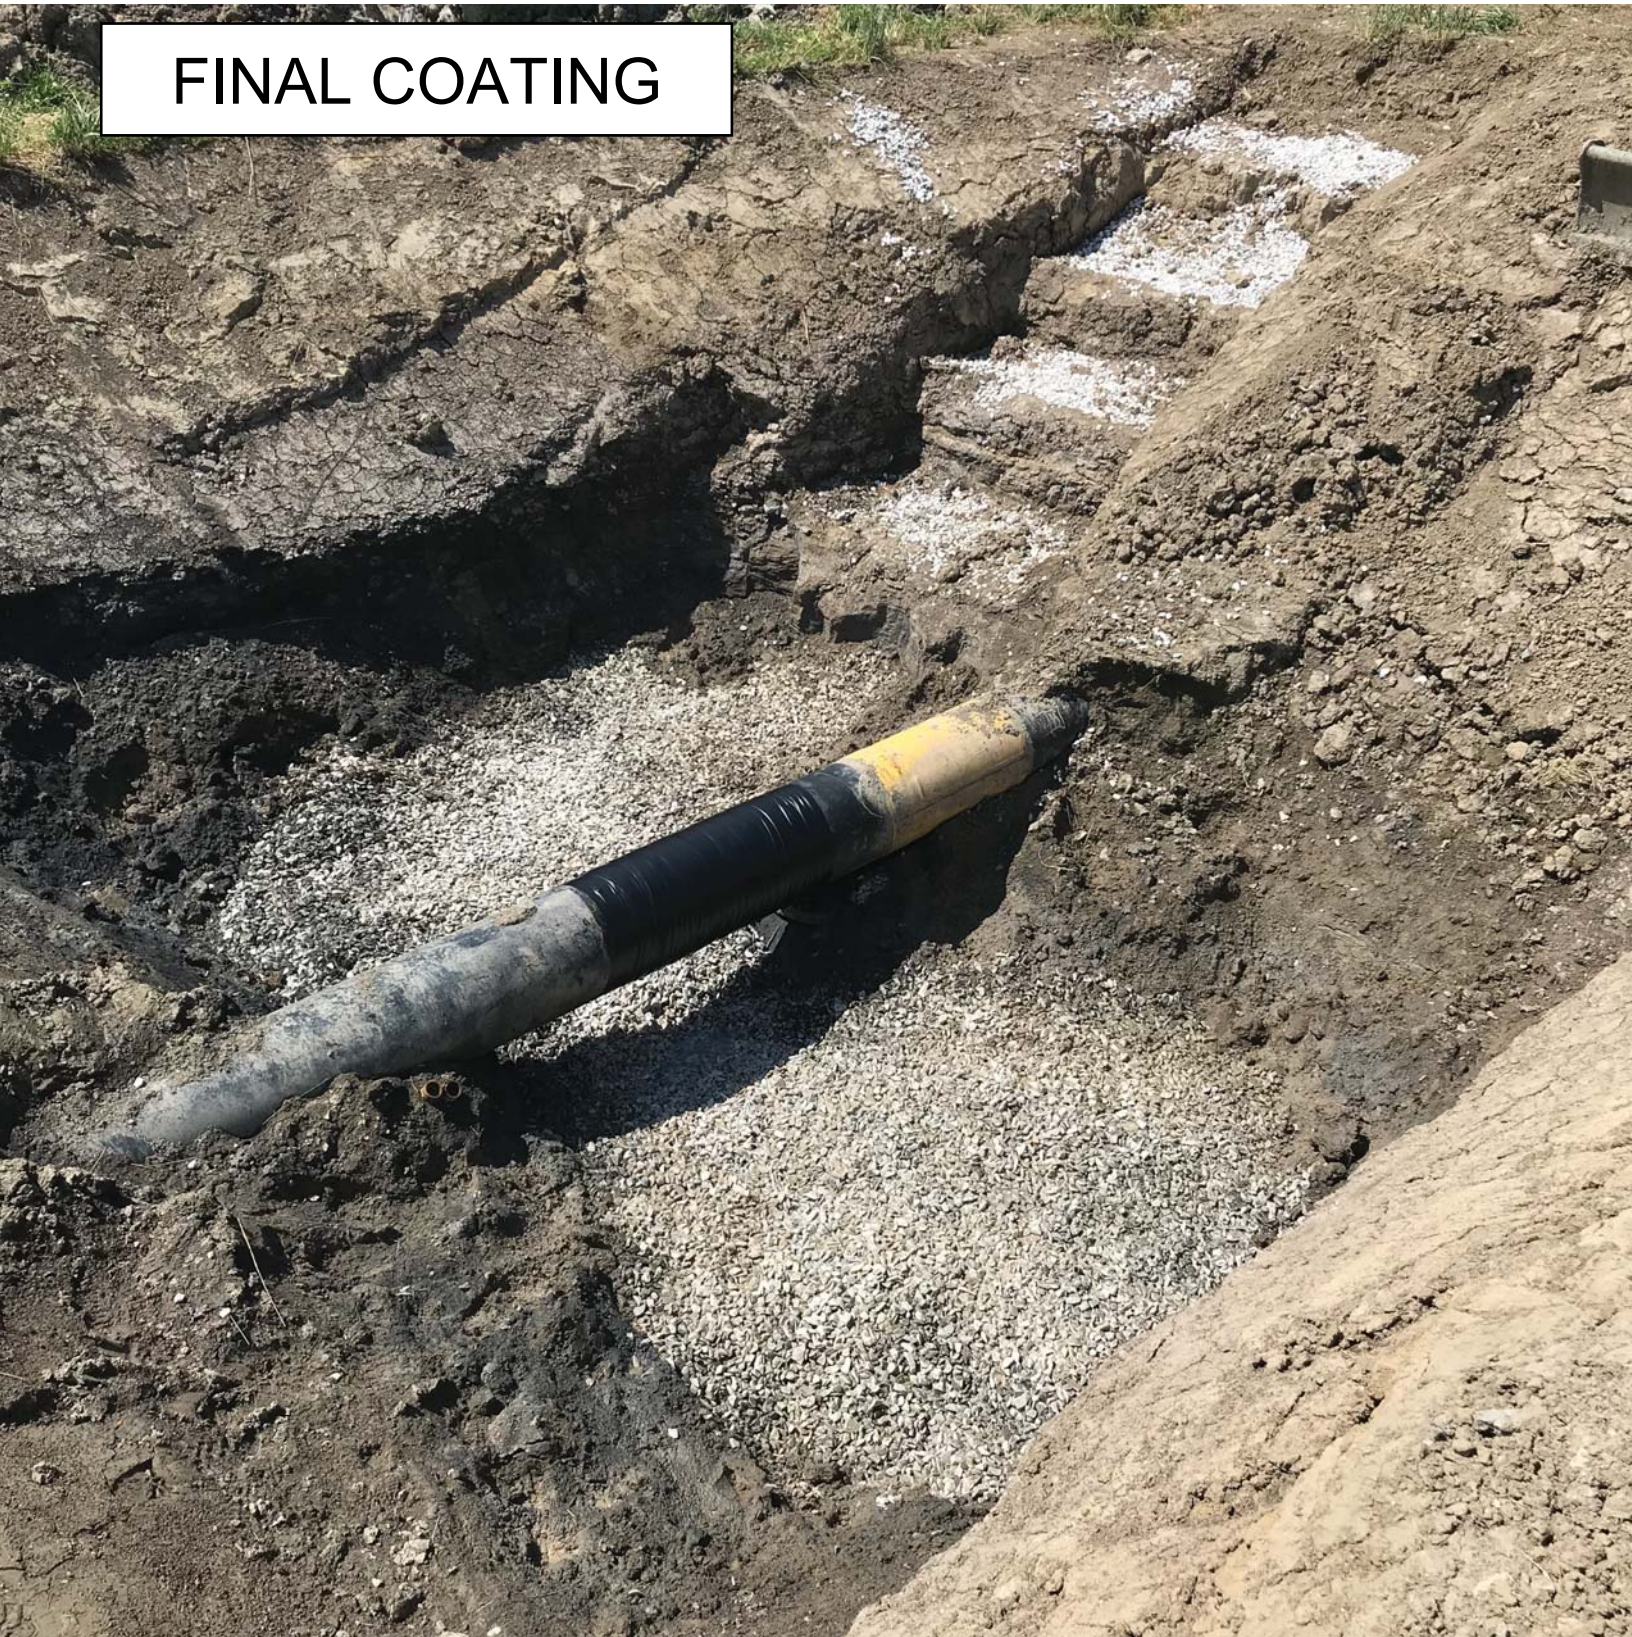
FINAL COATING

Type Replacement Coating: Denso Densyl Wax Tape			Replacement Coating Length: 18"		
Erosion length: N/A		Erosion Depth: N/A		Erosion Location: N/A	
Exposed bare pipe: Y <input checked="" type="checkbox"/> N <input type="checkbox"/>		Pitting: Y <input type="checkbox"/> N <input checked="" type="checkbox"/>		Pitting mapping: <small>Laser Scan of Anomaly</small> UT Gauge: 0.310" min.	
Soil: Sand <input type="checkbox"/> Clay <input checked="" type="checkbox"/> Loam <input type="checkbox"/> Cinders <input type="checkbox"/> Refuse <input type="checkbox"/> Rock <input type="checkbox"/>			Soil Packing: Loose <input type="checkbox"/> Medium <input checked="" type="checkbox"/> Hard <input type="checkbox"/>		
Soil Sample Taken: Y <input type="checkbox"/> N <input checked="" type="checkbox"/>			Soil Moisture Content: Dry <input type="checkbox"/> Damp <input checked="" type="checkbox"/> Wet <input type="checkbox"/>
