VERMONT GAS SYSTEMS, INC. TRANSMISSION LINE EXPOSURE REPORT

VERMONT GAS SYSTEMS, INC.
TRANSMISSION LINE EXPOSURE REPORT
SUPPLEMENTAL FOR ASSESSMENT EXCAVATIONS

Date: 7/30/2019	Location: Excavation Site 2 - Baldwin Road	Town: Hinesburg
Project/Work Plan Date: 07/30/2019	Revision #: 0	Pipe Diameter: 12"
Length of Pipe Exposed & Inspected: Exposed 4' of Pipe, Removed Approx. 2' of Coating		
Pipe Condition: Good. Pipe wrapped in rockshield. Found Pritec coating (on pipe) and Canusa shrink wrap (on weld) in good shape.		
Jeeping Results: Good. Jeeped at 7000v, no coating anomalies found.		
Trench and Backfill Conditions (described area around pipe, note presence of rocks, sandbags, rockshield, etc.): Trench had rocks. Soil around pipe was sandy soil mixed with small rocks. Pipe wrapped in rockshield. South of weld found sandbag trenchbreaker.		
Indication/Anomaly Found:	Wall Loss <input checked="" type="checkbox"/>	Dent <input type="checkbox"/>
	Manufacturing Anomaly <input type="checkbox"/>	Other: _____
	Ovality <input type="checkbox"/>	Weld Anomaly <input type="checkbox"/>

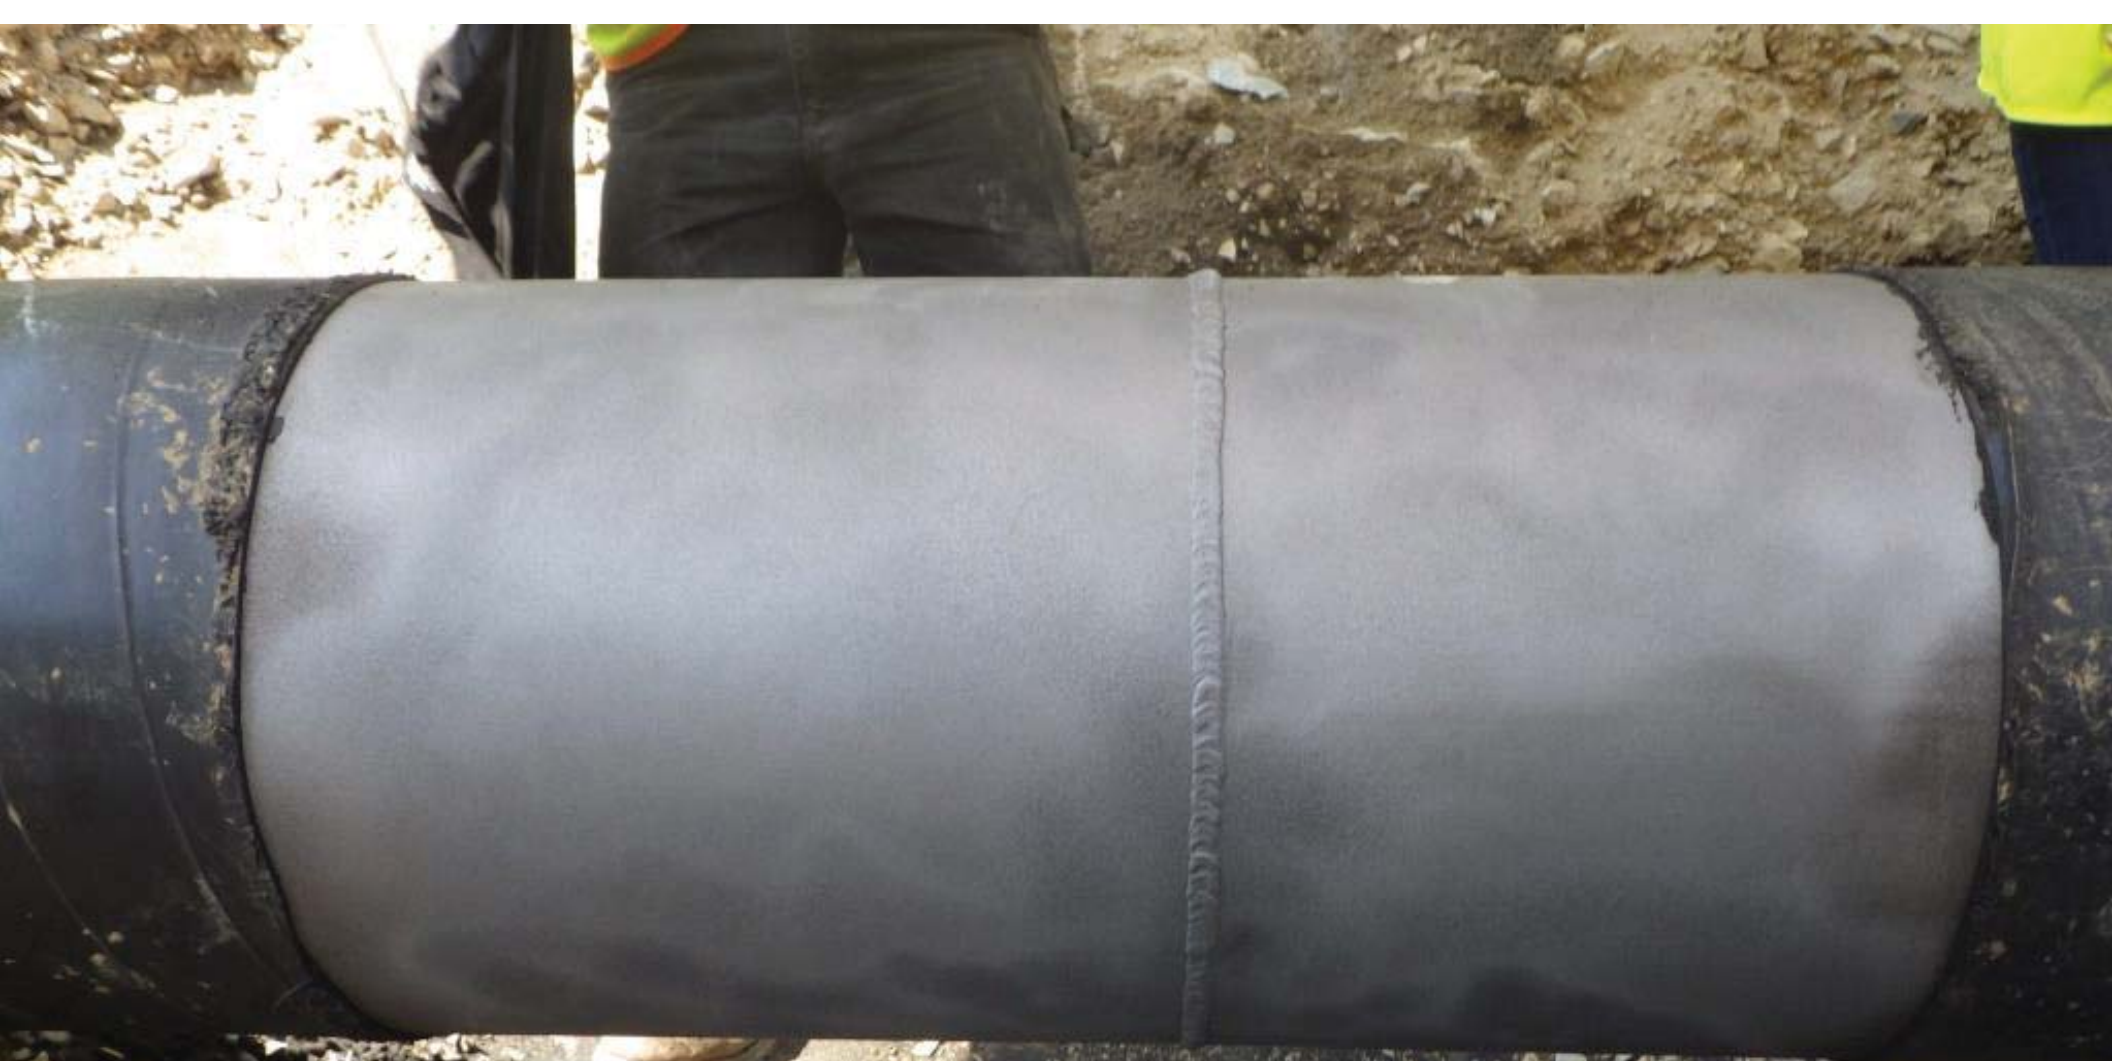
N/A <input type="checkbox"/>
Dimension of Indication/Anomaly (if found):	Length = 0.826"	Width = 1.183"
		Depth = 0.032"
Repair Made: Yes <input type="checkbox"/> No <input checked="" type="checkbox"/>	Length of Repair: <u>N/A</u>	
Repair Type (i.e. Clock Spring, Weld Sleeve, etc.): <u>N/A</u>		
Repair Notes: Anomaly was a smooth grind repair. See photos.		
ADDITIONAL COMMENTS: Used laser scanning mapping to measure anomaly LxWxD. The maximum depth of anomaly of 0.032" equates to 10.3% wall reduction.

V65
WC: 112310.94
D16 2
MEDIA BLASTED
PIPE
9:00
A

ANOMALY
