**VERMONT GAS SYSTEMS, INC.
TRANSMISSION LINE EXPOSURE REPORT**

VERMONT GAS SYSTEMS, INC.
TRANSMISSION LINE EXPOSURE REPORT
SUPPLEMENTAL FOR ASSESSMENT EXCAVATIONS

Date: 7/31/2019	Location: Excavation Site 3 - Palmer Chicken Farm	Town: New Haven
Project/Work Plan Date: 07/30/2019	Revision #: 0	Pipe Diameter: 12"
Length of Pipe Exposed & Inspected: Exposed 5' of Pipe, Removed Approx. 2' of Coating		
Pipe Condition: Good. Found Pritec coating (on pipe), Canusa shrink wraps (on welds), FBE (on fitting), and wax tape over previous coating removal all in good shape.		
Jeeping Results: Good. Jeeped at 7000v, no coating anomalies found.		
Trench and Backfill Conditions (described area around pipe, note presence of rocks, sandbags, rockshield, etc.): Found clean, rock-free clay. Zinc ribbon was found approximately 3' east of pipe. Backfilled with native clay.		
Indication/Anomaly Found:	Wall Loss <input checked="" type="checkbox"/>	Dent <input type="checkbox"/>
	Manufacturing Anomaly <input type="checkbox"/>	Other: _____
	Ovality <input type="checkbox"/>	Weld Anomaly <input type="checkbox"/>

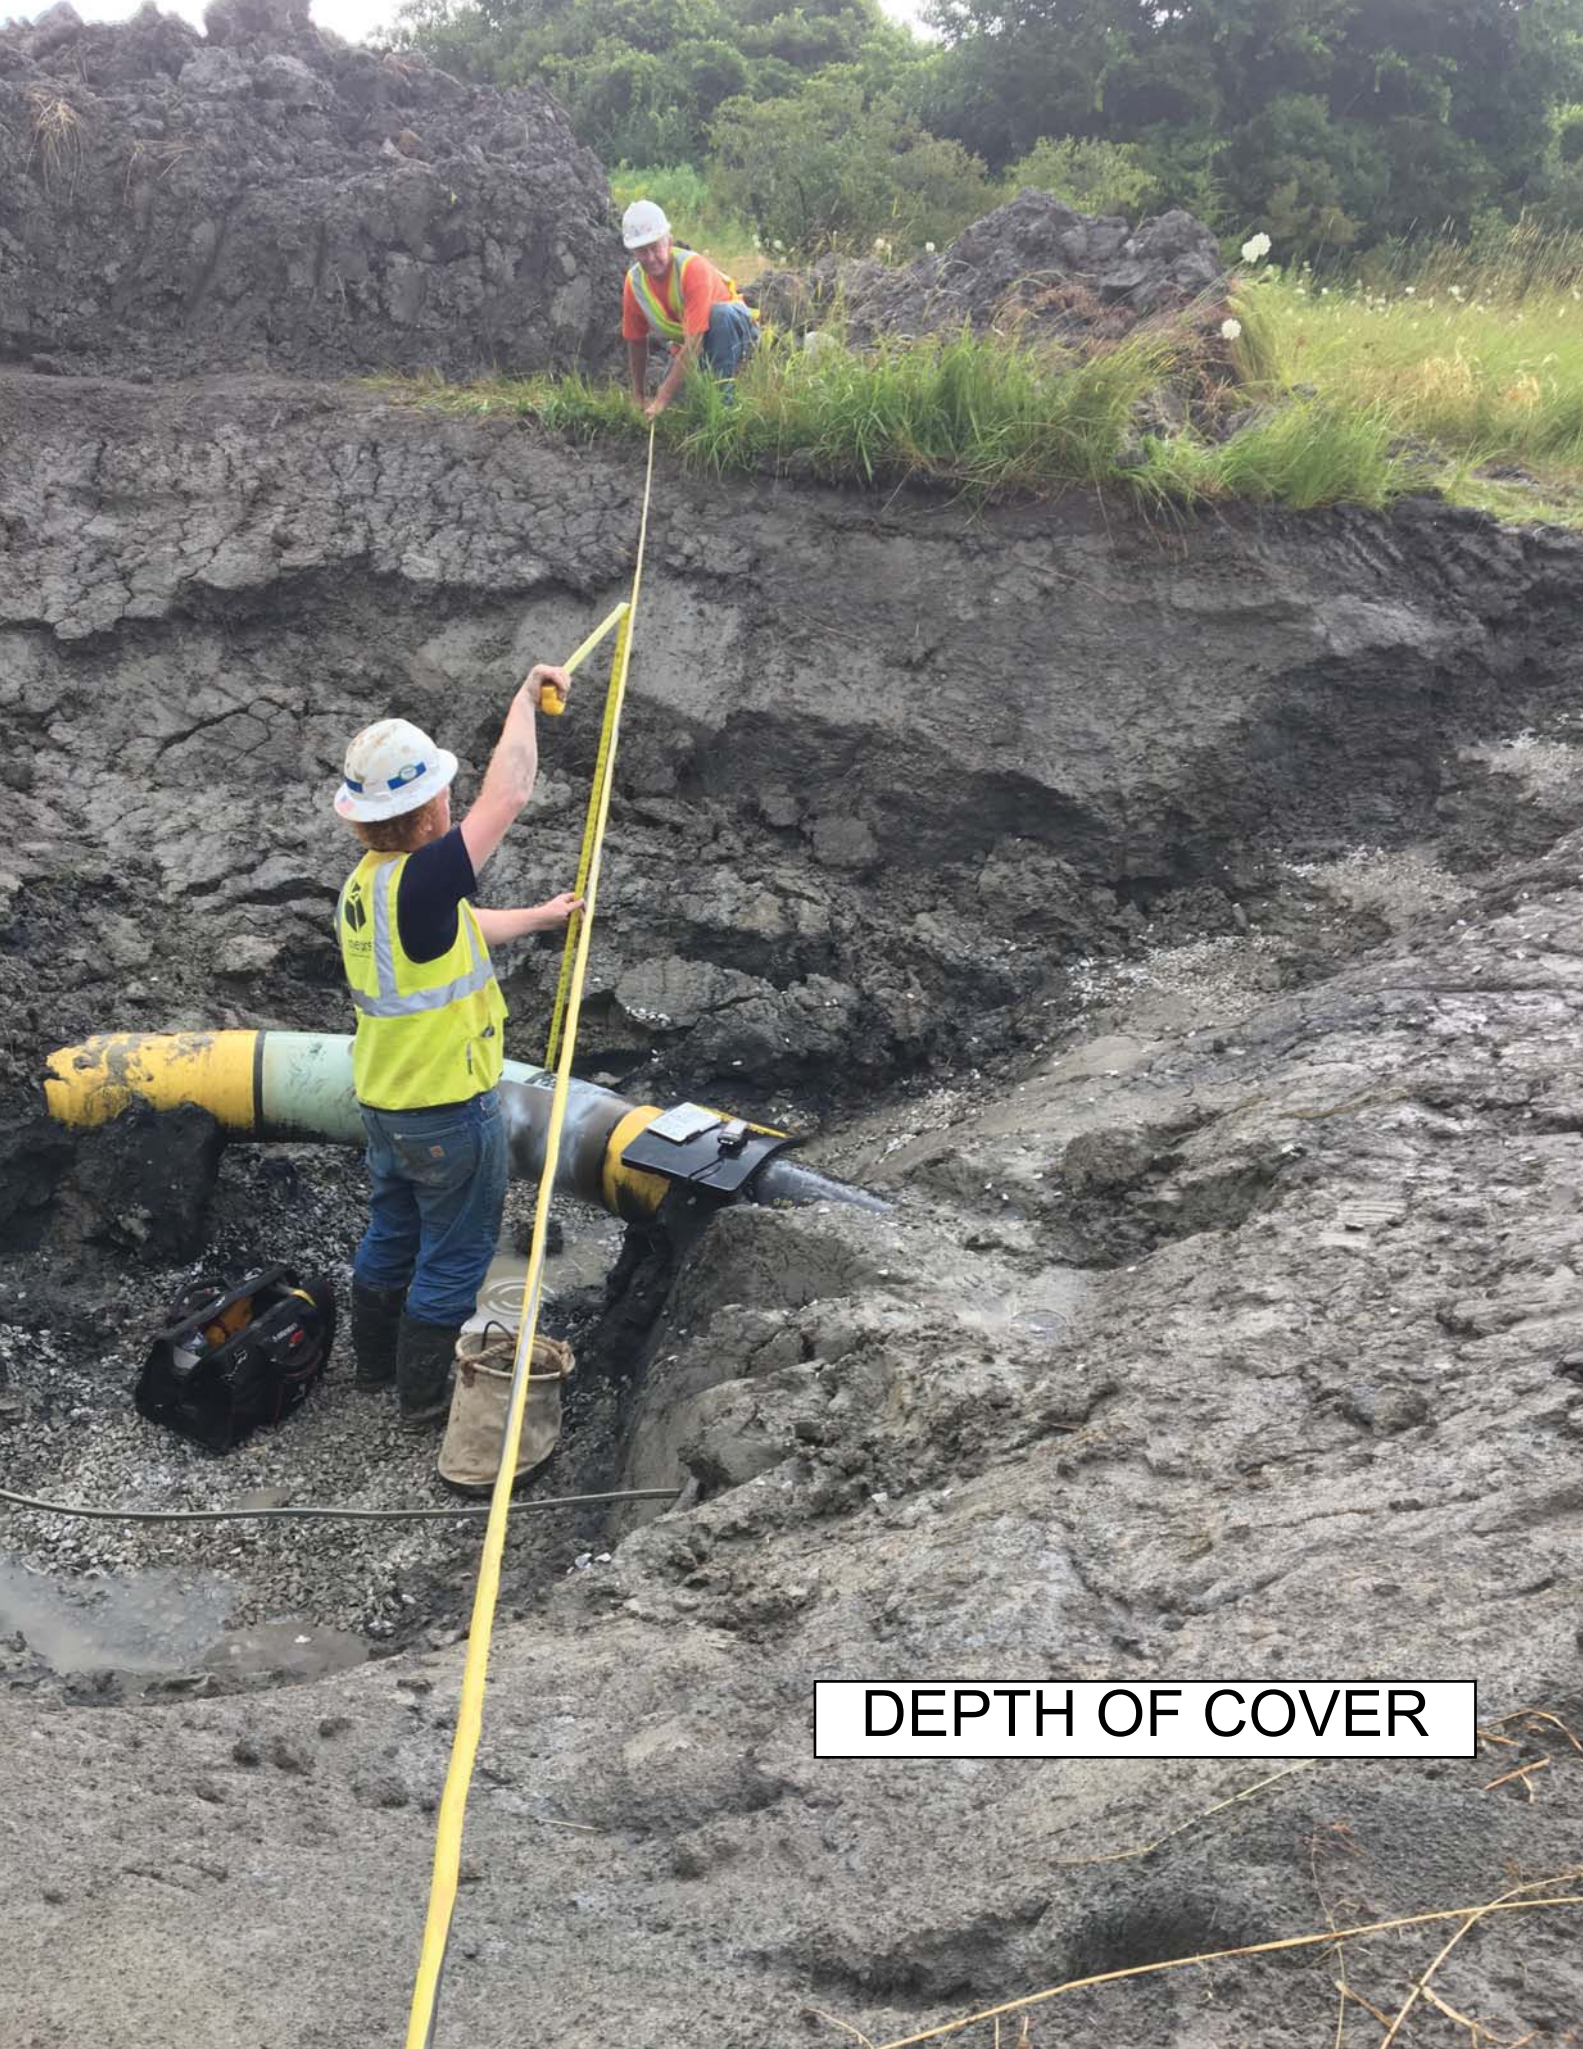
UT MEASUREMENT

N/A <input type="checkbox"/>
Dimension of Indication/Anomaly (if found):	Length = 2"	Width = 1"
		Depth = N/A
Repair Made: Yes <input type="checkbox"/> No <input checked="" type="checkbox"/>	Length of Repair: N/A	
Repair Type (i.e. Clock Spring, Weld Sleeve, etc.): N/A		
Repair Notes: Internal wall loss. Exterior repair wrap not approved for interior wall loss.		
ADDITIONAL COMMENTS: Removed coating from pipe, found smooth pipe. No indication of external wall loss. Mears used UT gauge to determine location of anomaly. Found indication on or very near to the longitudinal ERW. Lowest wall-thickness reading at 0.215". Approximate size based on 1" UT grid readings: 2"x1". Found the two other indications as called out by ILI with minimum wall thickness readings of 0.309" and 0.335". See Mears report for more info.
