**VERMONT GAS SYSTEMS, INC.
TRANSMISSION LINE EXPOSURE REPORT**

VERMONT GAS SYSTEMS, INC.
TRANSMISSION LINE EXPOSURE REPORT
SUPPLEMENTAL FOR ASSESSMENT EXCAVATIONS

Date: 7/31/2019	Location: Excavation Site 4 - Route 7	Town: New Haven
Project/Work Plan Date: 07/30/2019	Revision #: 0	Pipe Diameter: 12"
Length of Pipe Exposed & Inspected: Exposed 6' of Pipe, Removed Approx. 2' of Coating		
Pipe Condition: Good. Found Pritec coating (on pipe), FBE (on fitting) and Canusa shrink wrap (on weld) in good shape.		
Jeeping Results: Good. Jeeped at 7000v, no coating anomalies found.		
Trench and Backfill Conditions (described area around pipe, note presence of rocks, sandbags, rockshield, etc.): Soil around pipe was clay. Soil away from original pipe trench had some larger rocks. Found sandbag above pipe south of weld.		
Indication/Anomaly Found:	Wall Loss <input type="checkbox"/>	Dent <input type="checkbox"/>
	Manufacturing Anomaly <input type="checkbox"/>	Other: _____
	Ovality <input type="checkbox"/>	Weld Anomaly <input checked="" type="checkbox"/>
		N/A <input type="checkbox"/>

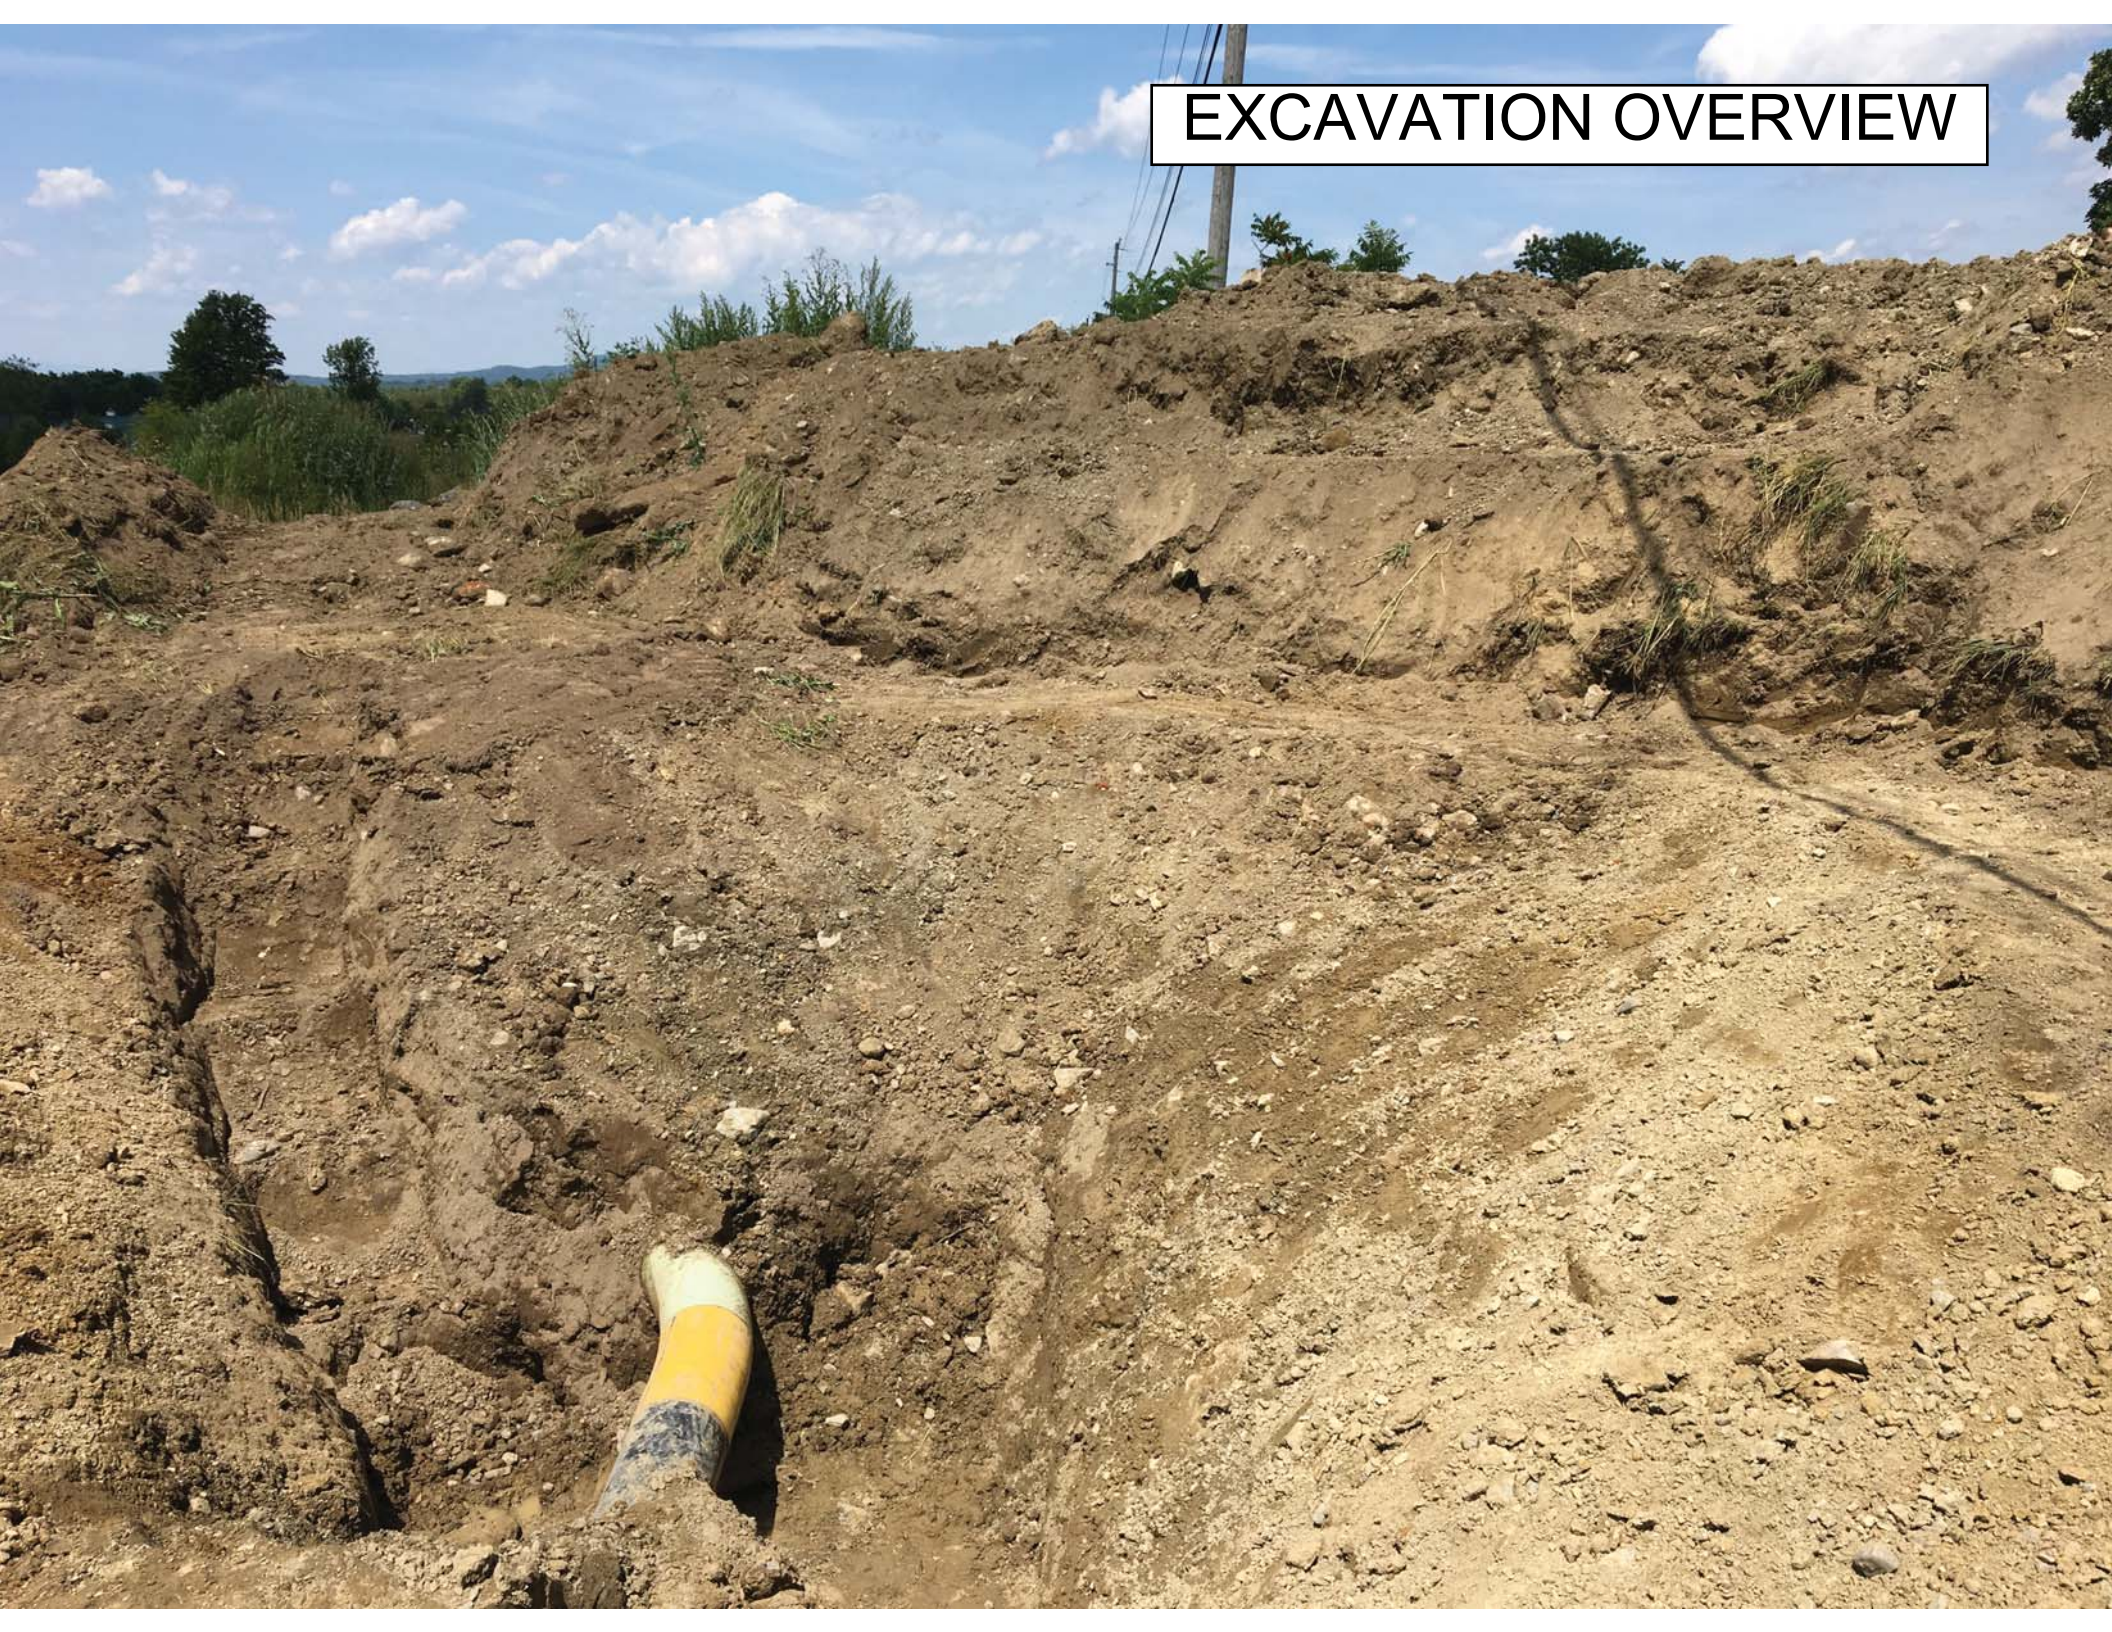
VGS
 WC: 192801.76
 D16 4
 EXISTING
 COATING
 12:00
 A
