### MEMORANDUM

RE: Addison Natural Gas Project (ANGP) Pipe Laid on Trench Bottom

# **Areas Pipe Lays on Ground or Pipe Using Dirt Berms**

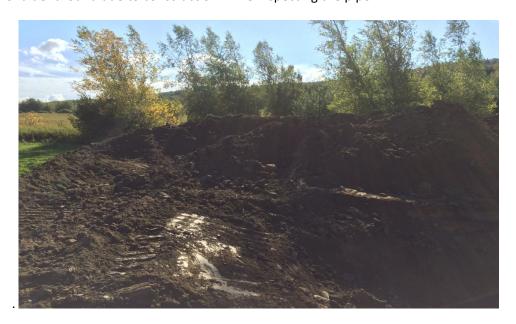
Excavation dirt pile with clumps of clay and no rocks.

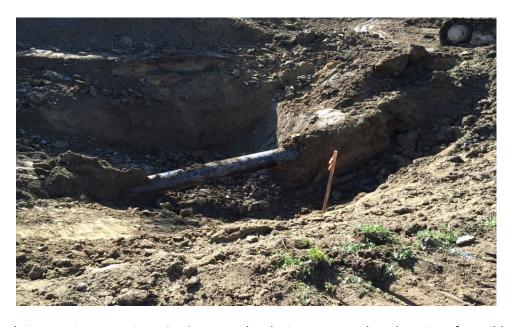
The Enduro Pipeline Services caliper inspection detected a 1.7% deformation in the pipe at the 4:00/4:30 location on the pipe at station 565+85, indicating a possible dent in the pipe. Pictures below show no rocks were detected around the pipe or anywhere in the excavation. Pictures also show no indication of a dent found due to construction while inspecting the pipe.

Exposed pipe section at station 565+85. Moved stake into area to show location of possible dent.

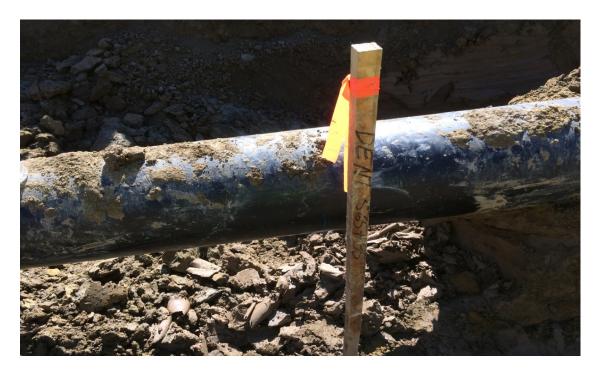
No dent or coating damage spotted at station 565+85 after cleaning the pipe and thoroughly inspecting the pipe by hand. Checked the pipe several feet upstream and downstream of station number.

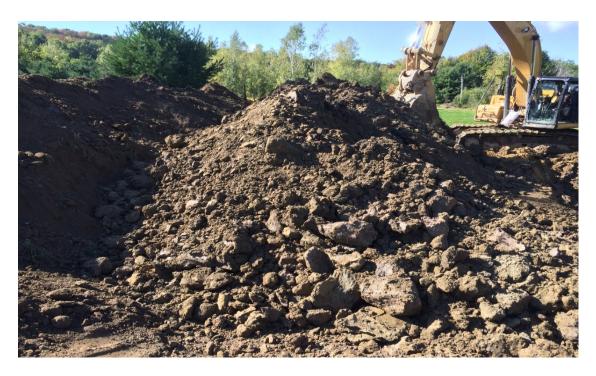
Excavation dirt pile with clumps of clay and no rocks. Expanded excavation to locate weld 0193.

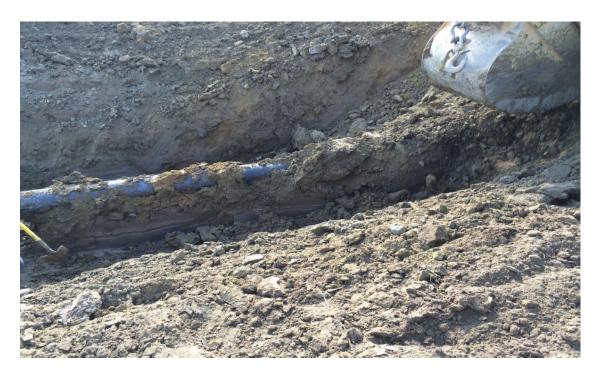
Exposing more pipe to weld 0193. No rocks detected just clumps of clay and clay topsoil mix.

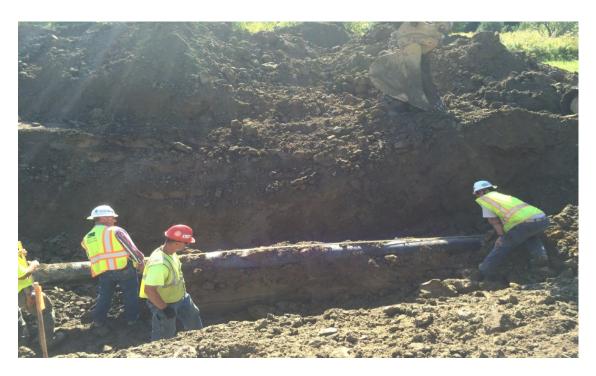
Measurement of 17' from weld 0193 to possible dent to confirm location.

Confirmation measurement came to the same location from the first location observed based point set by survey. No dent detected due to a construction condition on any part of the pipe upstream or downstream of station 565+85. Re-inspected the pipe by hand several feet upstream and down stream of station 565+85 to feel for any damage. Also inspected pipe for damage in the entire section exposed. No coating damage detected or indication of a dent due to construction in the section of pipe exposed.

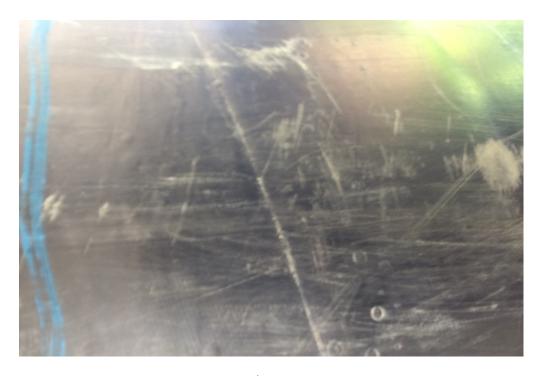
Close up picture of station 565+85 at the 4:00/4:30 location. No coating damage or dent detected
