**STATE OF VERMONT
PUBLIC UTILITY COMMISSION**

Notice of Probable Violations by Vermont Gas)
Systems, Inc. for certain aspects of the) Case No. 18-0395-PET
construction of the Addison Natural Gas)
Project)

RESPONSE OF VERMONT GAS SYSTEMS, INC. TO DPS FEBRUARY 16, 2018 NOPV

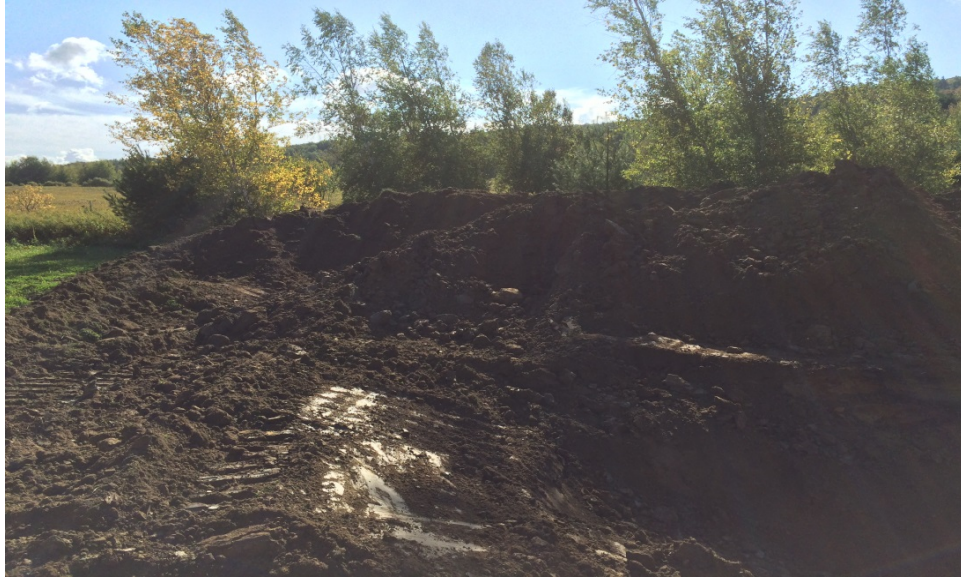
The Enduro Pipeline Services caliper inspection detected a 1.7% deformation in the pipe at the 4:00/4:30 location on the pipe at station 565+85, indicating a possible dent in the pipe. Pictures below show no rocks were detected around the pipe or anywhere in the excavation. Pictures also show no indication of a dent found due to construction while inspecting the pipe.

Excavation dirt pile with clumps of clay and no rocks.

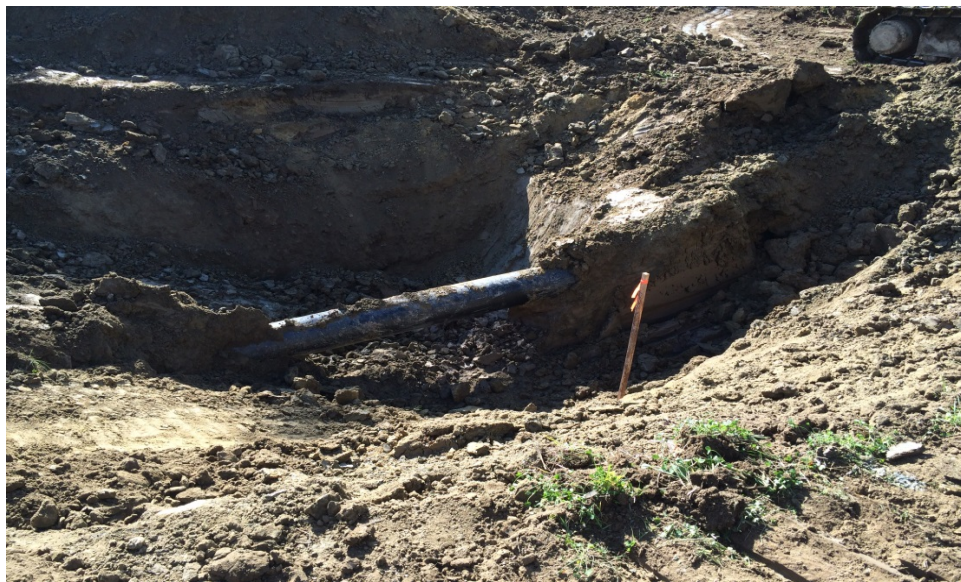
ANGP Pipeline Anomaly Dig, @ station 565+85

Exposed pipe section at station 565+85. Moved stake into area to show location of possible dent.

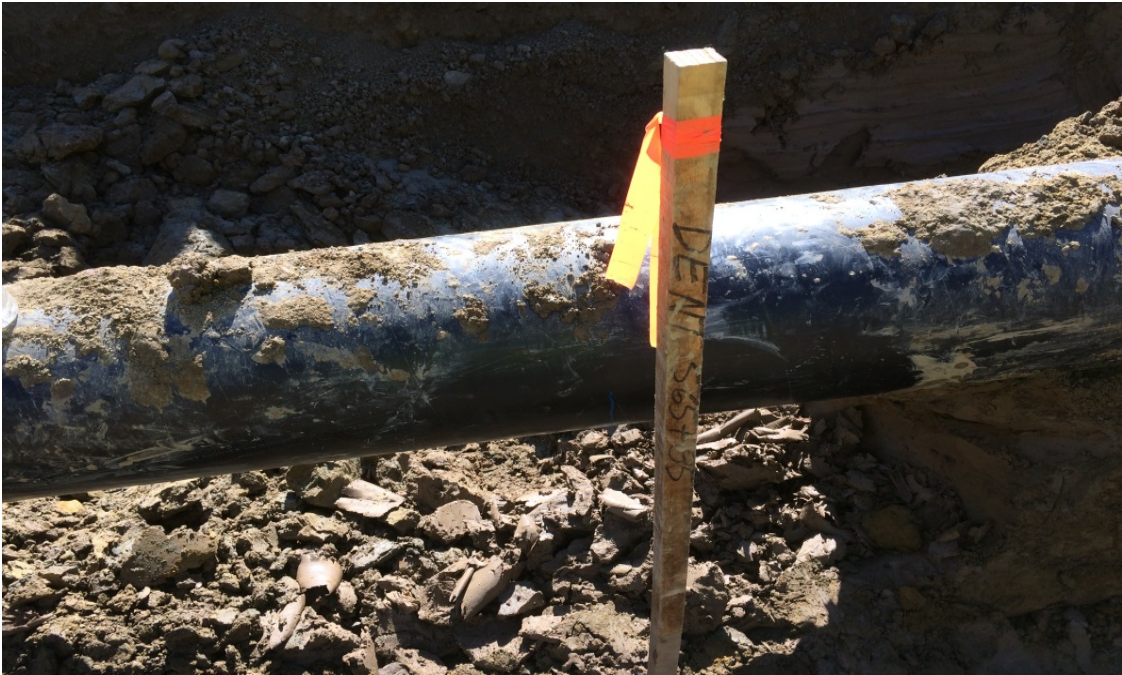
No dent or coating damage spotted at station 565+85 after cleaning the pipe and thoroughly inspecting the pipe by hand. Checked the pipe several feet upstream and downstream of station number.

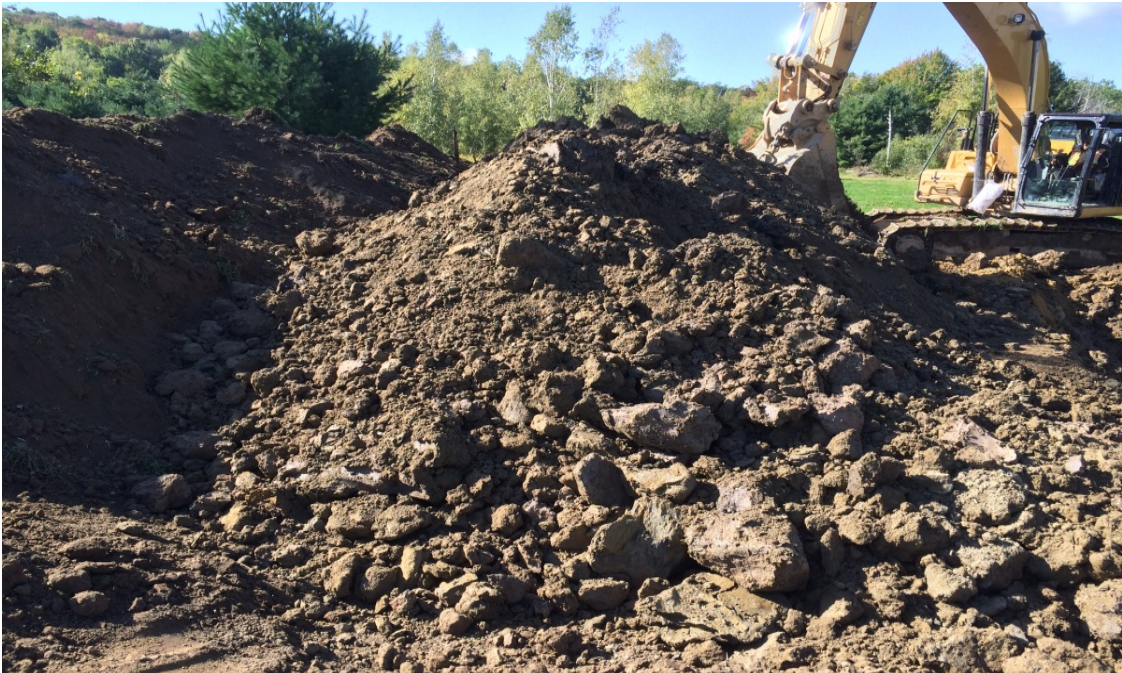
ANGP Pipeline Anomaly Dig, @ station 565+85

Excavation dirt pile with clumps of clay and no rocks. Expanded excavation to locate weld 0193.

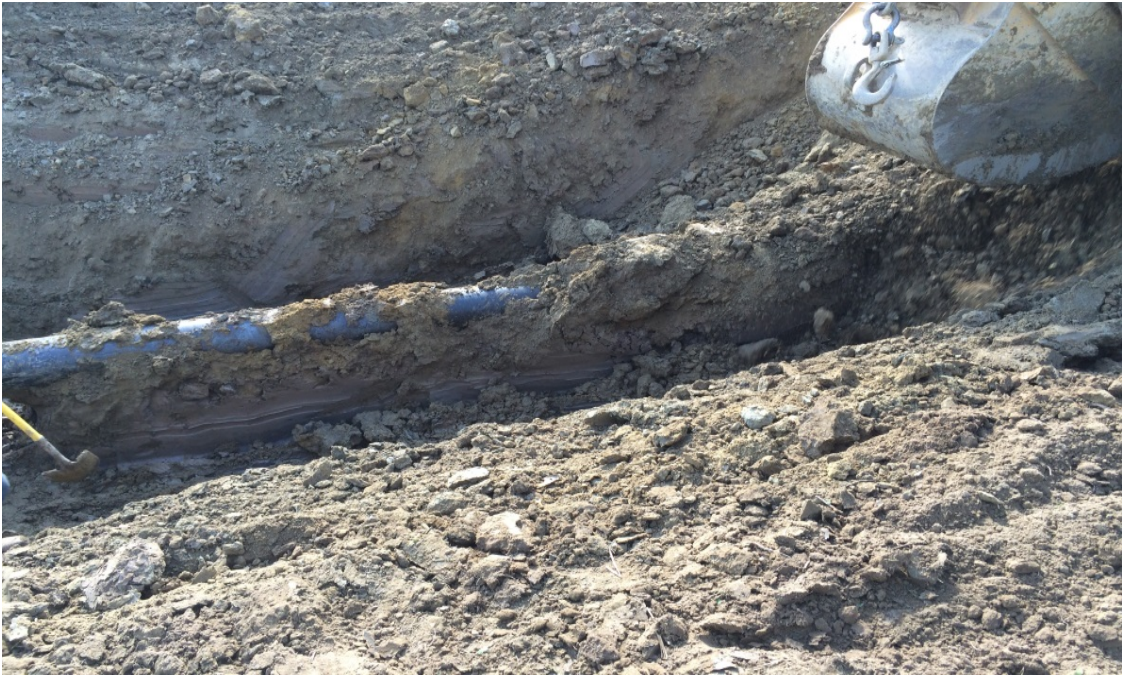
Exposing more pipe to weld 0193. No rocks detected just clumps of clay and clay topsoil mix.

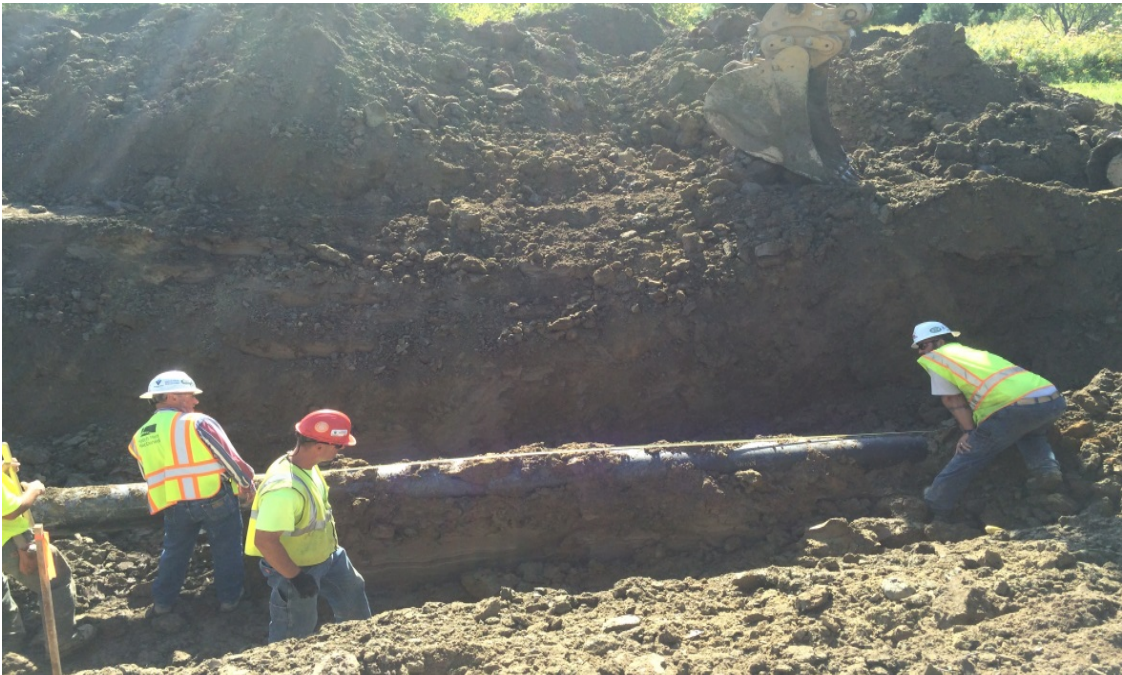
Measurement of 17' from weld 0193 to possible dent to confirm location.

Confirmation measurement came to the same location from the first location observed based point set by survey. No dent detected due to a construction condition on any part of the pipe upstream or downstream of station 565+85. Re-inspected the pipe by hand several feet upstream and down stream of station 565+85 to feel for any damage. Also inspected pipe for damage in the entire section exposed. No coating damage detected or indication of a dent due to construction in the section of pipe exposed.

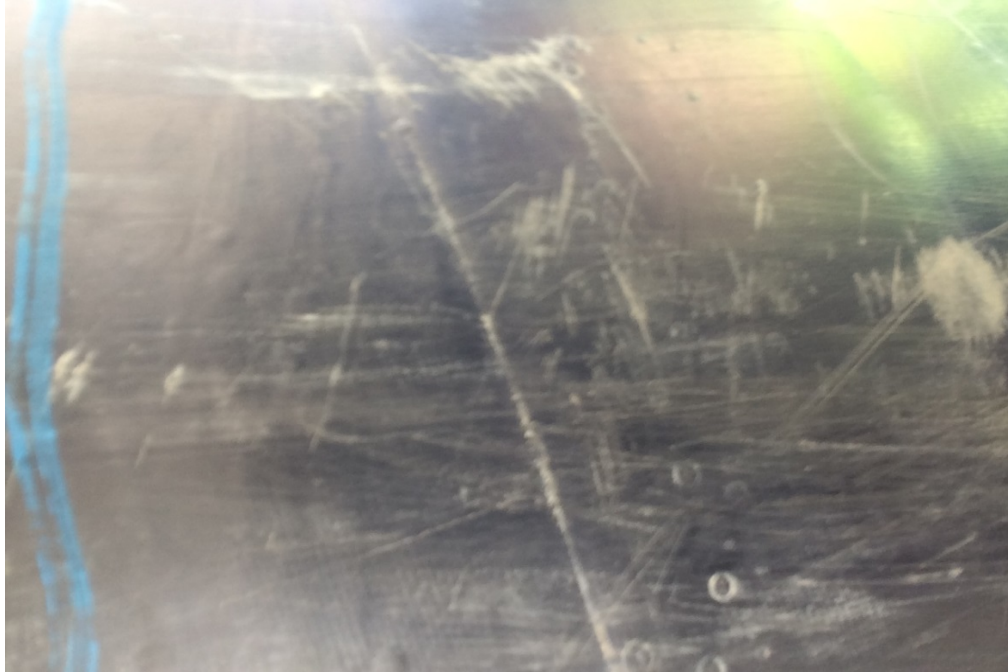
Close up picture of station 565+85 at the 4:00/4:30 location. No coating damage or dent detected

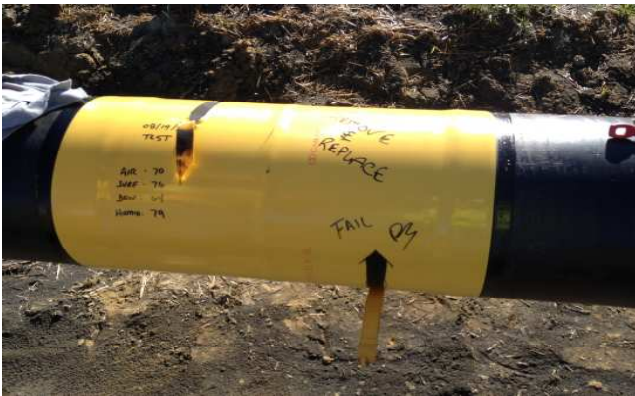
Figure 1: Canusa K-60/L, QA# 13-B-319 SL

The testing and results obtained described above indicate that the Sleeve's performance was normal, acceptable and the peel testing in the field was conducted at a peel failure mode transition temperature (temperature differential). Both results would be considered a PASS.
