Vermont Gas Systems Addison Natural Gas Project  
Road Crossing Observation Report

March 30<sup>th</sup>, 2021

ADDENDUM 1: FINAL OBSERVATIONS

June 24<sup>th</sup>, 2021

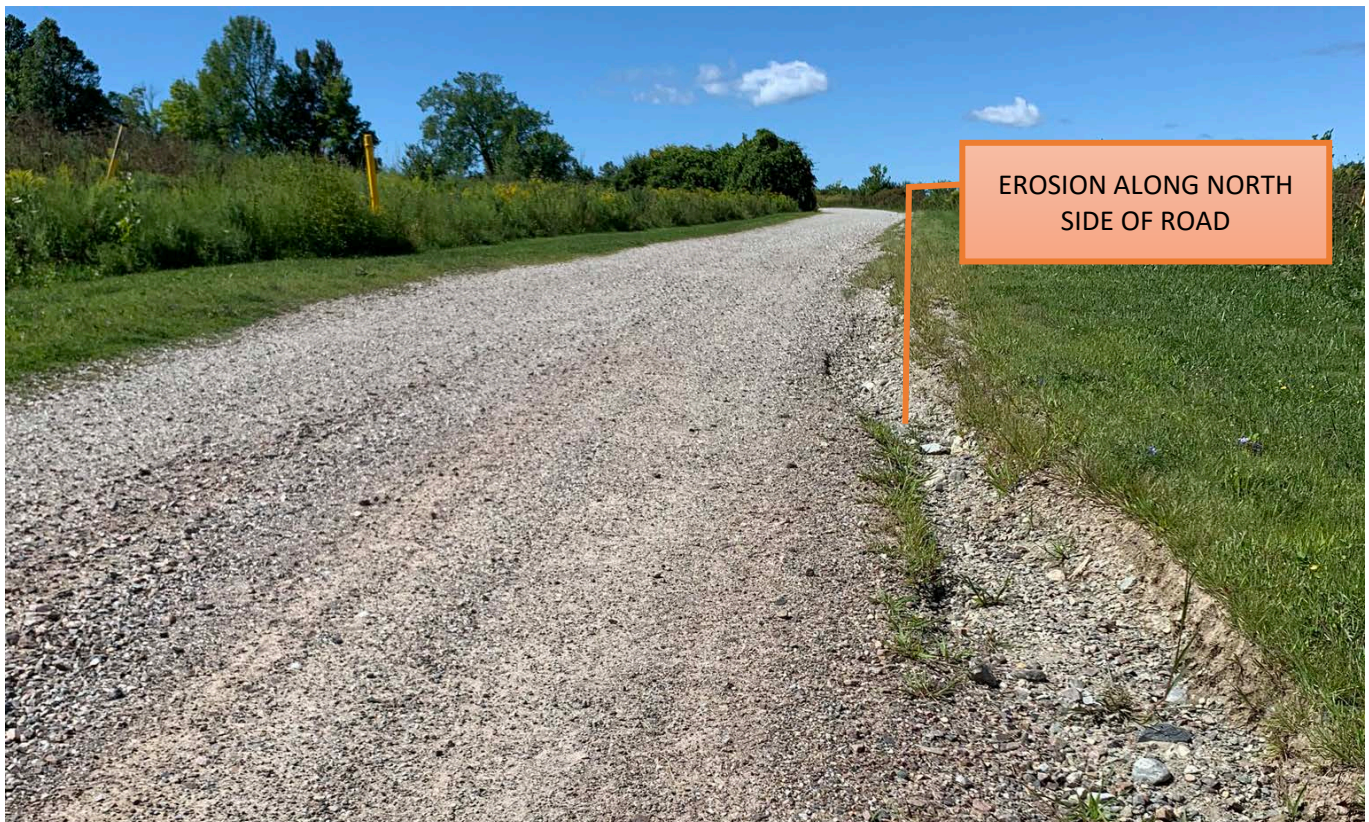
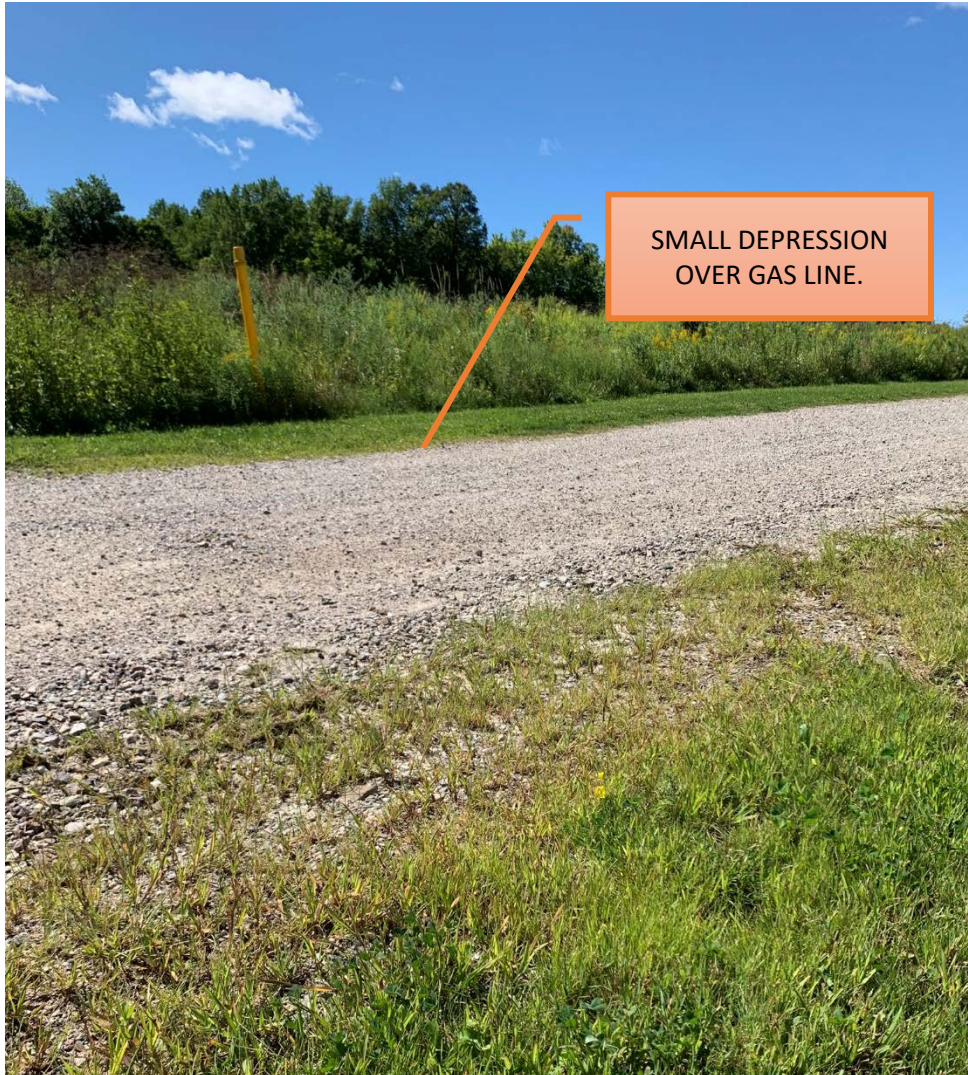
**Location:** Hickory Place (STA 947+95)

- 1"-2" of settlement in road above gas line.
- Settlement appeared to cause stormwater to channel and create erosion along the north side of the road.

- See February 2021 recommendations.

- Monitor during spring thaw, after final freeze-thaw cycle of the season, and during summer 2021 to see if settlement returns.

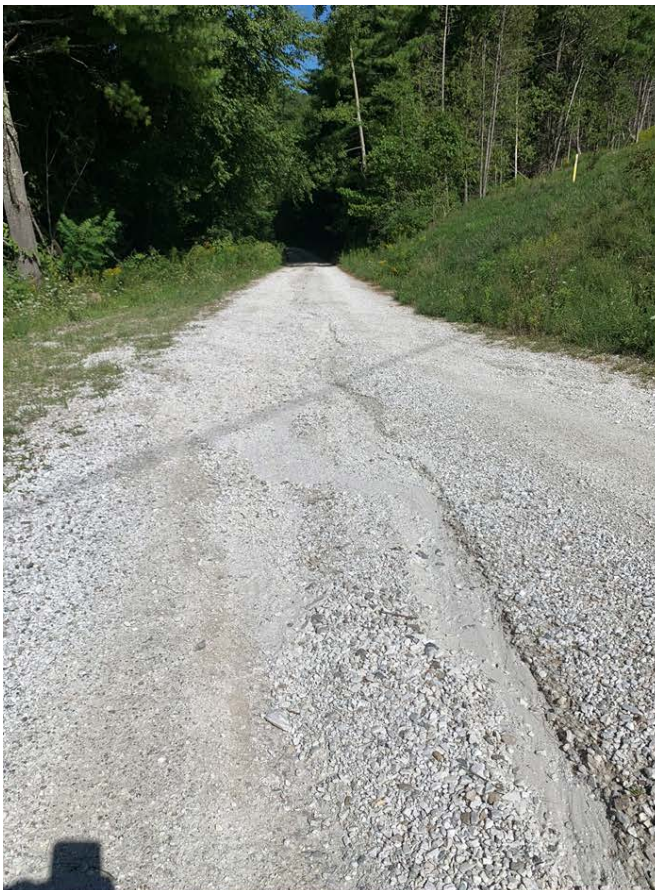
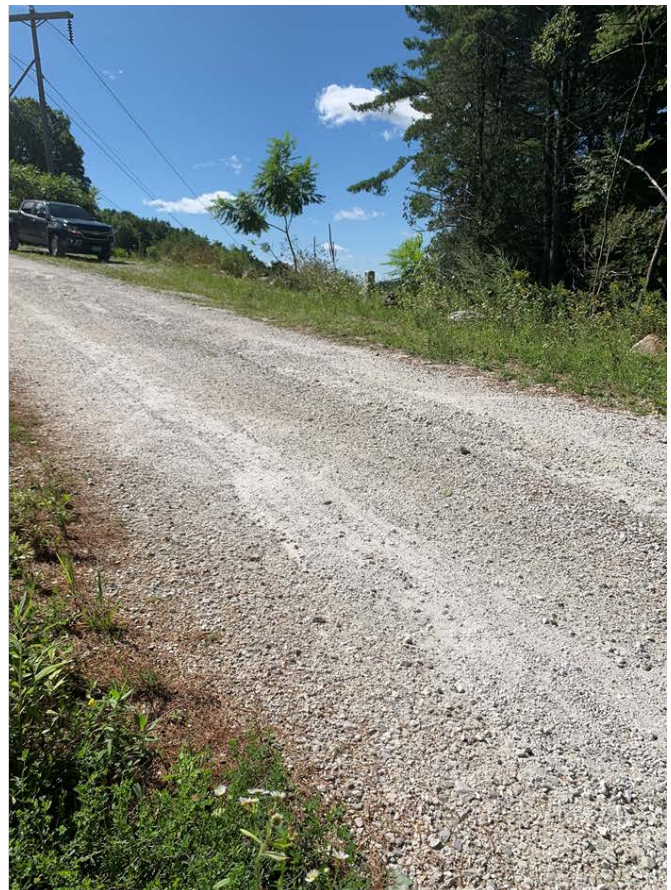
**Location:** Post Road (STA 1424+25)

- Washout in middle of road. The washout does not appear to be caused by settlement from gas line installation, but rather from the lack of proper road surface grading.

- Roadway should be regraded by Owner to force runoff to drain to one, or both, of the roadside swales.

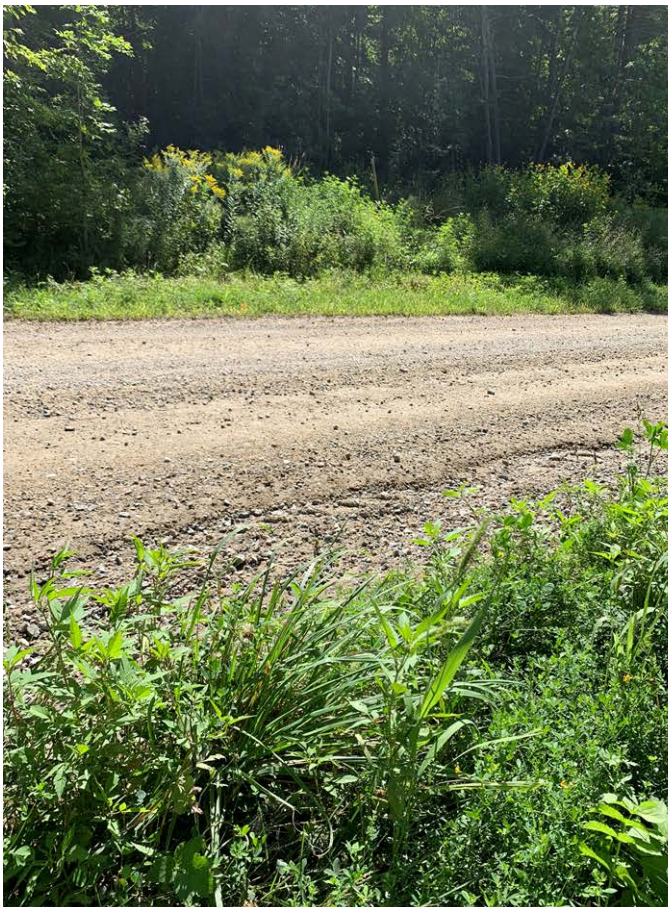
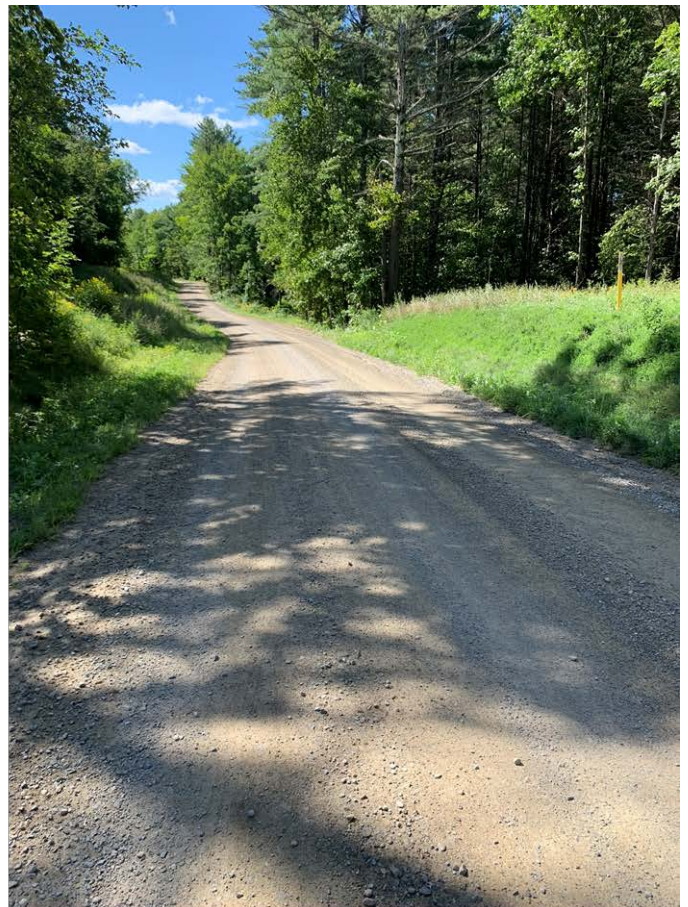
**Location:** Old Stage Road (STA 1553+55)

- Visible erosion in swale on west side of the road before it enters into a small swale. The erosion starts uphill from the crossing and does not appear to be caused by the pipe line installation.

- Roadway should be regraded by Town to force runoff to drain to one, or both, of the roadside swales.

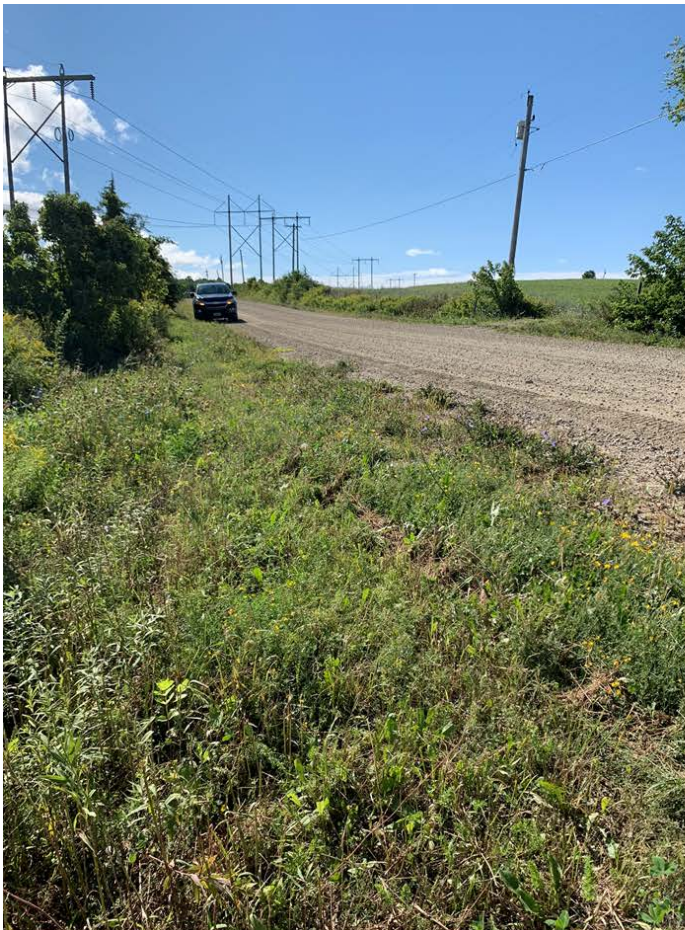
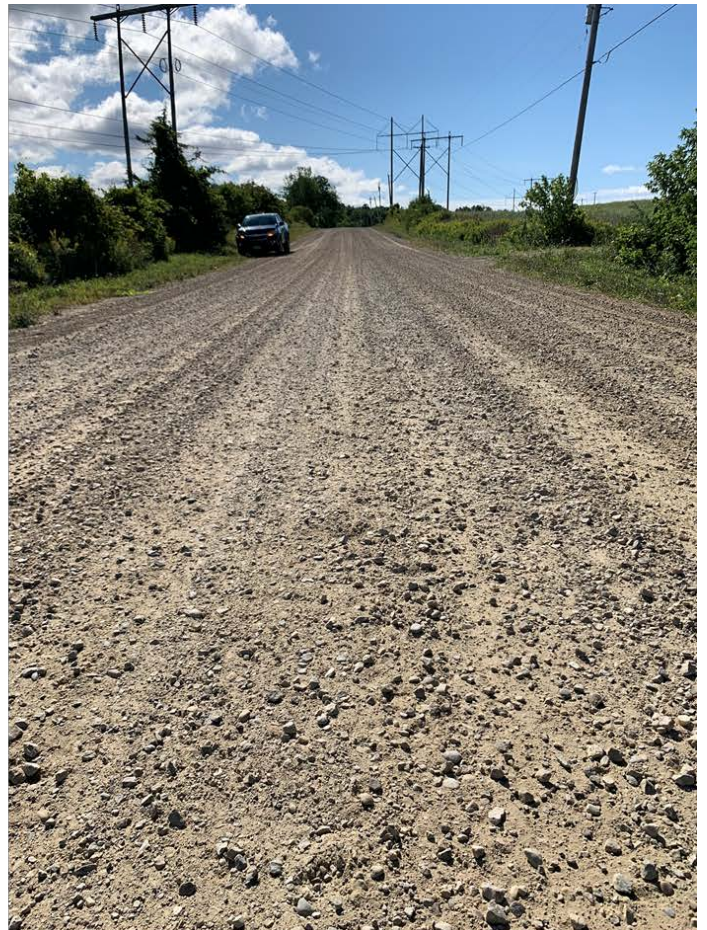
**Location:** Hunt Road (STA 2011+60)

- Small washout located above gas lines at southern edge of road.

- Line swale with stone.

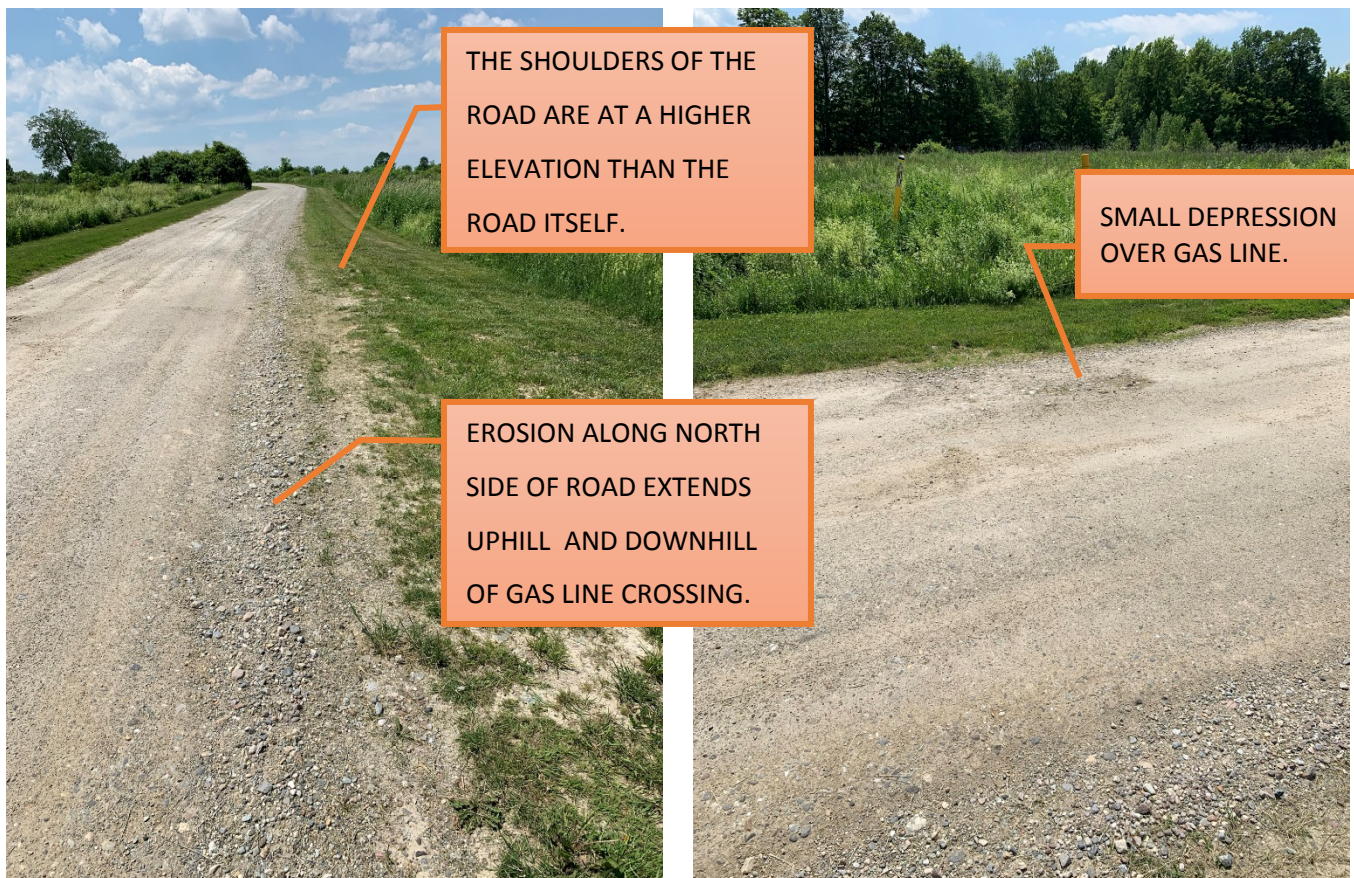
- 1"-2" of settlement in road above gas line.
- Erosion down north side of road. The erosion is not from the gas line installation but from improper road grading.
- VGS should follow up and develop a plan for construction to address the settlement above the gas line.

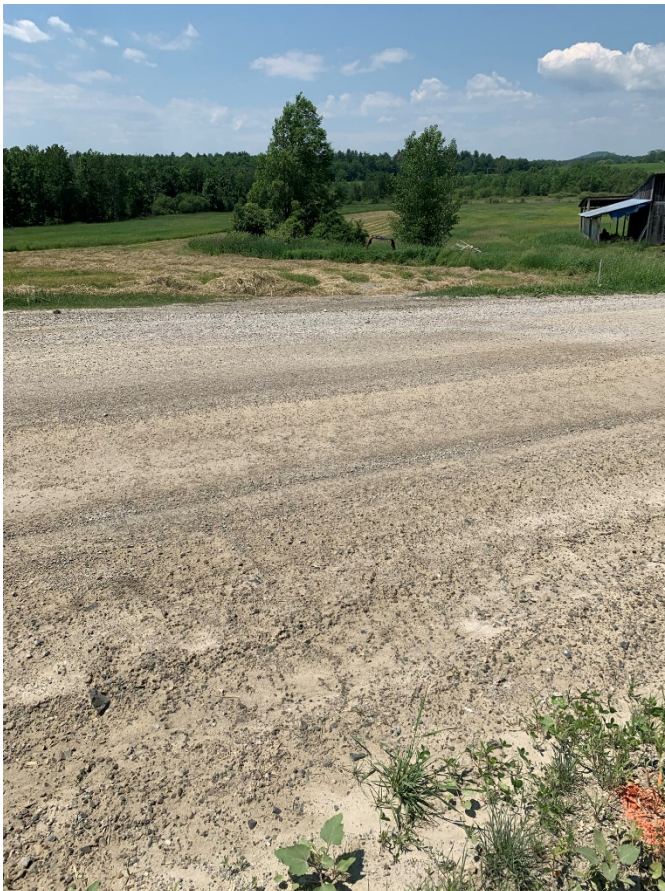
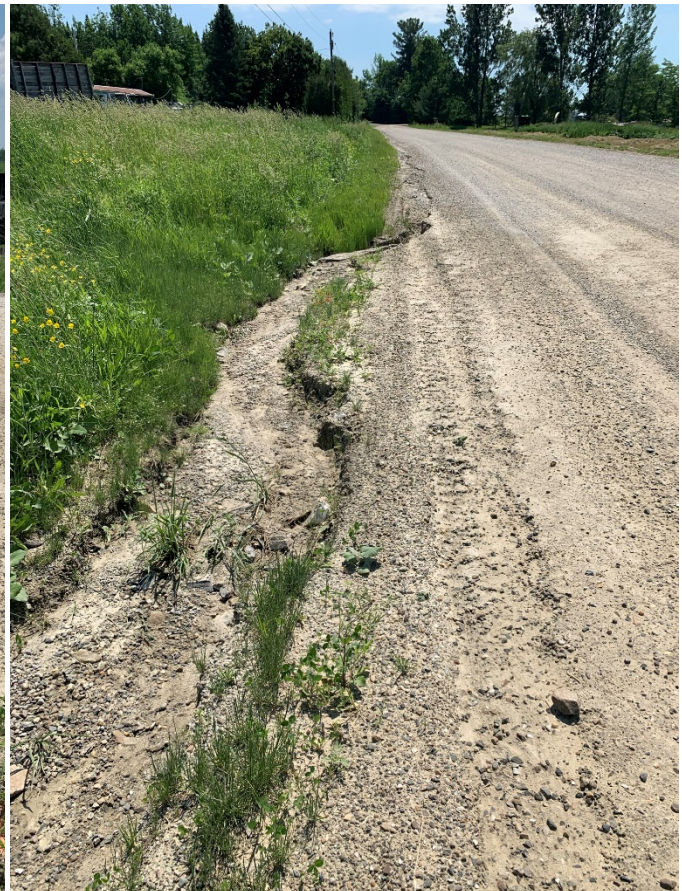
- Erosion along the north side of the road which starts near driveway entrance to barn upslope from crossing and continues downslope of crossing. The erosion is not from the installation of the gas line but from the lack of a well-defined roadside swale along the north side of the road.
- No visible evidence of poor roadbed performance or settlement of road above gas line.

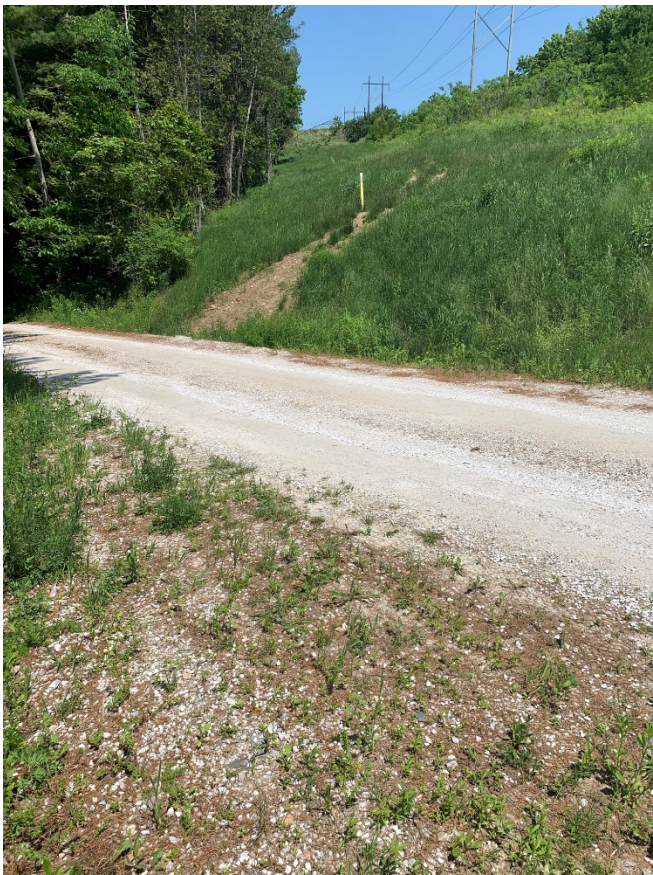
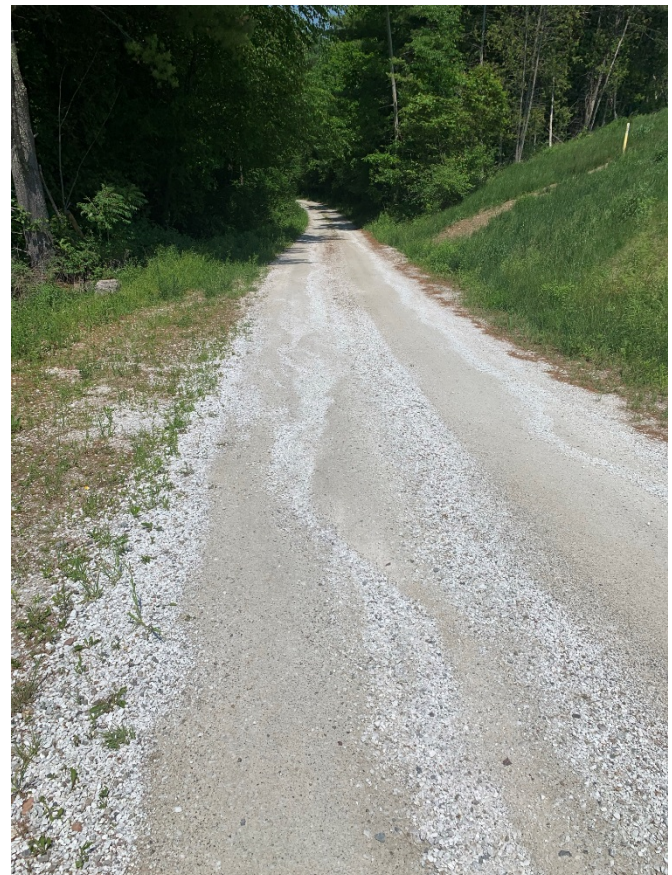
- The washout remains in the middle of the road. It extends uphill of the gas line crossing and continues downslope of the crossing. The erosion is not from the gas line installation but from improper road grading.
- No visible evidence of poor roadbed performance or settlement of road above gas line.

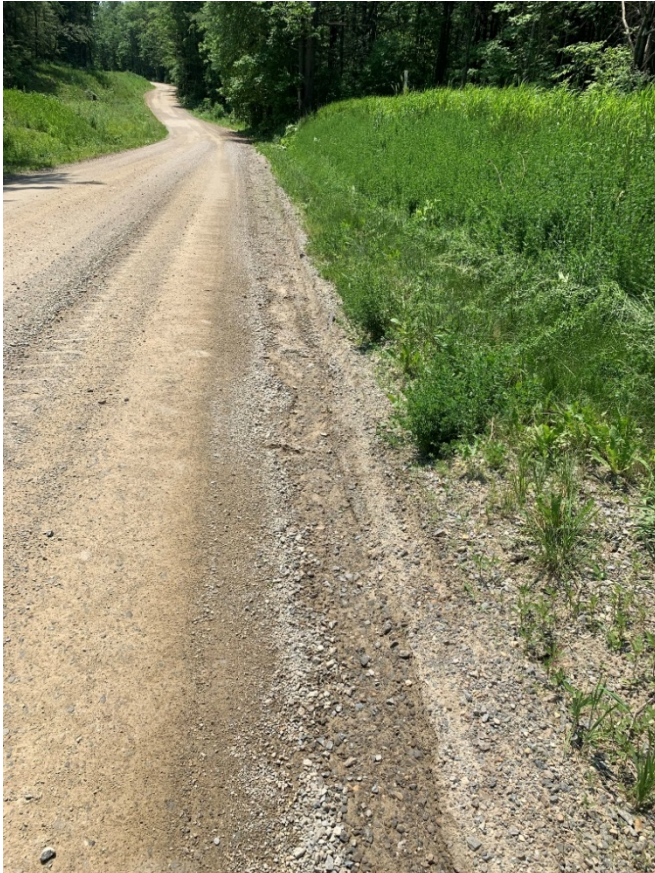
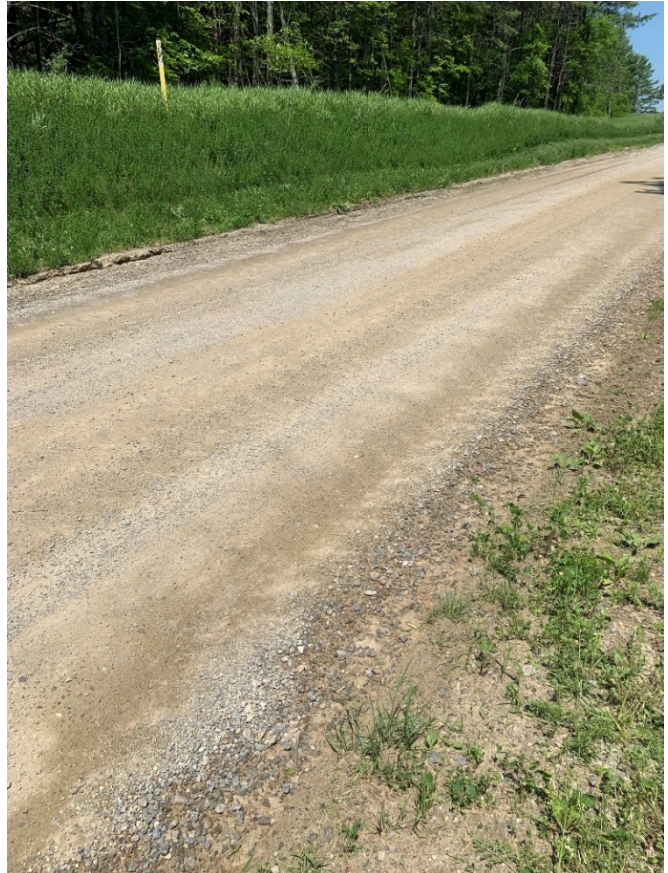
- The road appears to have been regraded in the Spring. The roadside swale along the west side of the road appears to have been filled in during the road regrading. This is causing erosion down the west side of the crowned road as there is no defined area for stormwater to flow. Erosion is not from the gas line installation.
- No visible evidence of poor roadbed performance or settlement of road above gas line.

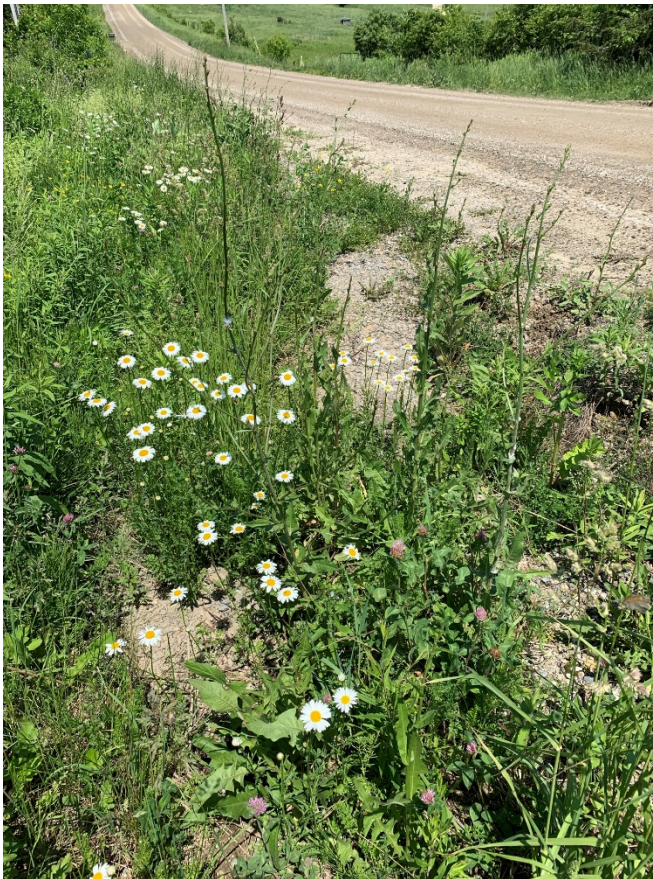
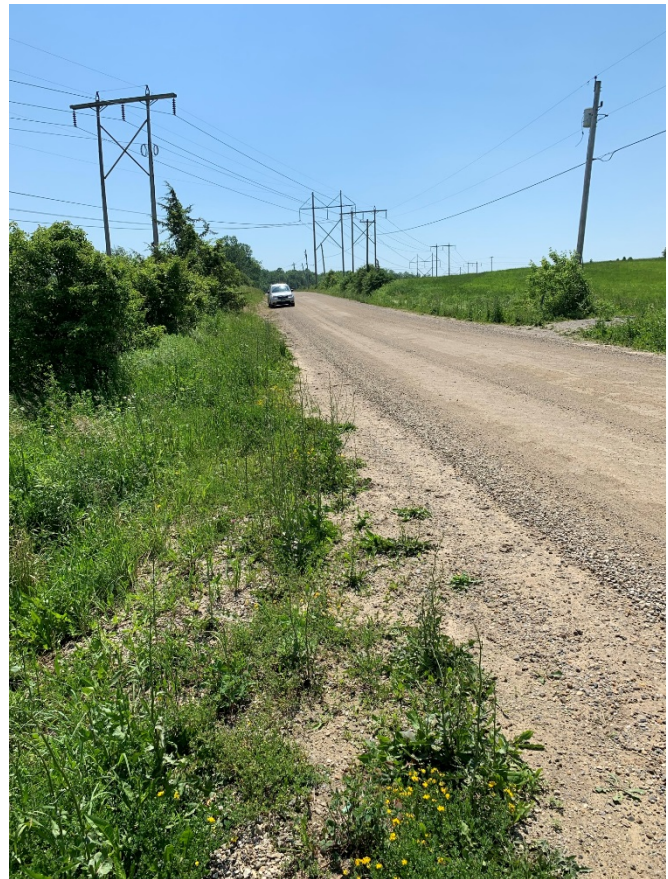
- Small washout located above gas line at southern edge of road.
- VGS should follow up and develop a plan for construction to address the washout above the gas line.
