**VERMONT GAS SYSTEMS, INC.
TRANSMISSION LINE EXPOSURE REPORT**

VERMONT GAS SYSTEMS, INC.
TRANSMISSION LINE EXPOSURE REPORT
SUPPLEMENTAL FOR ASSESSMENT EXCAVATIONS

Date: 7/30/2019	Location: Excavation Site 1 - Breezy Valley Storage	Town: St. George
Project/Work Plan Date: 07/30/2019	Revision #: 0	Pipe Diameter: 12"
Length of Pipe Exposed & Inspected: Exposed 4' of Pipe, Removed Approx. 18" of Coating		
Pipe Condition: Good. Found Pritec coating (on pipe), Canusa shrink wrap (on weld), and wax tape over previous coating removal all in good shape.		
Jeeping Results: Good. Jeeped at 7000v, no coating anomalies found.		
Trench and Backfill Conditions (described area around pipe, note presence of rocks, sandbags, rockshield, etc.): Found clean, rock-free clay. Sand Bags under weld.		
Indication/Anomaly Found:	Wall Loss <input checked="" type="checkbox"/>	Dent <input type="checkbox"/>
	Manufacturing Anomaly <input type="checkbox"/>	Other: _____
	Ovality <input type="checkbox"/>	Weld Anomaly <input type="checkbox"/>
		N/A <input type="checkbox"/>
Dimension of Indication/Anomaly (if found):	Length = 0.768"	Width = 0.885"

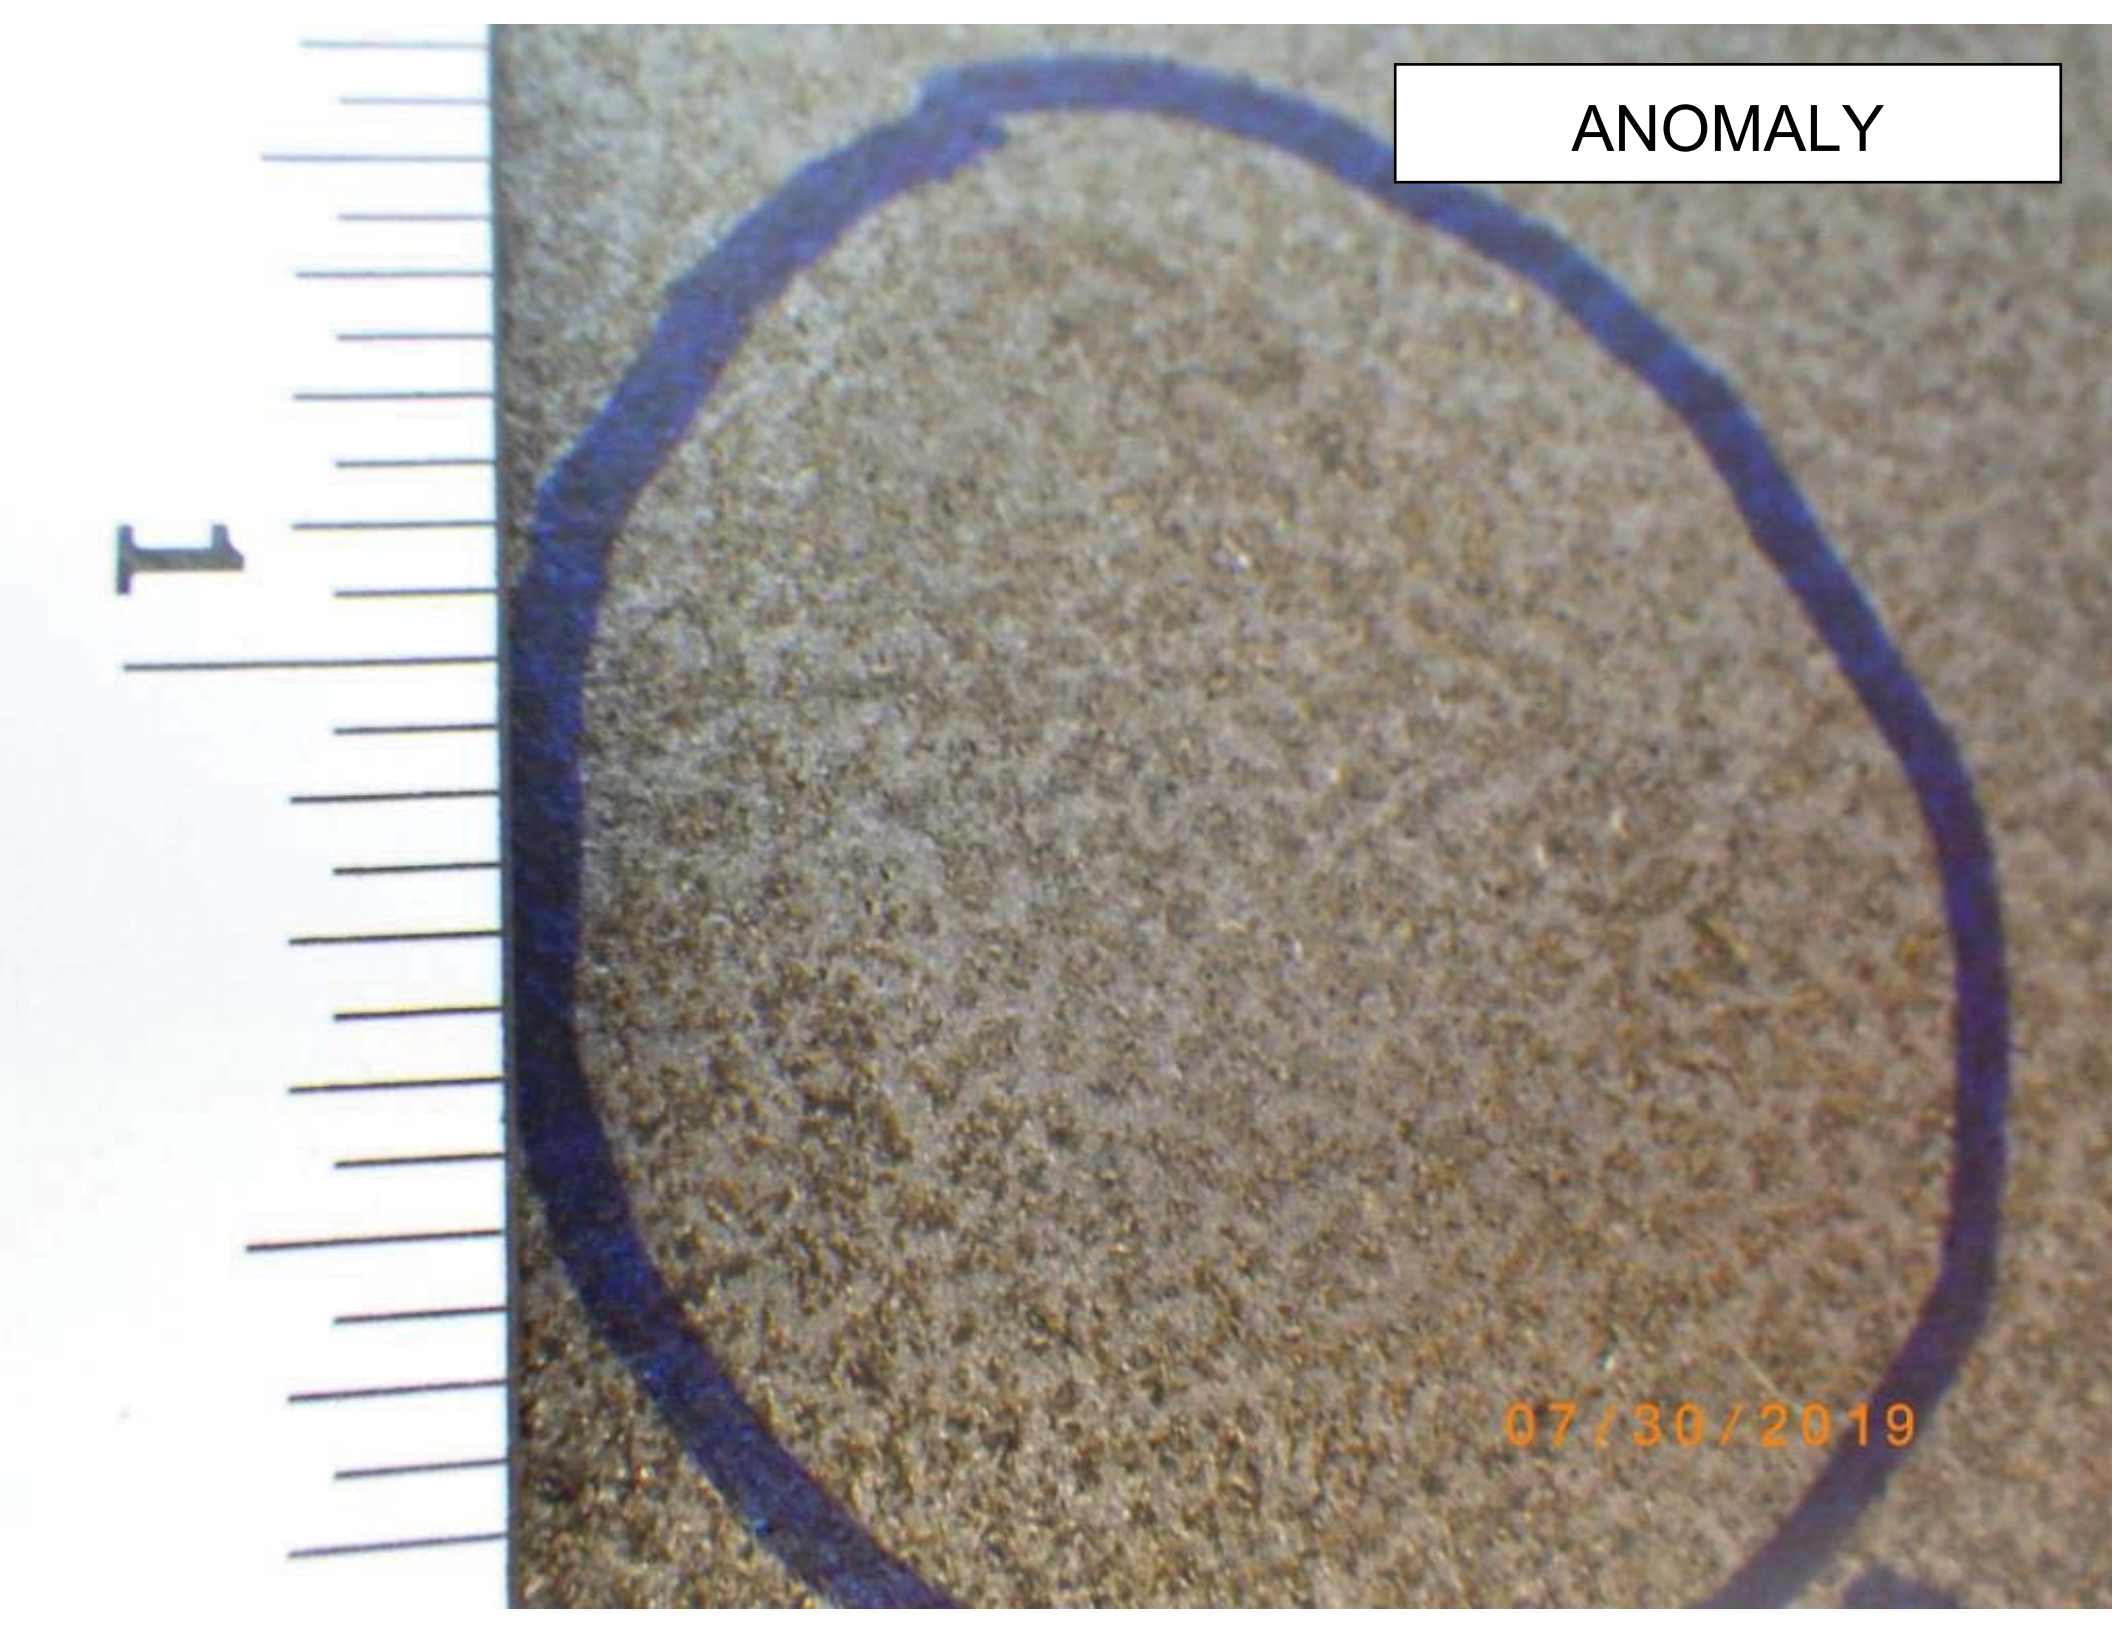
Depth = 0.029"
Repair Made: Yes <input type="checkbox"/> No <input checked="" type="checkbox"/>	Length of Repair: <u>N/A</u>	
Repair Type (i.e. Clock Spring, Weld Sleeve, etc.): <u>N/A</u>		
Repair Notes: Anomaly was a smooth grind repair. See photos.		
ADDITIONAL COMMENTS: Used laser scanning mapping to measure anomaly LxWxD. The maximum depth of anomaly of 0.029" equates to 9.4% wall reduction.

ANOMALY
