**VERMONT GAS SYSTEMS, INC.
TRANSMISSION LINE EXPOSURE REPORT**

VERMONT GAS SYSTEMS, INC.
TRANSMISSION LINE EXPOSURE REPORT
SUPPLEMENTAL FOR ASSESSMENT EXCAVATIONS

Date: 7/30/2019	Location: Excavation Site 2 - Baldwin Road	Town: Hinesburg
Project/Work Plan Date: 07/30/2019	Revision #: 0	Pipe Diameter: 12"
Length of Pipe Exposed & Inspected: Exposed 4' of Pipe, Removed Approx. 2' of Coating		
Pipe Condition: Good. Pipe wrapped in rockshield. Found Pritec coating (on pipe) and Canusa shrink wrap (on weld) in good shape.		
Jeeping Results: Good. Jeeped at 7000v, no coating anomalies found.		
Trench and Backfill Conditions (described area around pipe, note presence of rocks, sandbags, rockshield, etc.): Trench had rocks. Soil around pipe was sandy soil mixed with small rocks. Pipe wrapped in rockshield. South of weld found sandbag trenchbreaker.		
Indication/Anomaly Found:	Wall Loss <input checked="" type="checkbox"/>	Dent <input type="checkbox"/>
	Manufacturing Anomaly <input type="checkbox"/>	Other: _____
	Ovality <input type="checkbox"/>	Weld Anomaly <input type="checkbox"/>

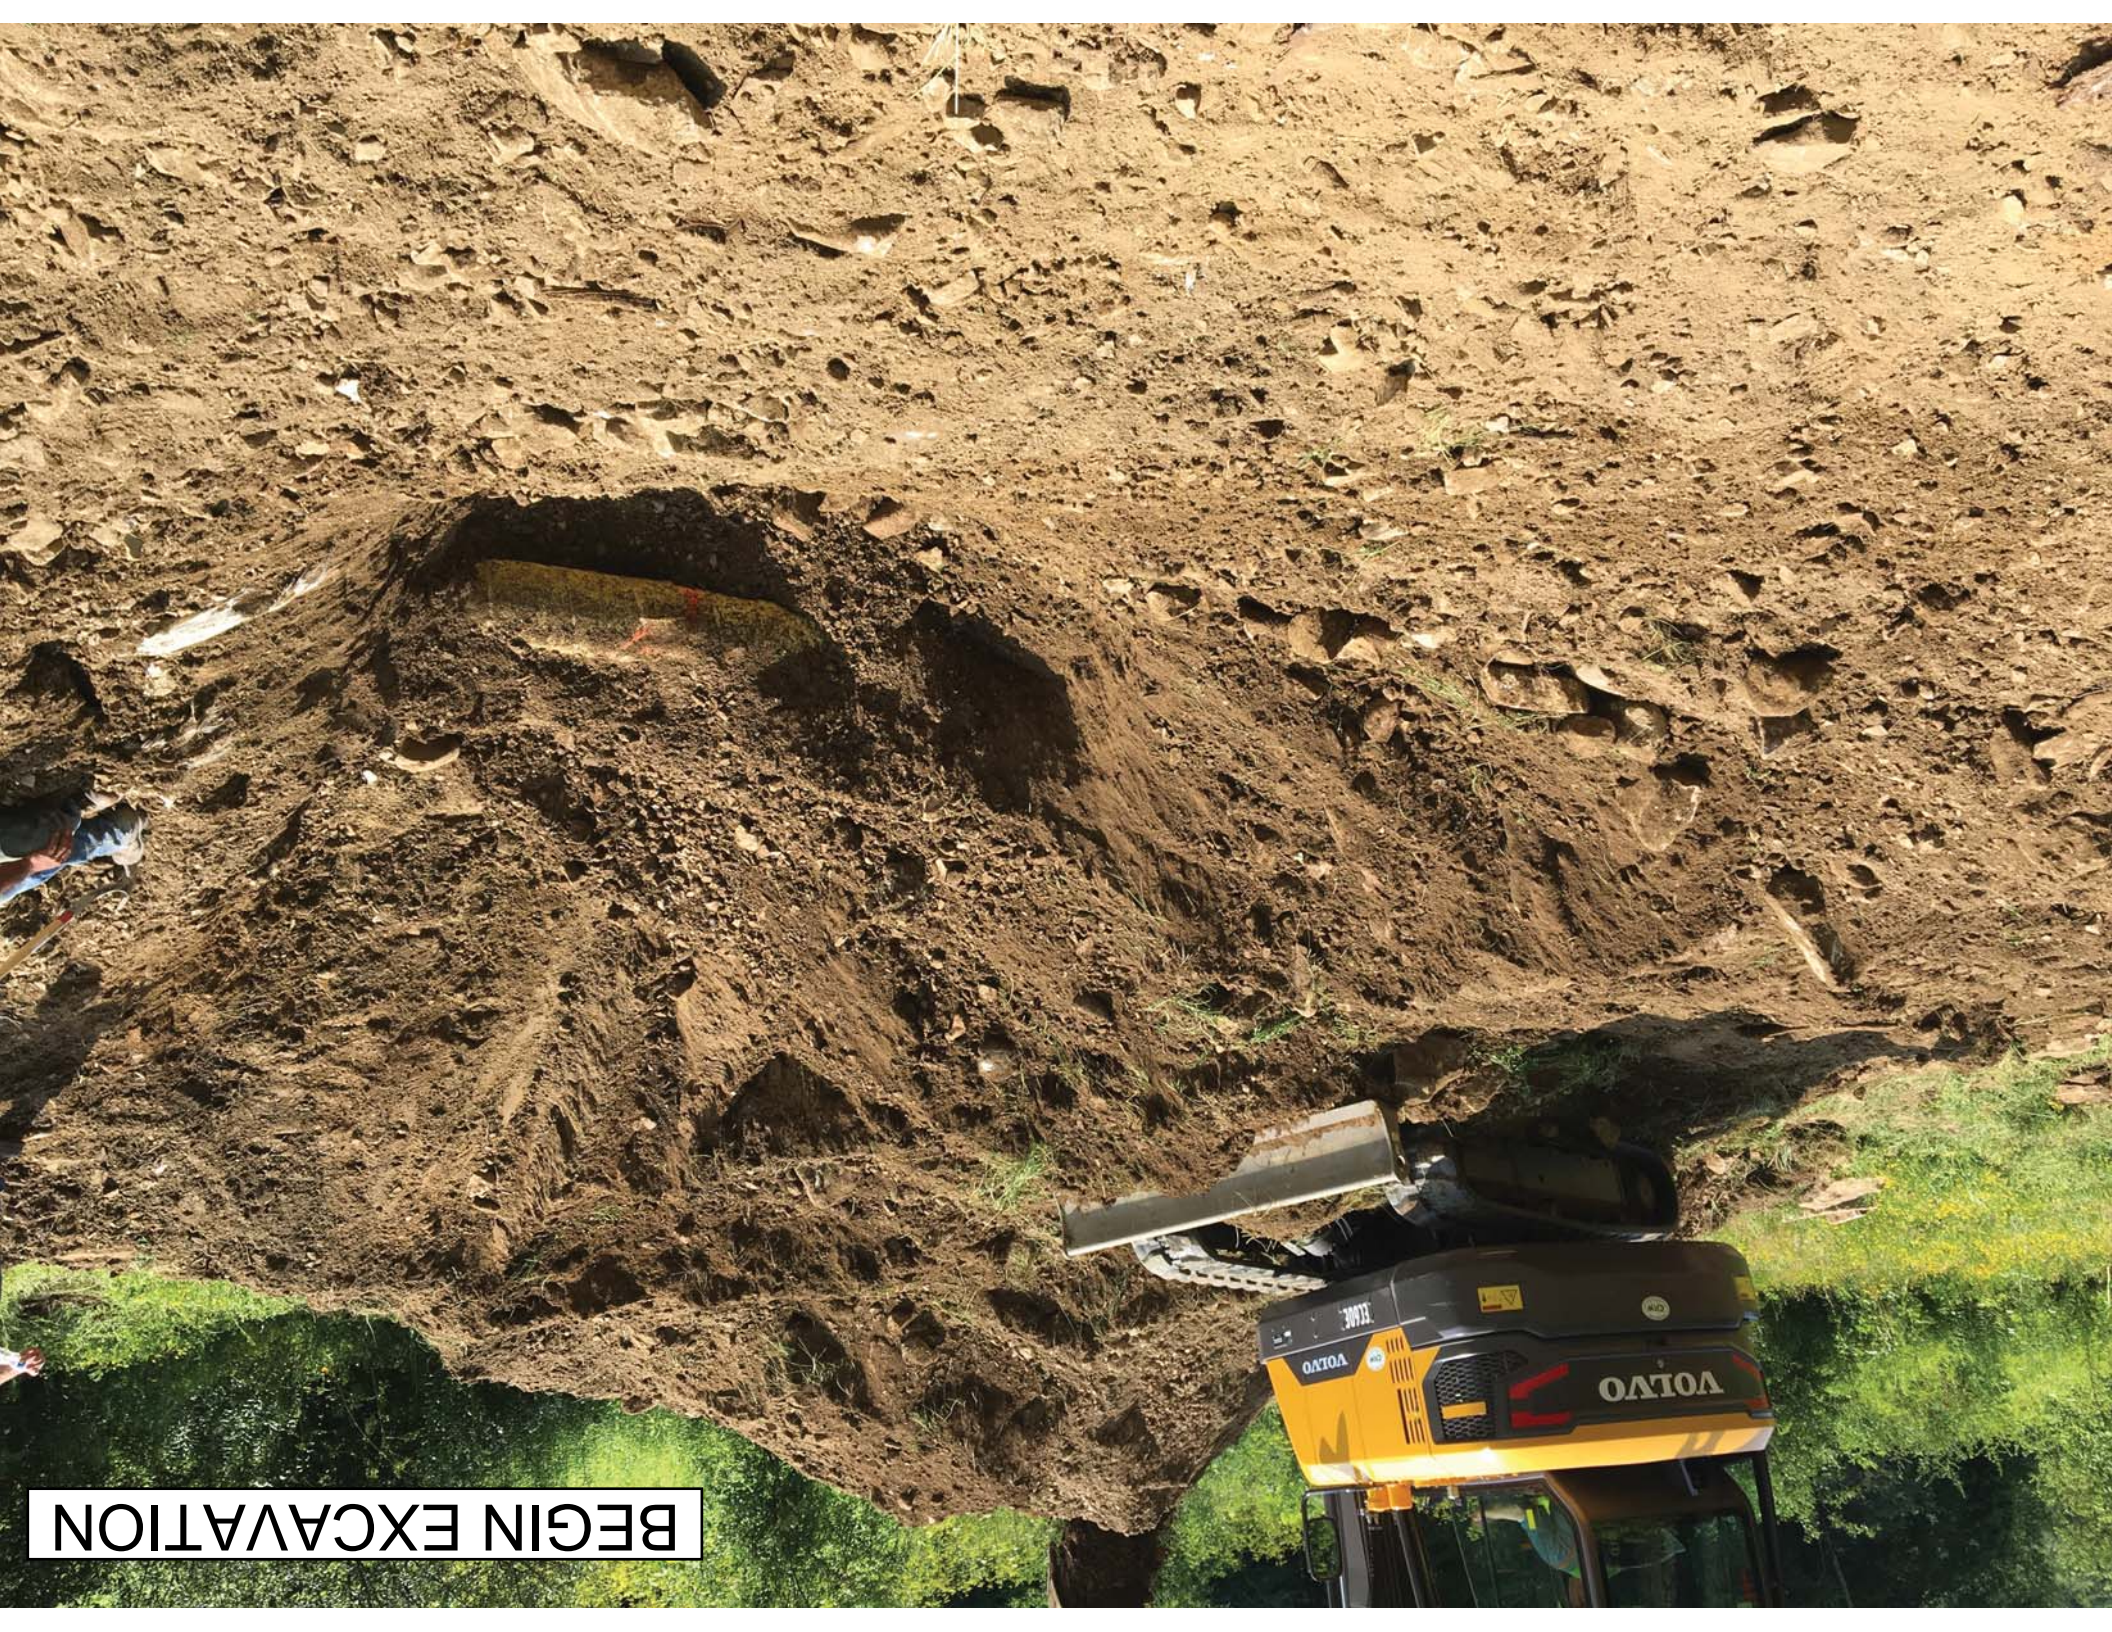
BEGIN EXCAVATION

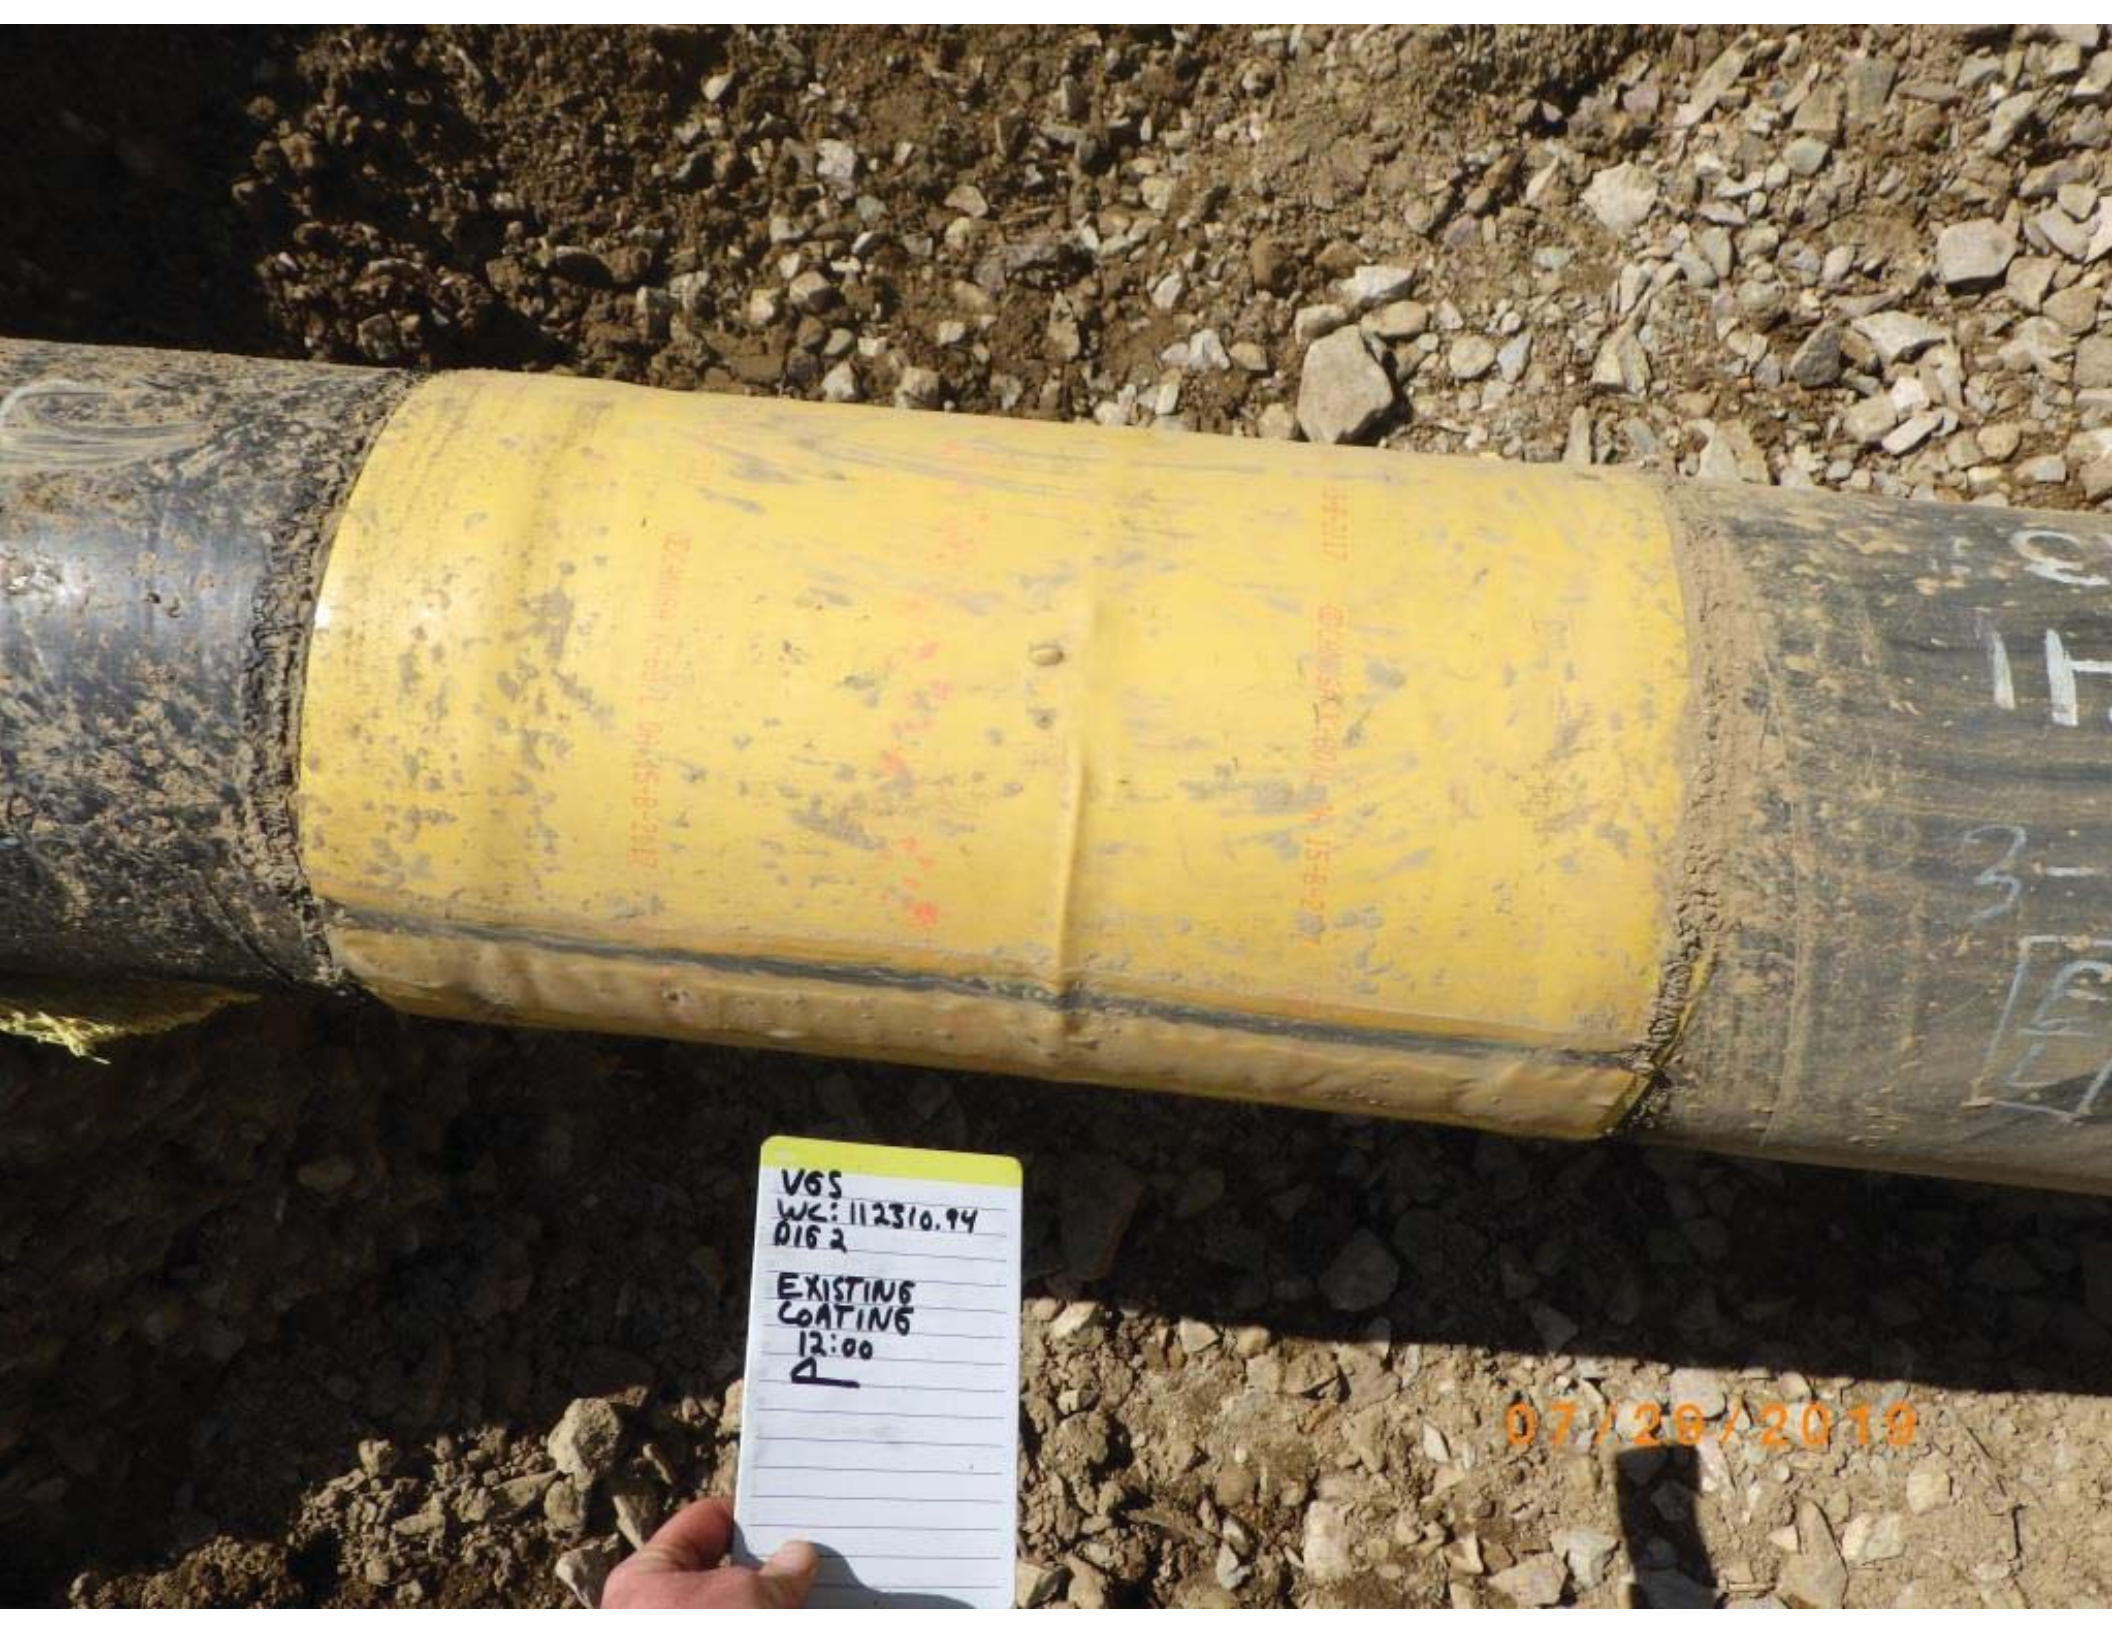
**EXCAVATION OVERVIEW
(FACING NORTH)**

V65
WC: 112310.94
D16.2
EXISTING COATING
12:00
A

EXISTING
CRATING

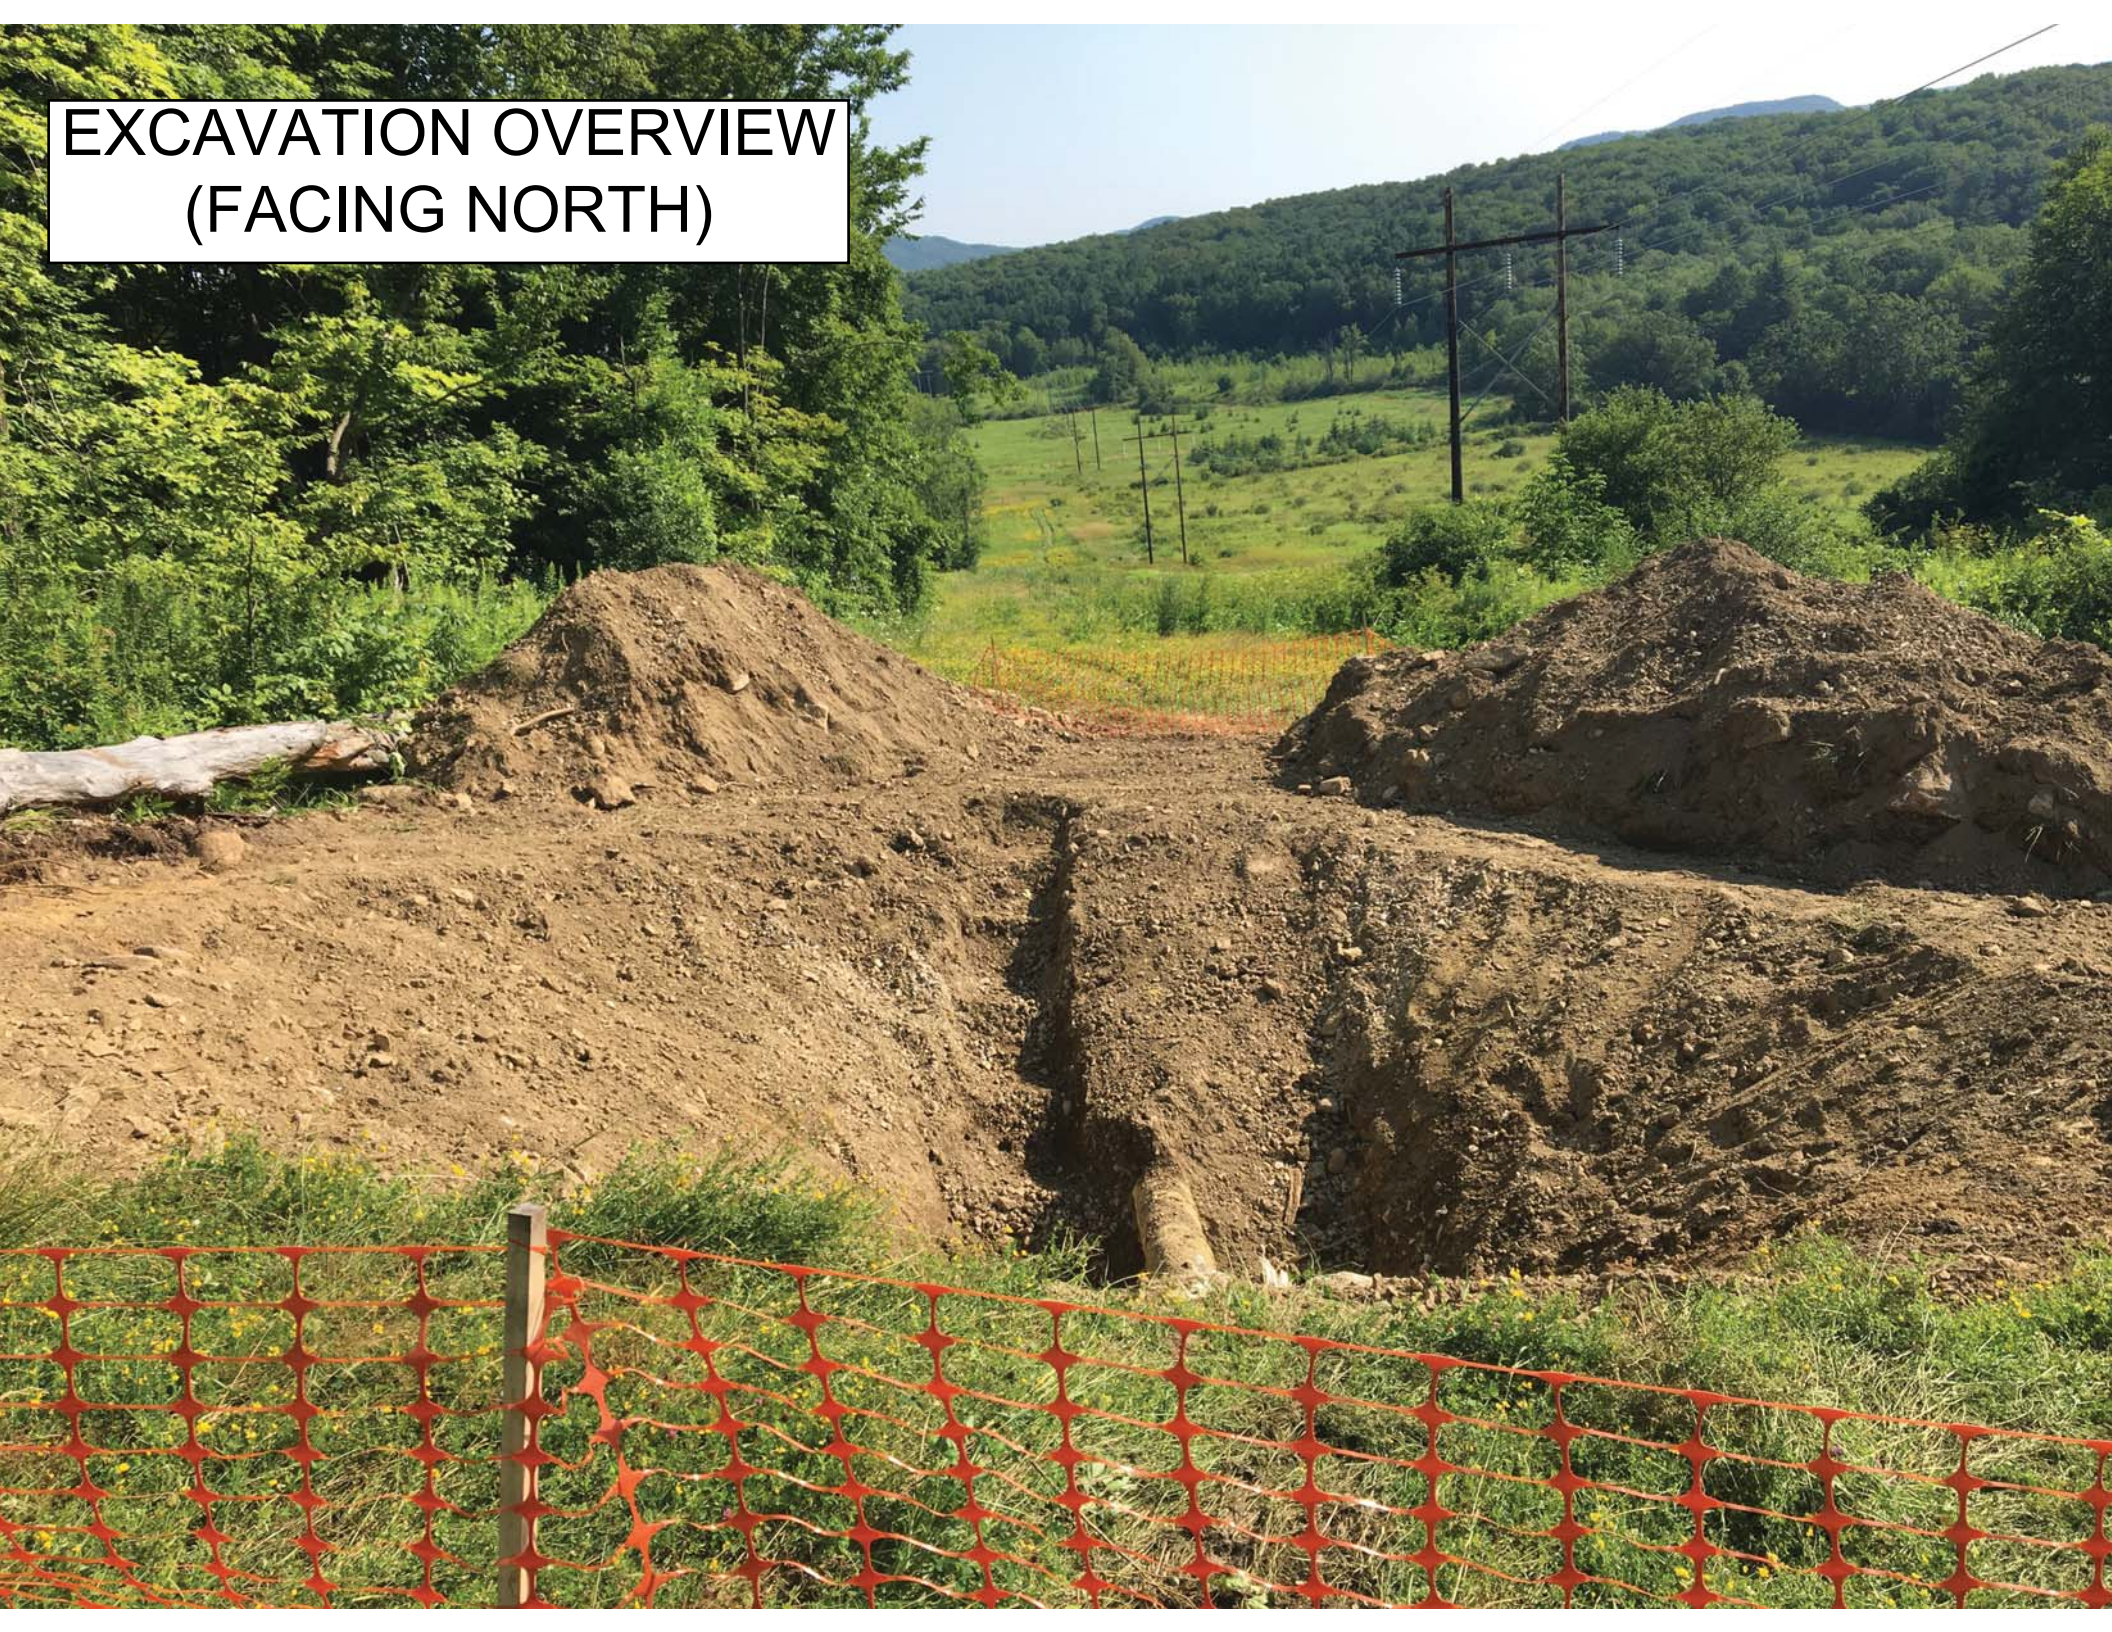
N/A <input type="checkbox"/>
Dimension of Indication/Anomaly (if found):	Length = 0.826"	Width = 1.183"
		Depth = 0.032"
Repair Made: Yes <input type="checkbox"/> No <input checked="" type="checkbox"/>	Length of Repair: <u>N/A</u>	
Repair Type (i.e. Clock Spring, Weld Sleeve, etc.): <u>N/A</u>		
Repair Notes: Anomaly was a smooth grind repair. See photos.		
ADDITIONAL COMMENTS: Used laser scanning mapping to measure anomaly LxWxD. The maximum depth of anomaly of 0.032" equates to 10.3% wall reduction.

MEDIA BLASTED
PIPE
9:00
A

ANOMALY

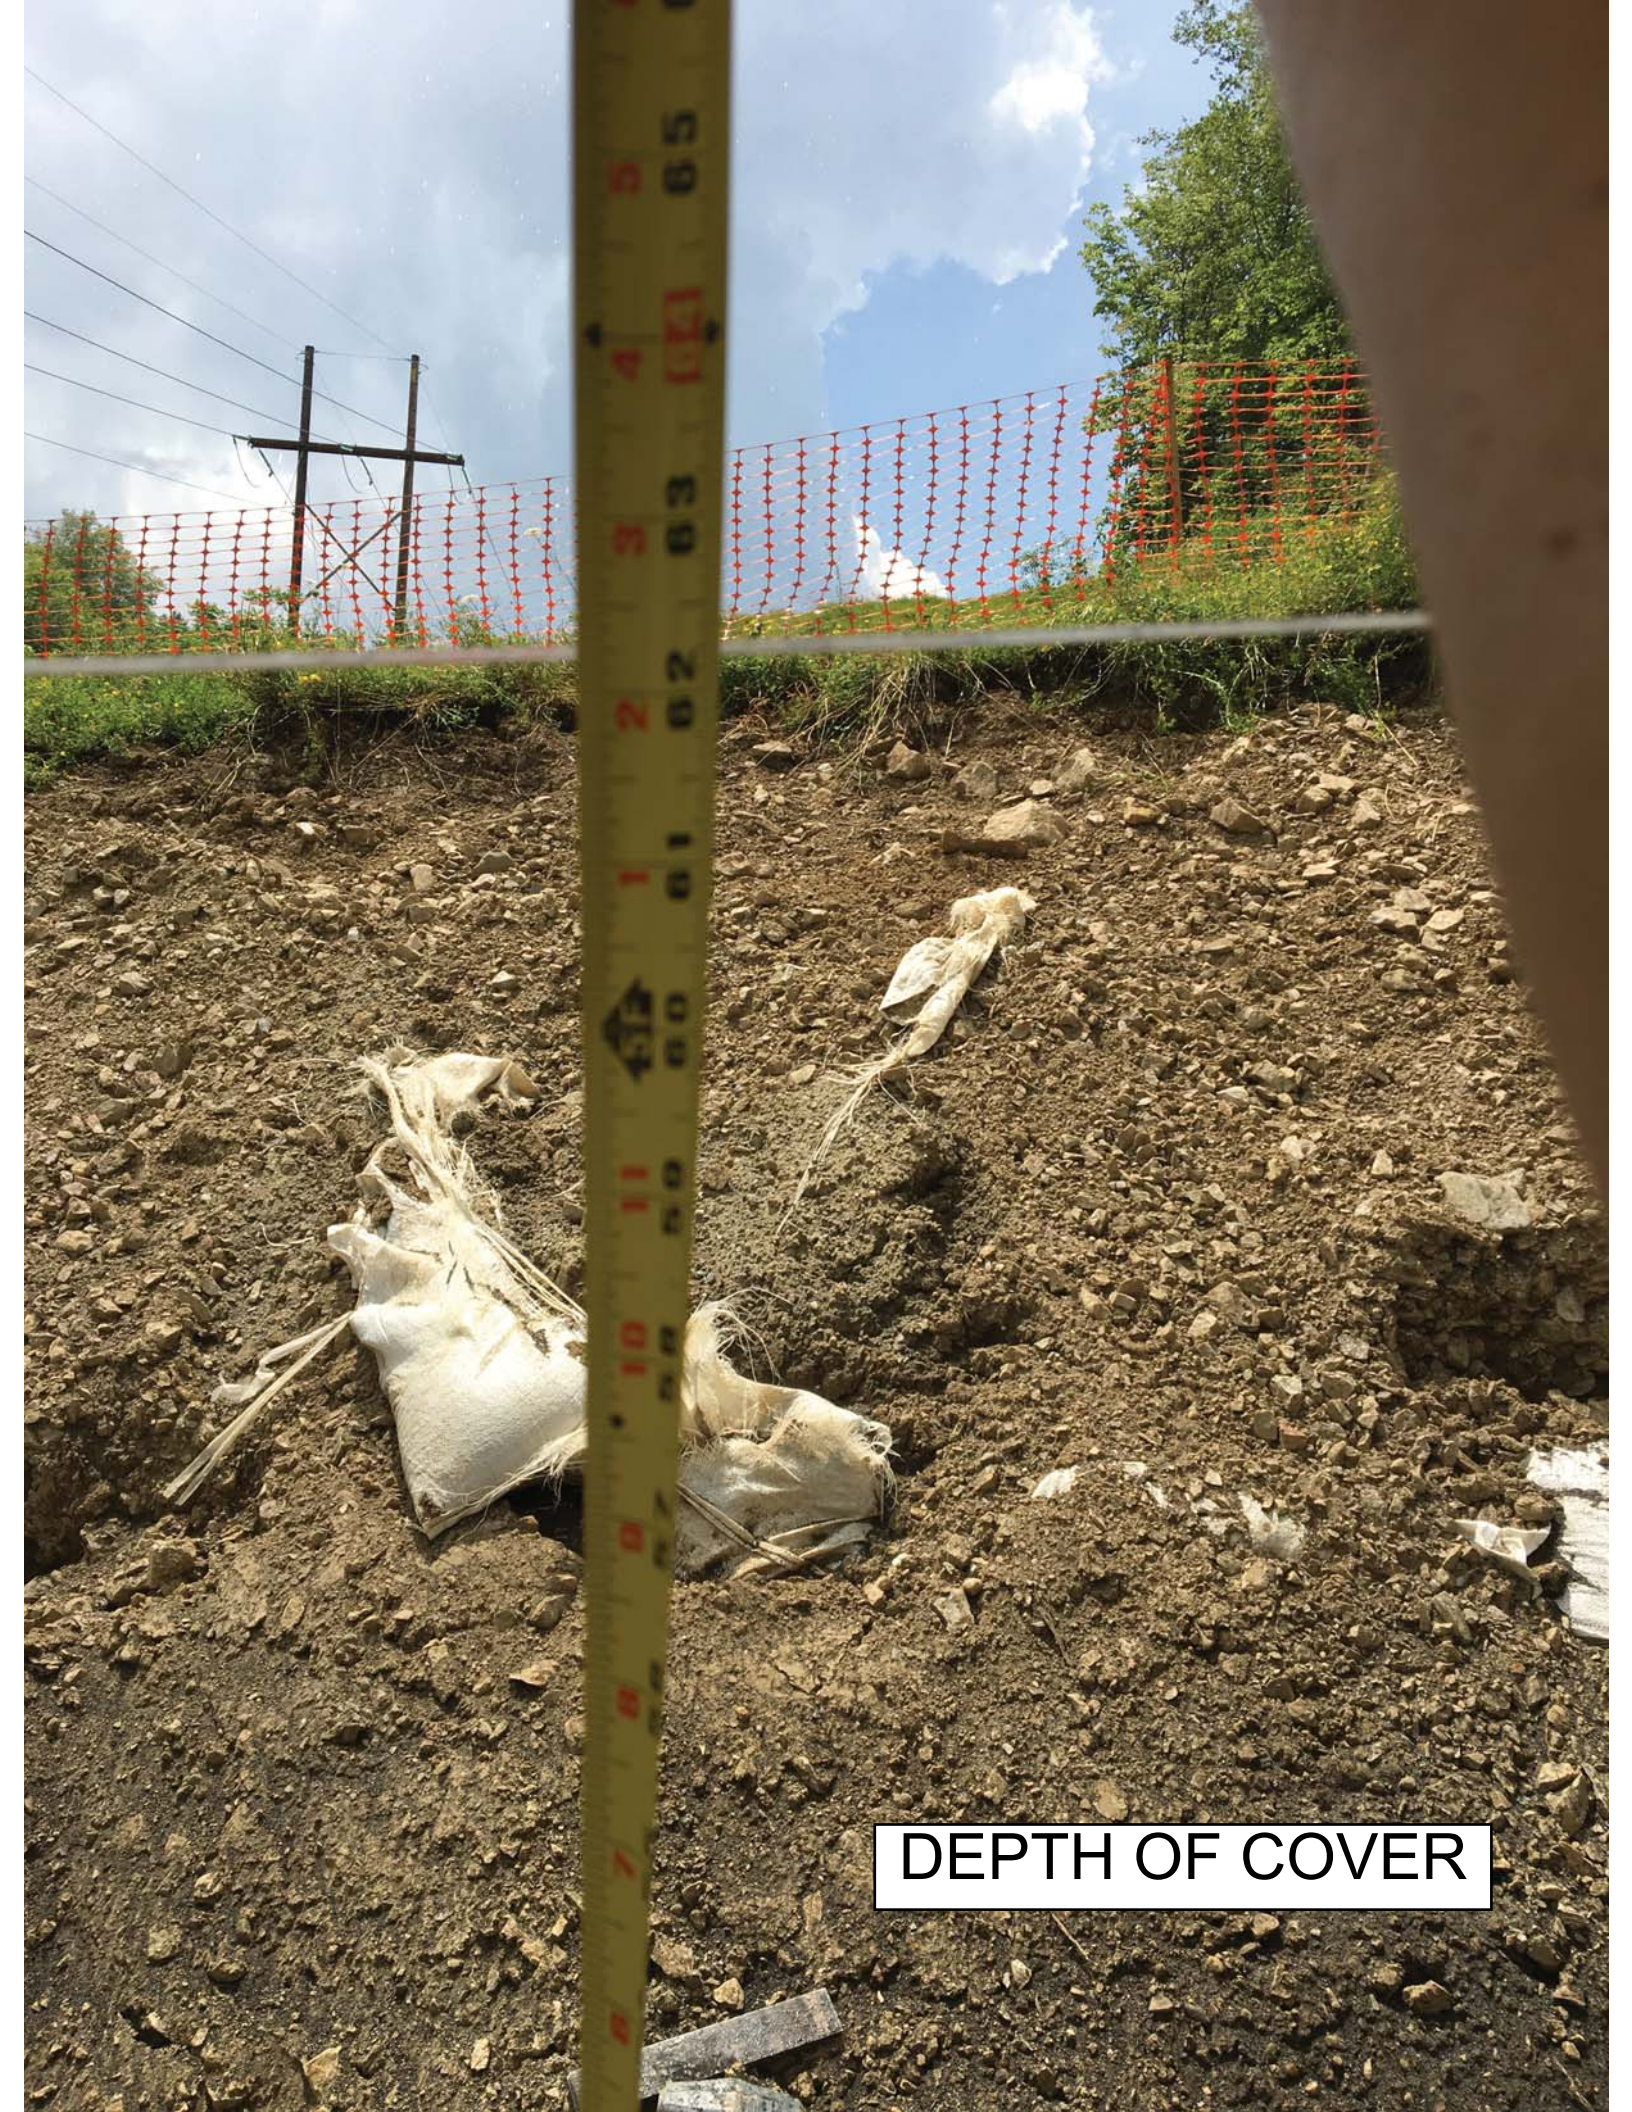
DEPTH OF COVER

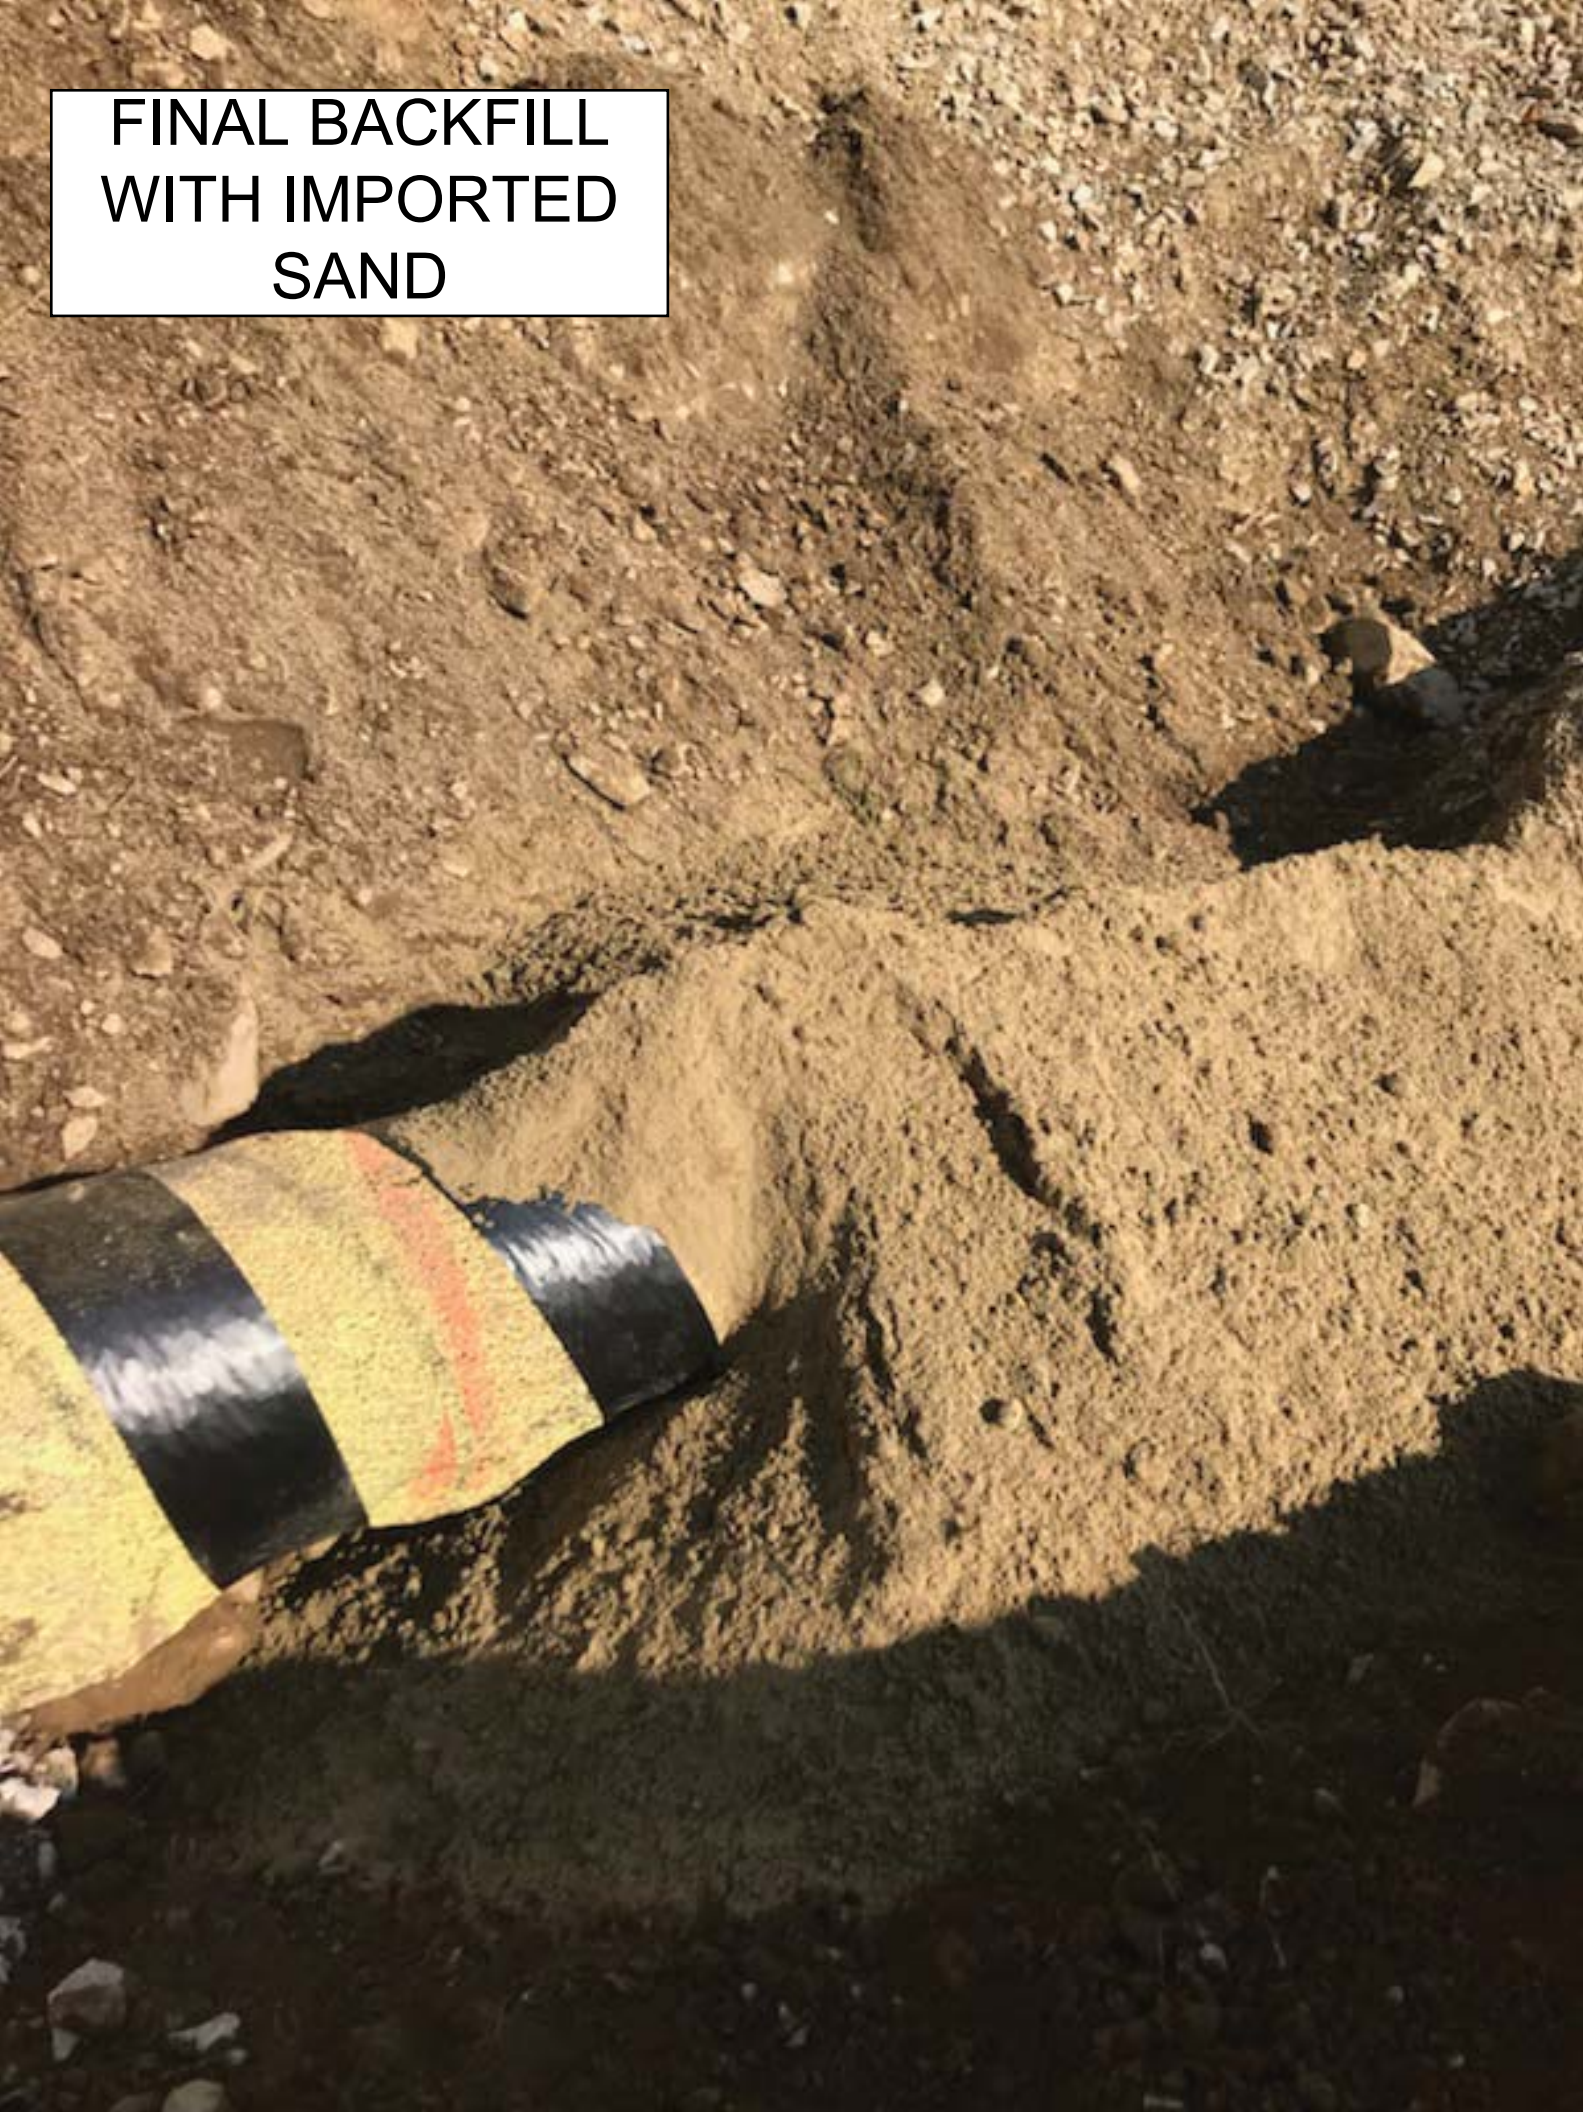
FINAL BACKFILL
WITH IMPORTED
SAND
