**VERMONT GAS SYSTEMS, INC.  
TRANSMISSION LINE EXPOSURE REPORT**

| Location: <b>Excavation Site 3 - Palmer Chicken Farm</b> | | | Length Unsupported Pipe: <b>5'</b> | | |

**VERMONT GAS SYSTEMS, INC.**  
**TRANSMISSION LINE EXPOSURE REPORT**  
**SUPPLEMENTAL FOR ASSESSMENT EXCAVATIONS**

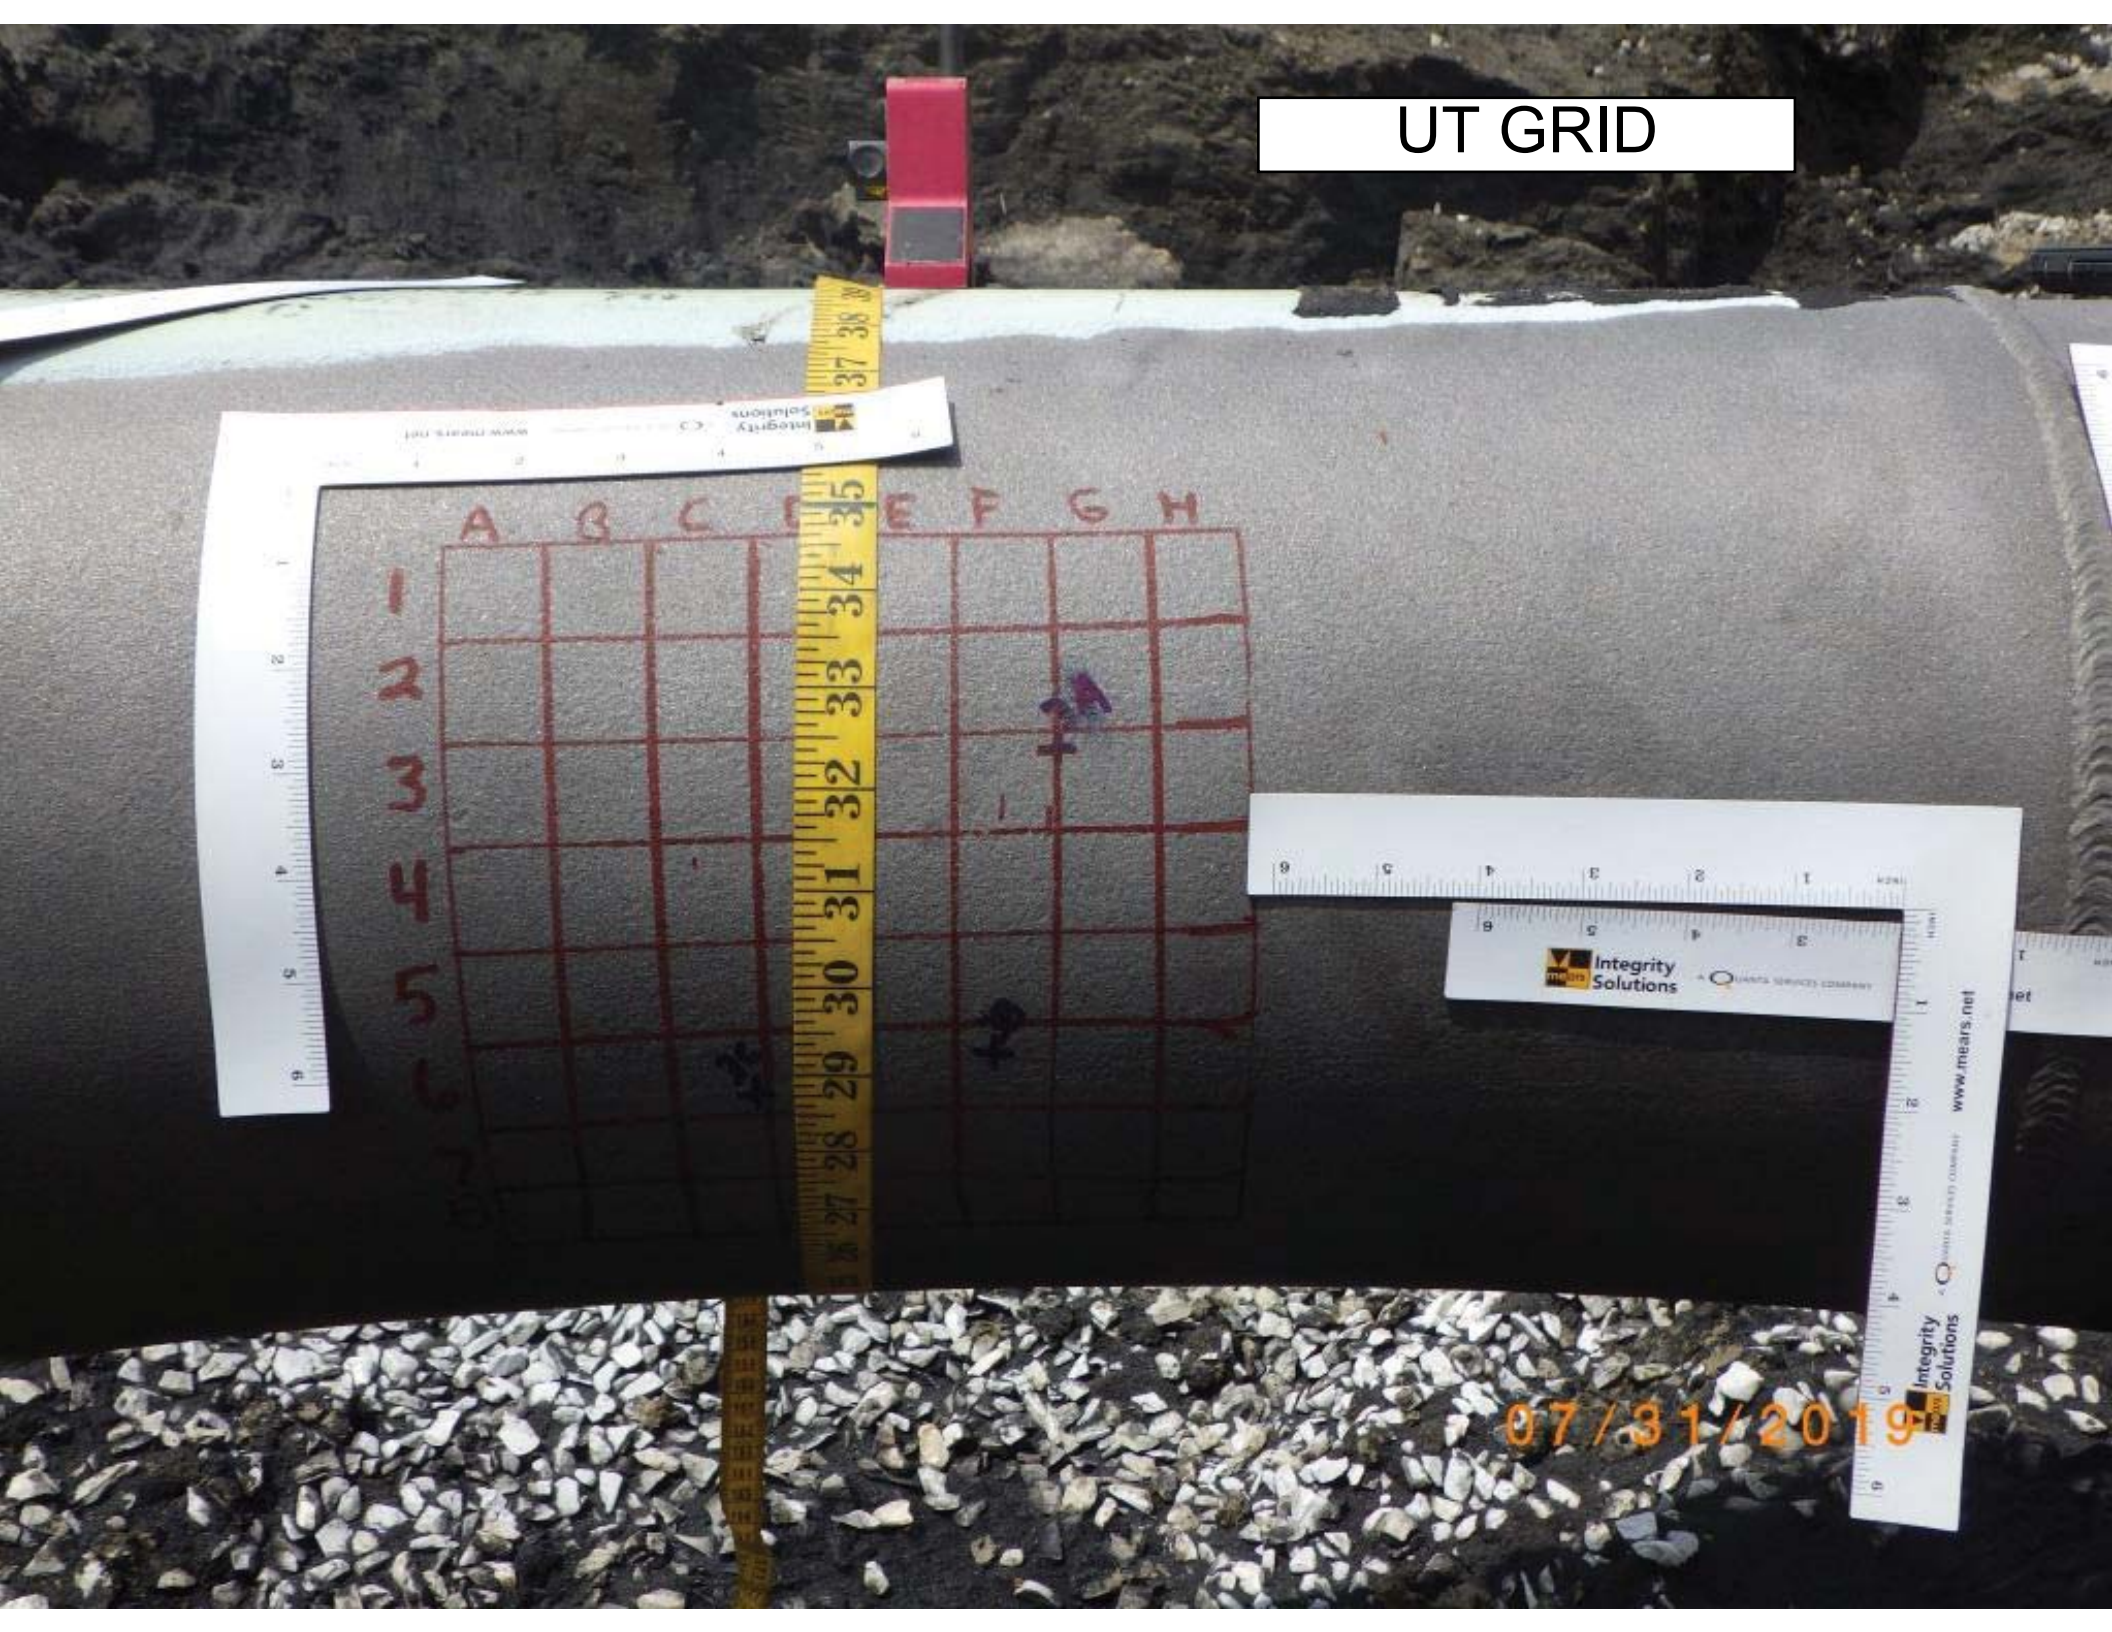
UGS  
WC: 193368.31  
193368.36  
193368.61  
DIG 3A, B, C  
MEDIA BLASTED  
PIPE  
9:00  
A

| Pipe Condition: <b>Good. Found Pritec coating (on pipe), Canusa shrink wraps (on welds), FBE (on fitting), and wax tape over previous coating removal all in good shape.</b> | | |

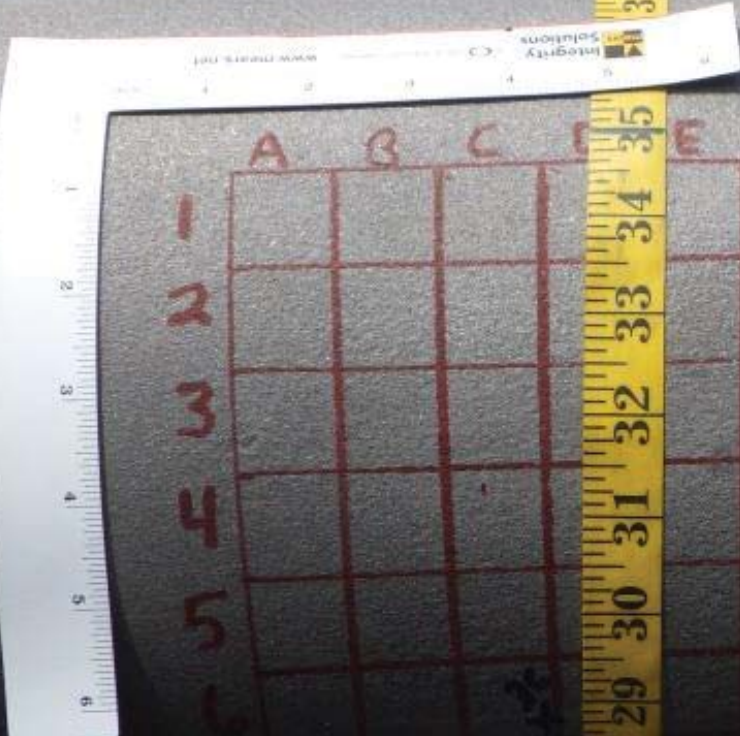
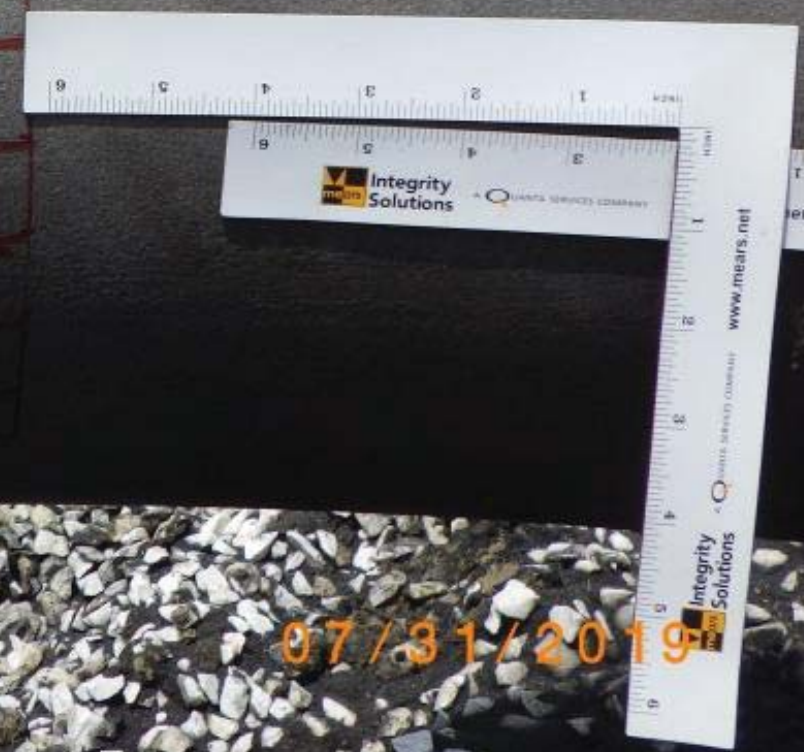
UT GRID

| ADDITIONAL COMMENTS:<br>Removed coating from pipe, found smooth pipe. No indication of external wall loss. Mears used UT gauge to determine location of anomaly. Found indication on or very near to the longitudinal ERW. Lowest wall-thickness reading at 0.215". Approximate size based on 1" UT grid readings: 2"x1". Found the two other indications as called out by ILI with minimum wall thickness readings of 0.309" and 0.335". See Mears report for more info. | | |

| Repair Notes: <b>Internal wall loss. Exterior repair wrap not approved for interior wall loss.</b> | | |

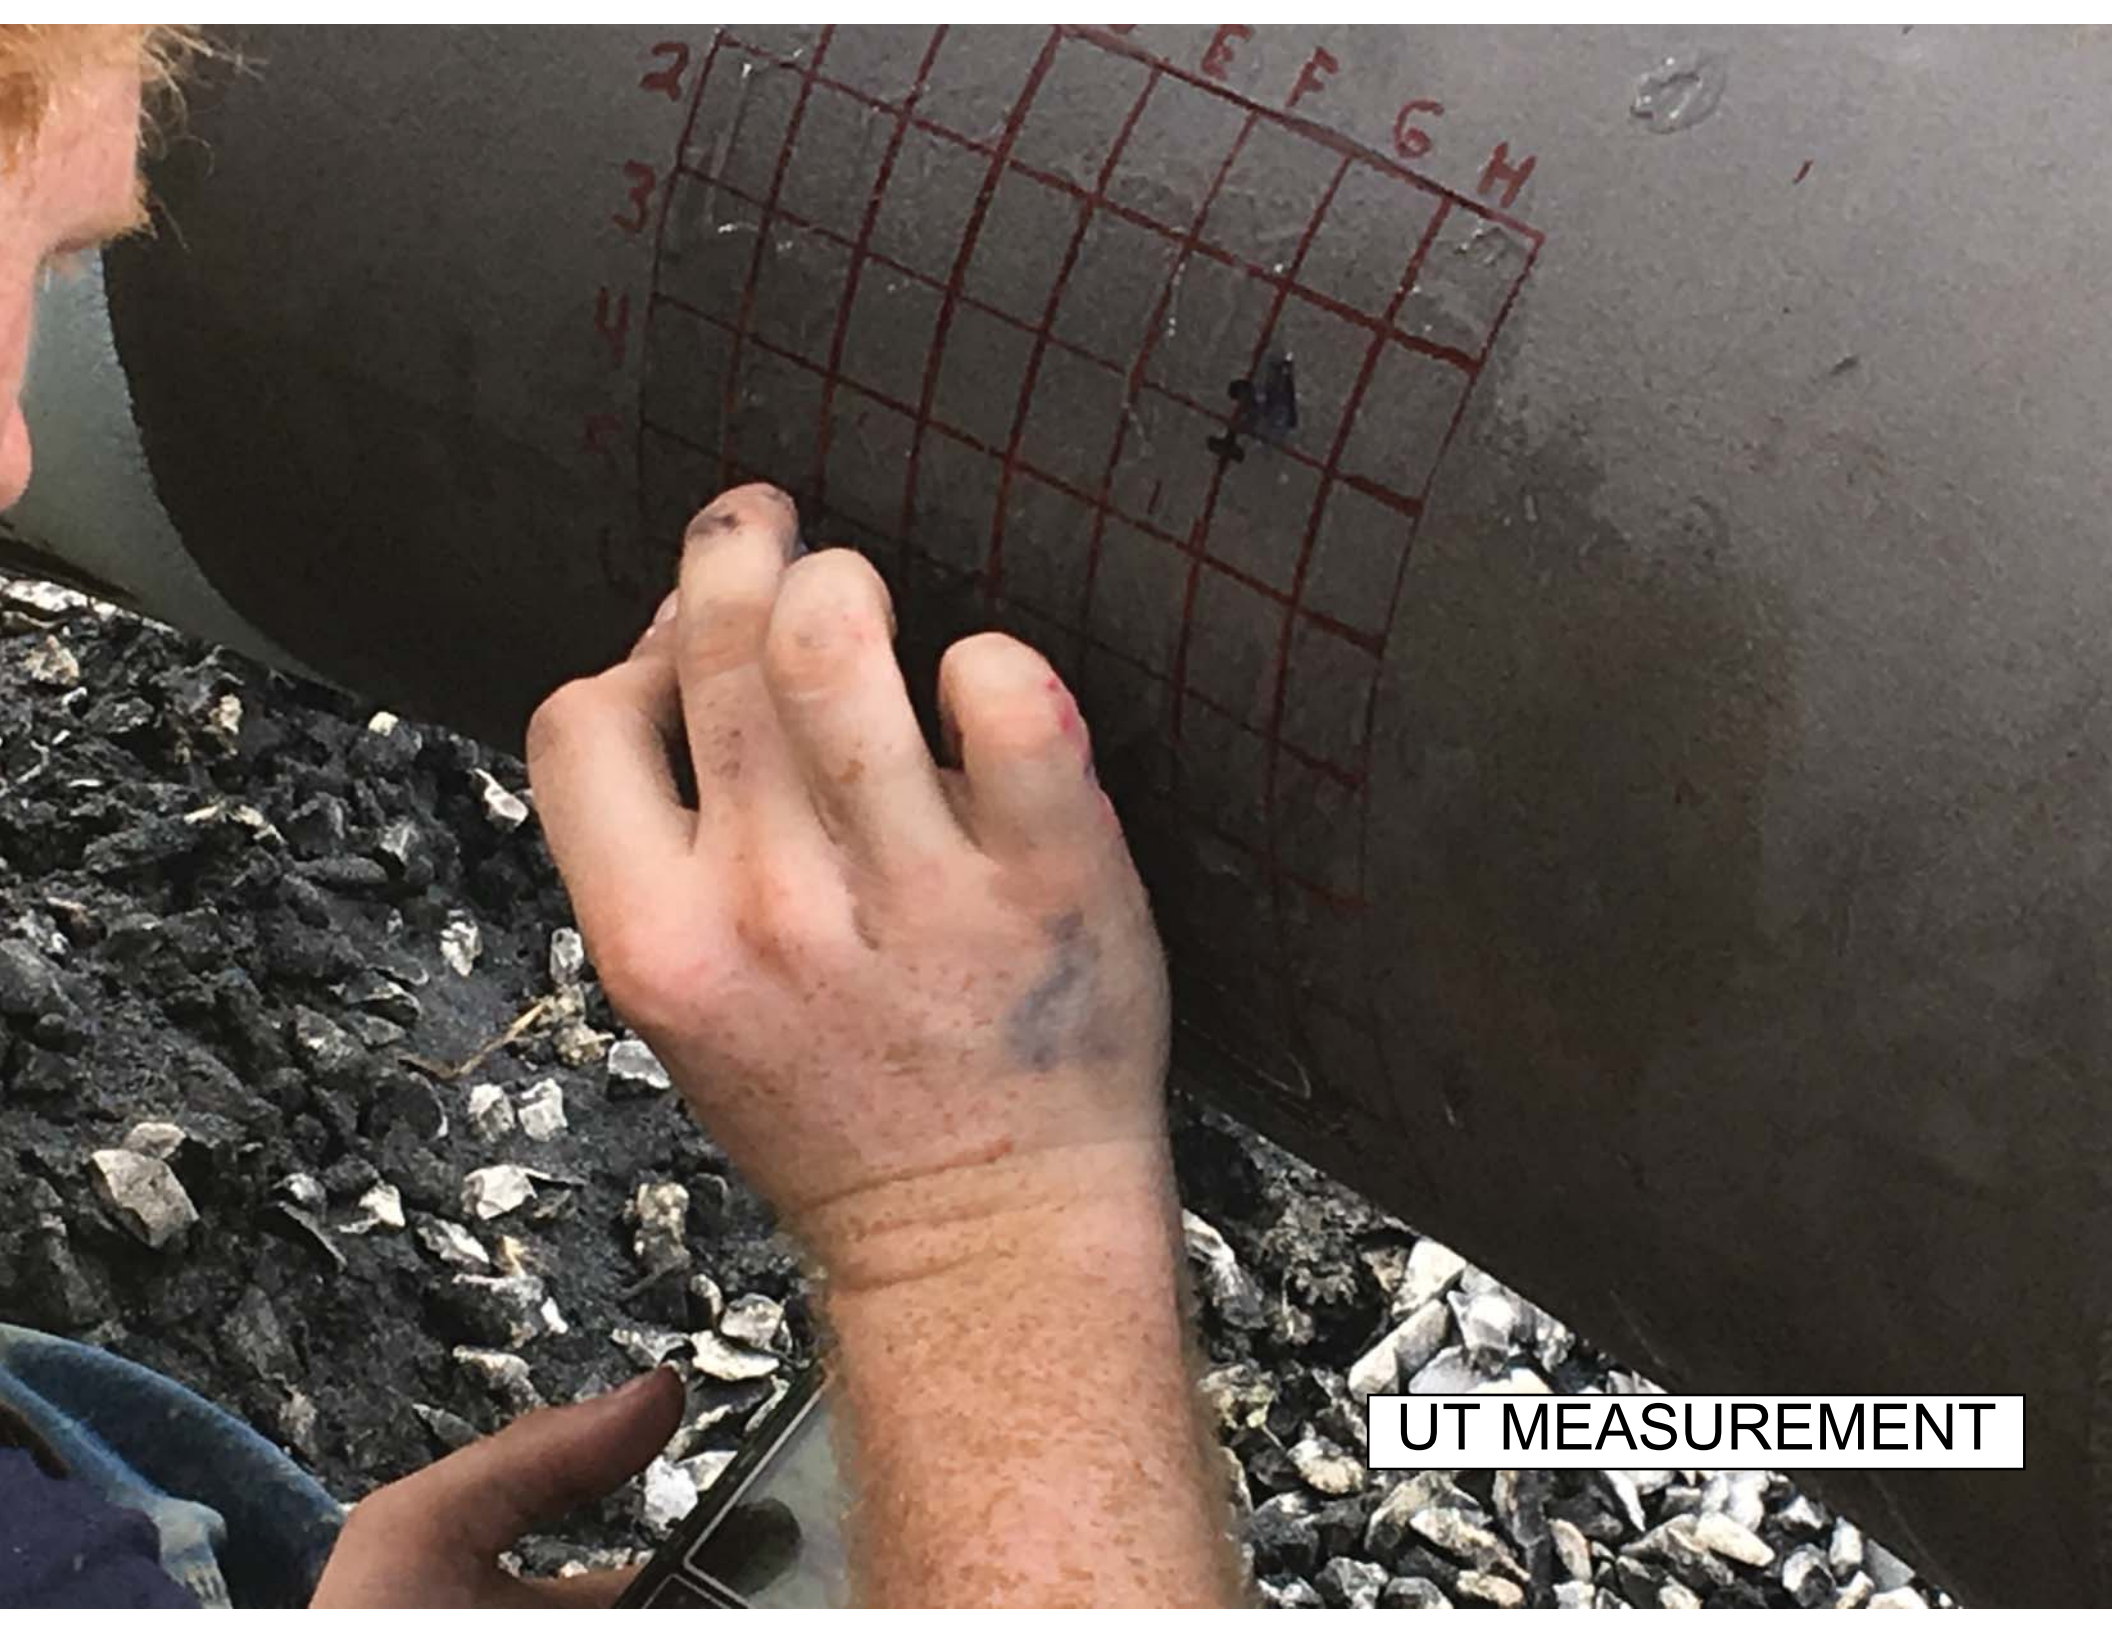
UT MEASUREMENT

| | | UT Gauge: <b>0.215" min.</b> | | | |

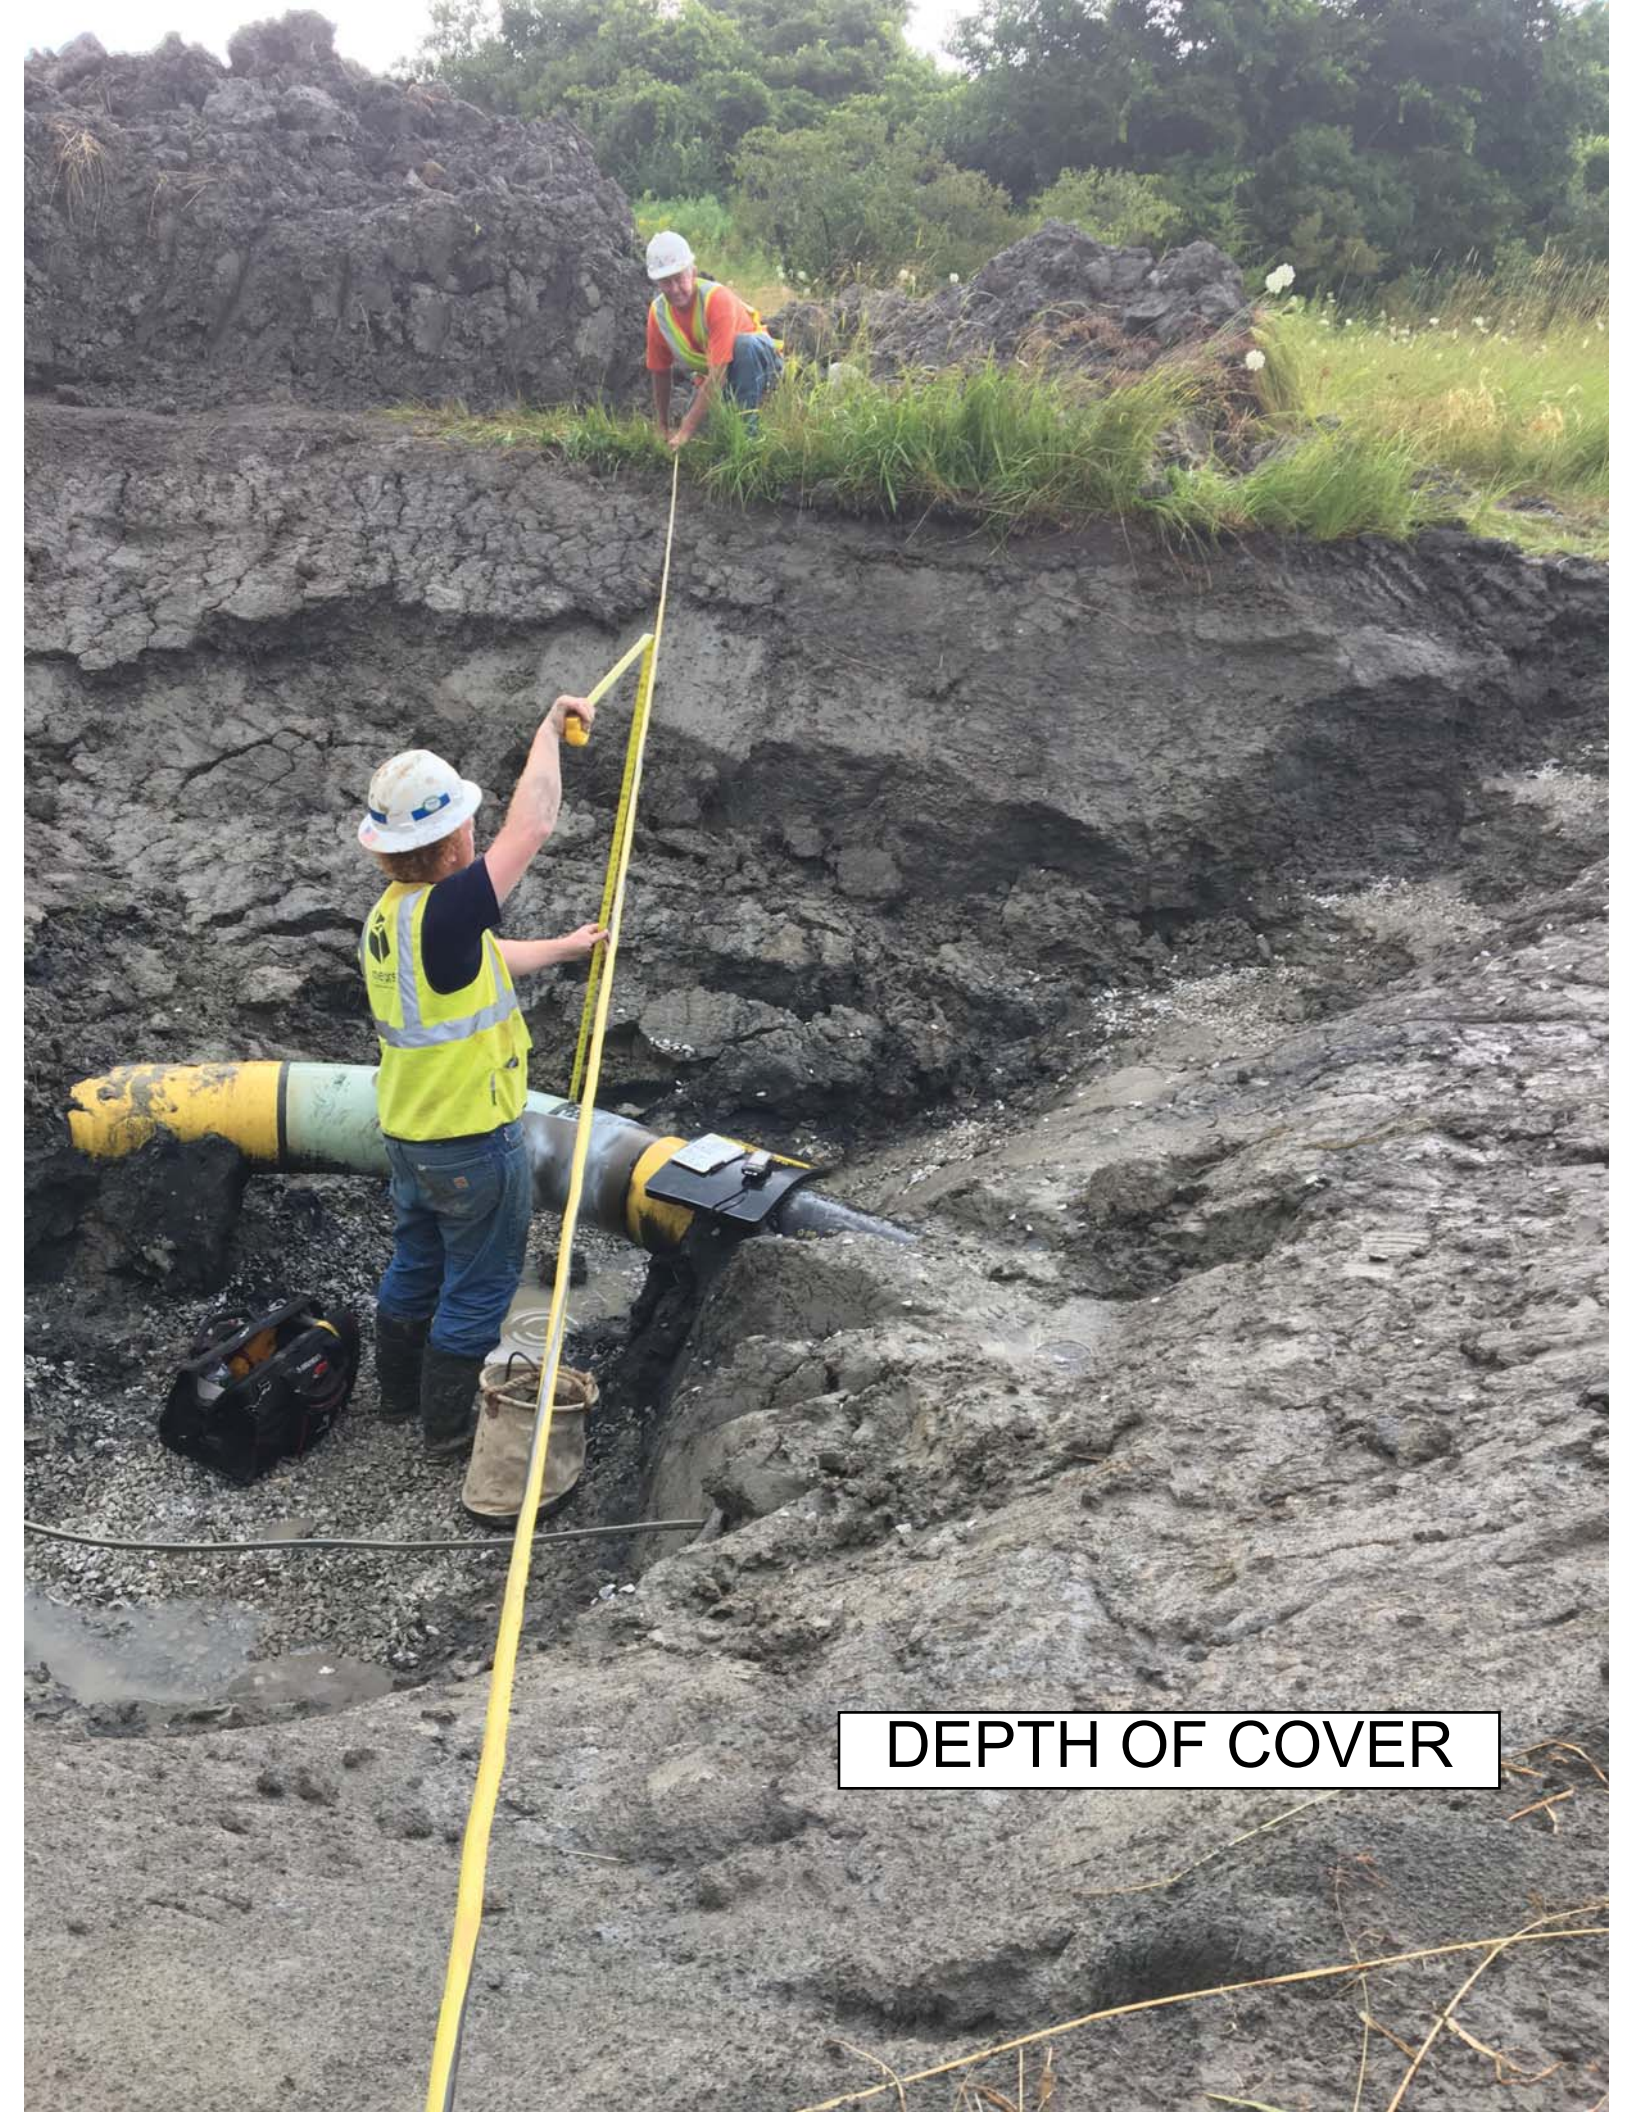
DEPTH OF COVER

| CP Pipe to Soil Reading: <b>-1.4</b> v | | Coating Type: <b>FBE</b> | | Pipe Depth: <b>4'5"</b> | |

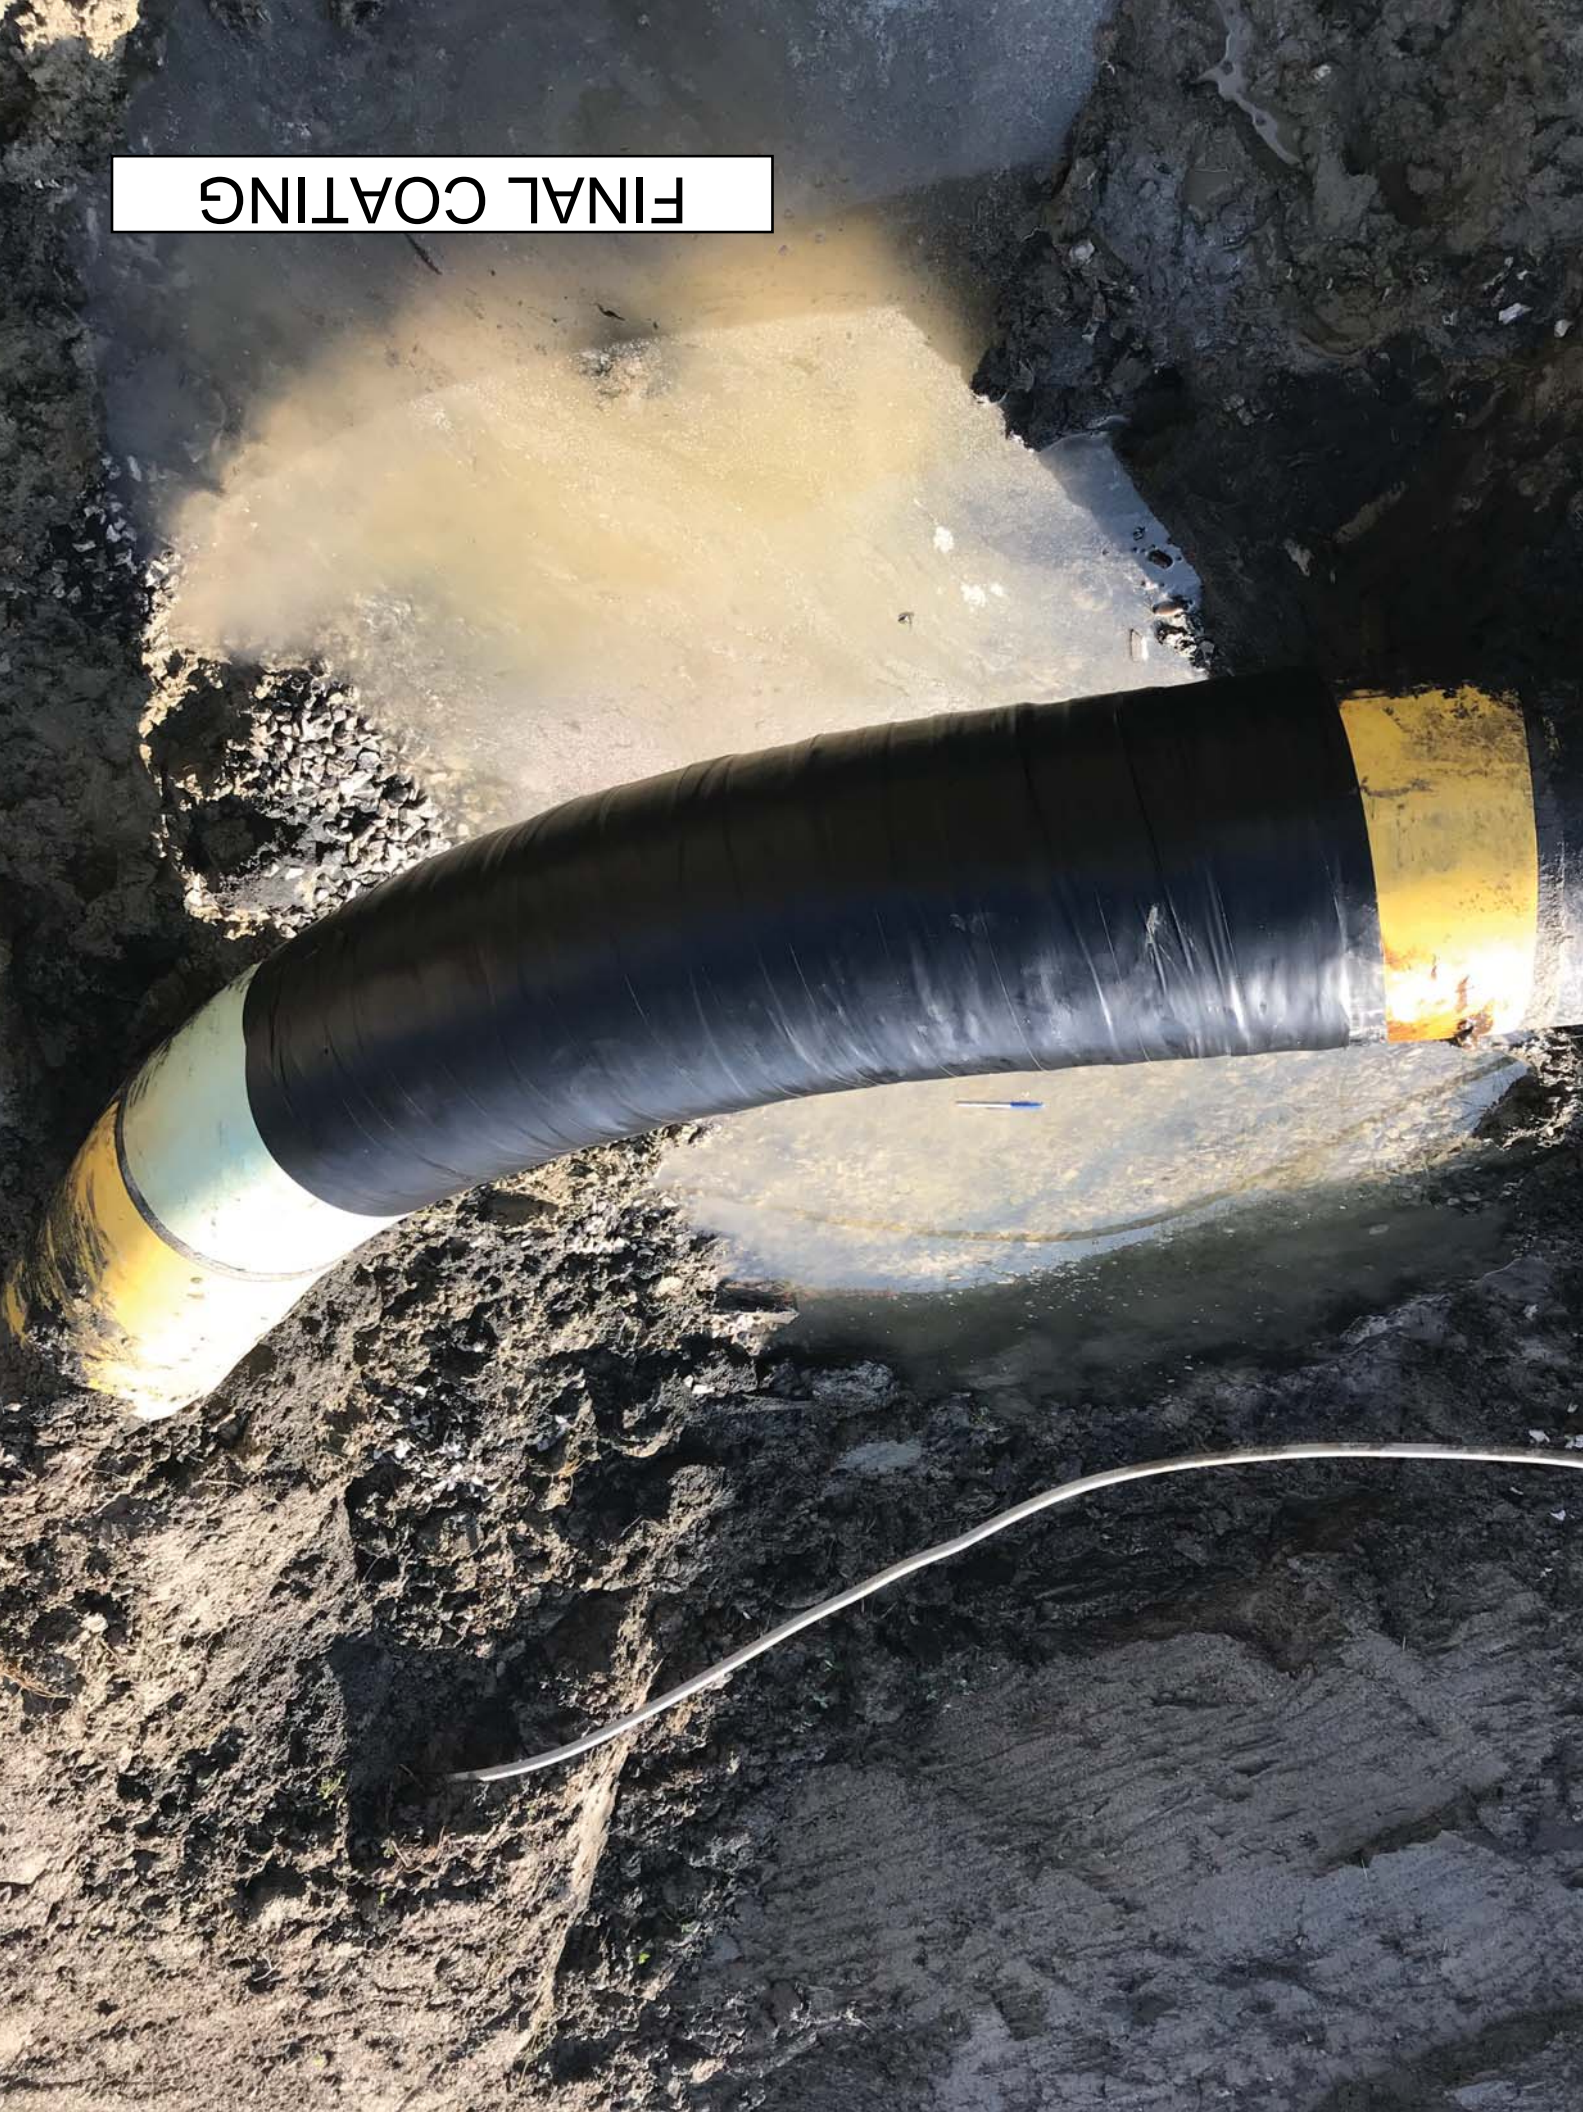
FINAL COATING

| Type Replacement Coating: <b>Denso Densyl Wax Tape</b> | | | Replacement Coating Length: <b>Approx. 2'</b> | | |

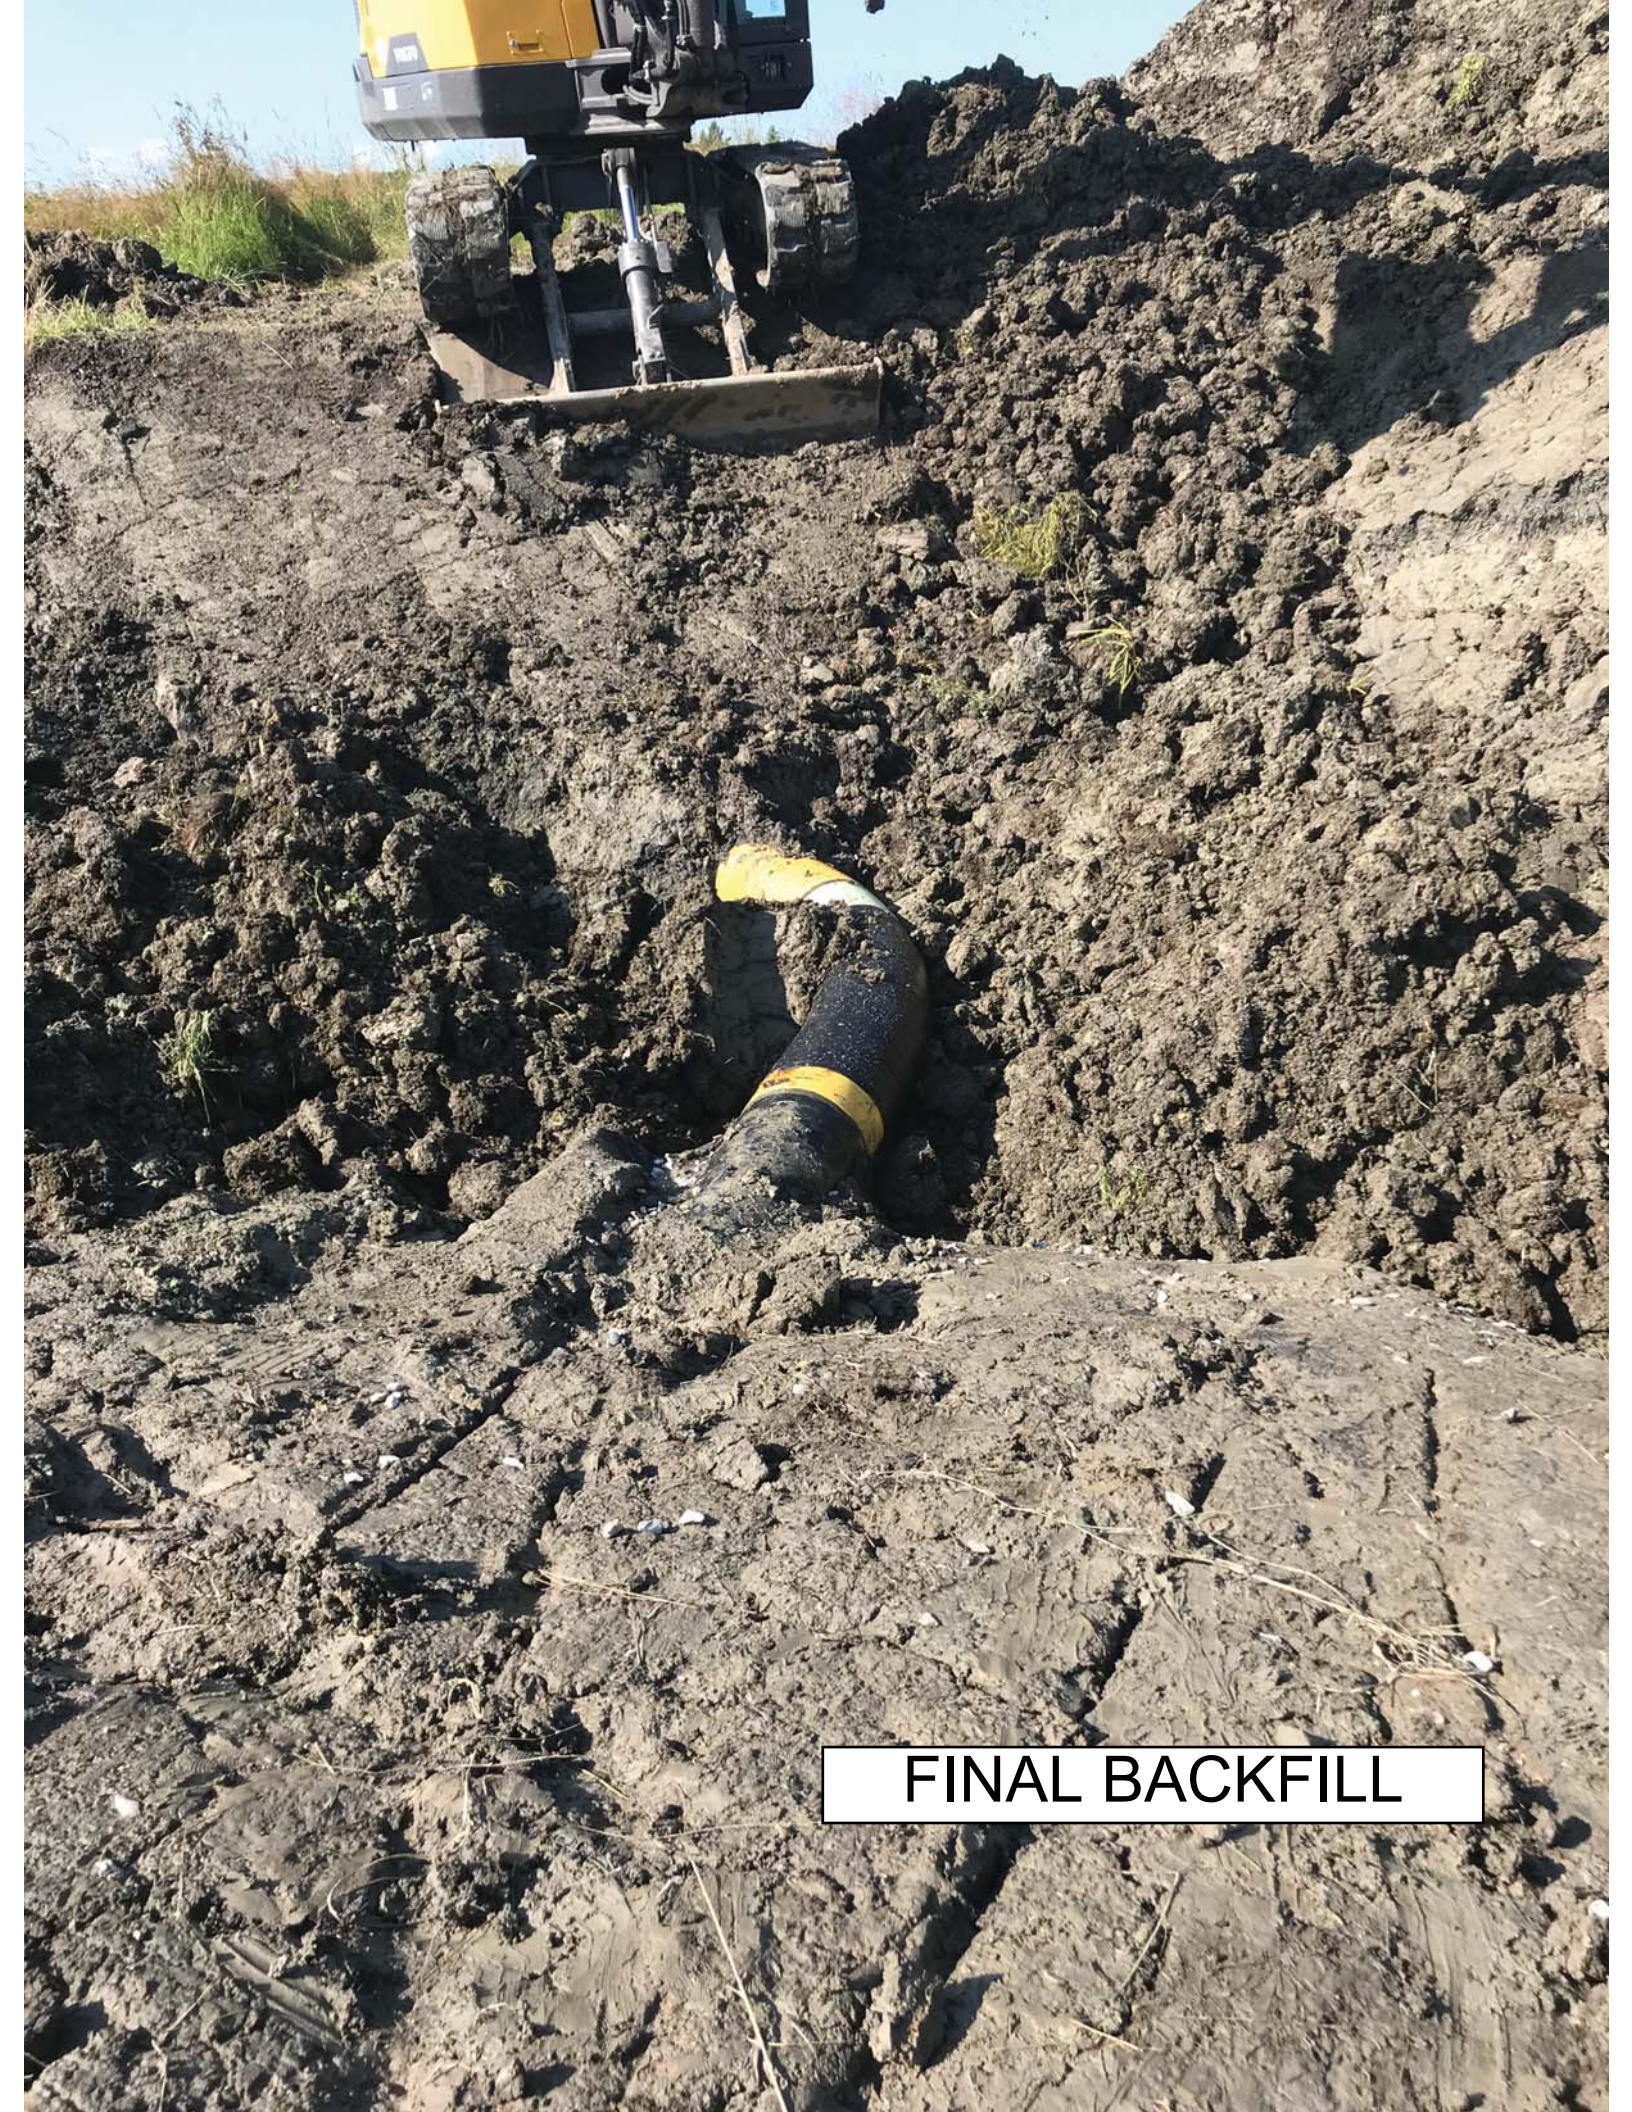
**FINAL BACKFILL**

| Trench and Backfill Conditions (described area around pipe, note presence of rocks, sandbags, rockshield, etc.):<br><b>Found clean, rock-free clay. Zinc ribbon was found approximately 3' east of pipe. Backfilled with native clay.</b> | | |
