**VERMONT GAS SYSTEMS, INC.
TRANSMISSION LINE EXPOSURE REPORT**

VERMONT GAS SYSTEMS, INC.
TRANSMISSION LINE EXPOSURE REPORT
SUPPLEMENTAL FOR ASSESSMENT EXCAVATIONS

Date: 7/31/2019	Location: Excavation Site 4 - Route 7	Town: New Haven
Project/Work Plan Date: 07/30/2019	Revision #: 0	Pipe Diameter: 12"
Length of Pipe Exposed & Inspected: Exposed 6' of Pipe, Removed Approx. 2' of Coating		
Pipe Condition: Good. Found Pritec coating (on pipe), FBE (on fitting) and Canusa shrink wrap (on weld) in good shape.		
Jeeping Results: Good. Jeeped at 7000v, no coating anomalies found.		
Trench and Backfill Conditions (described area around pipe, note presence of rocks, sandbags, rockshield, etc.): Soil around pipe was clay. Soil away from original pipe trench had some larger rocks. Found sandbag above pipe south of weld.		
Indication/Anomaly Found:	Wall Loss <input type="checkbox"/>	Dent <input type="checkbox"/>
	Manufacturing Anomaly <input type="checkbox"/>	Other: _____
	Ovality <input type="checkbox"/>	Weld Anomaly <input checked="" type="checkbox"/>
		N/A <input type="checkbox"/>

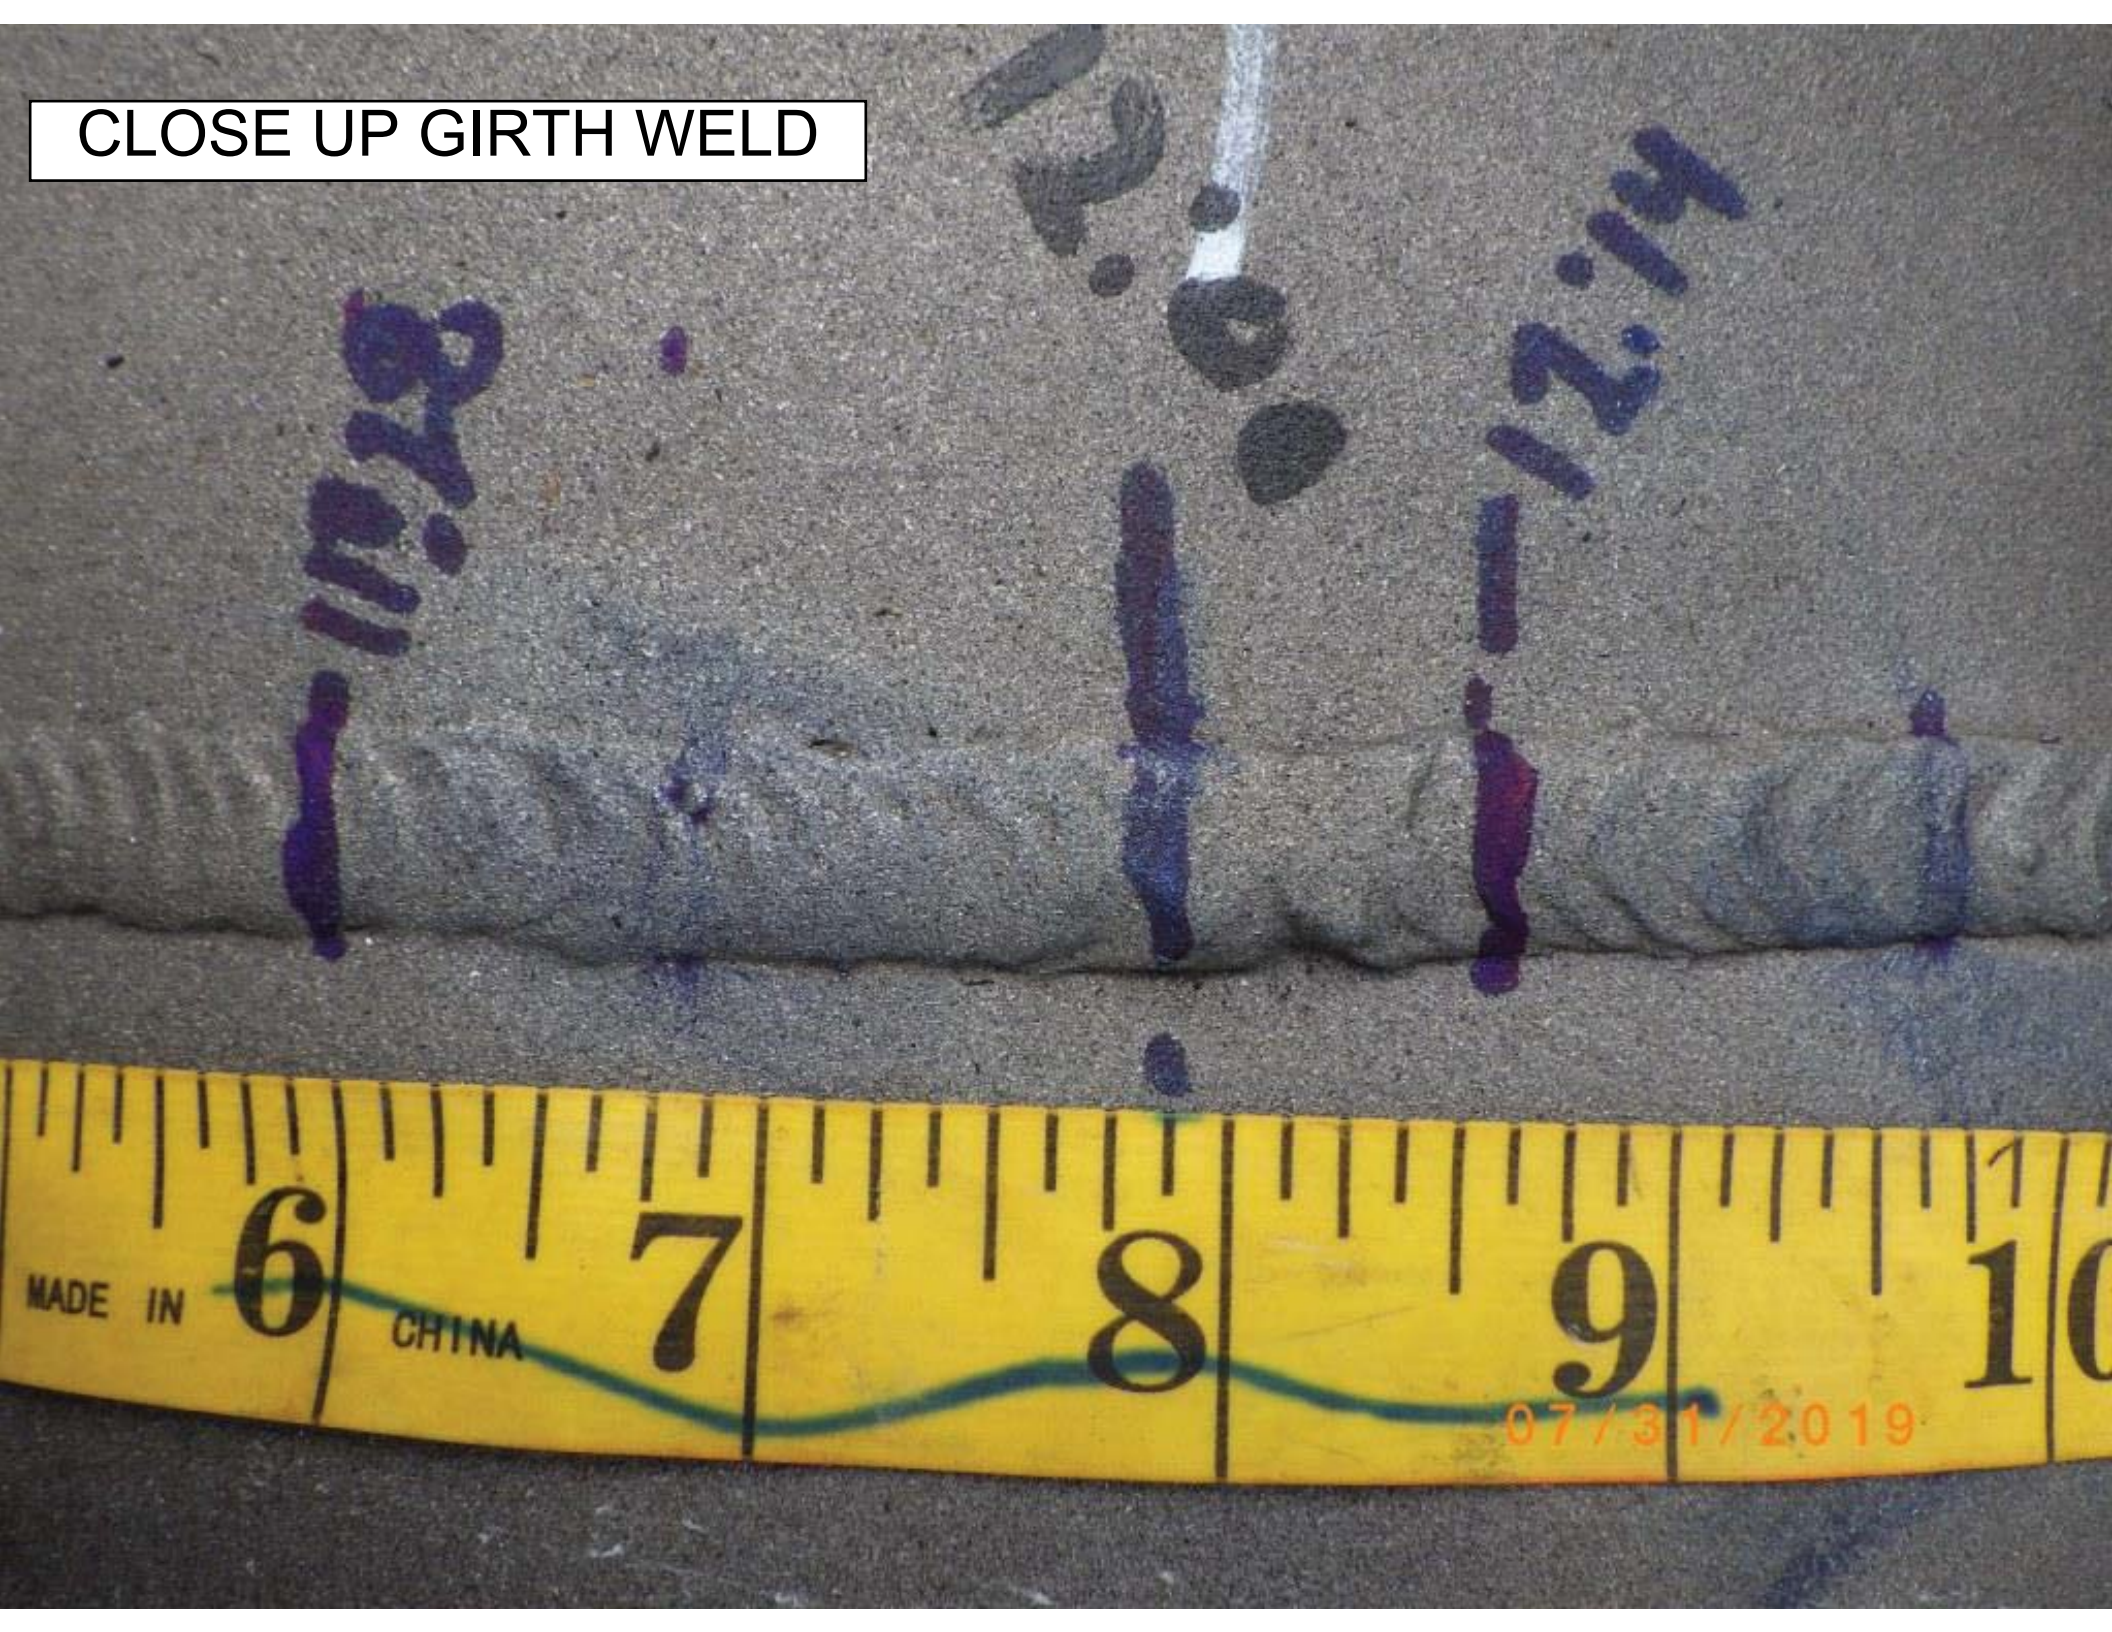
GIRTH WELD PAUT GRID

Dimension of Indication/Anomaly (if found):	Length = N/A	Width = N/A
	Depth = N/A	
Repair Made: Yes <input type="checkbox"/> No <input checked="" type="checkbox"/>	Length of Repair: N/A	
Repair Type (i.e. Clock Spring, Weld Sleeve, etc.): N/A		
Repair Notes: N/A		
ADDITIONAL COMMENTS: JanX Level II technician performed RT on the weld and passed the weld on API 1104 20th editon standards. Mears perform PAUT and MT on the weld and found no indications. No repair necessary.
