MEMORANDUM

RE: Addison Natural Gas Project (ANGP) Pipe Laid on Trench Bottom

ANGP Pipeline Anomaly Dig, @ station 565+85

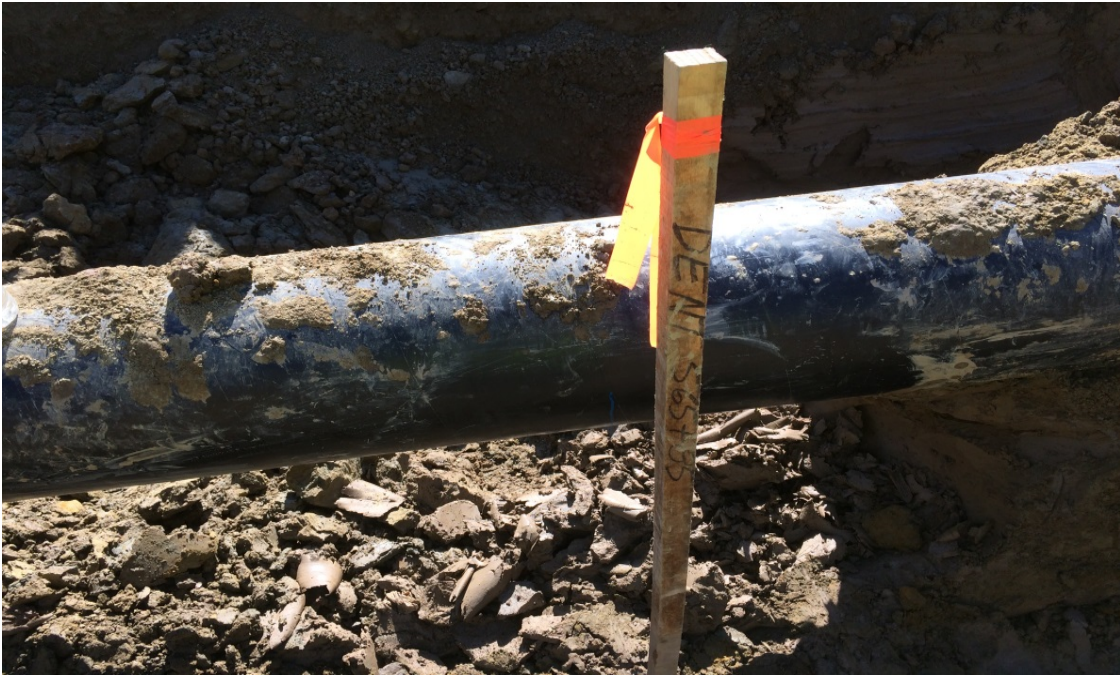
No dent or coating damage spotted at station 565+85 after cleaning the pipe and thoroughly inspecting the pipe by hand. Checked the pipe several feet upstream and downstream of station number.

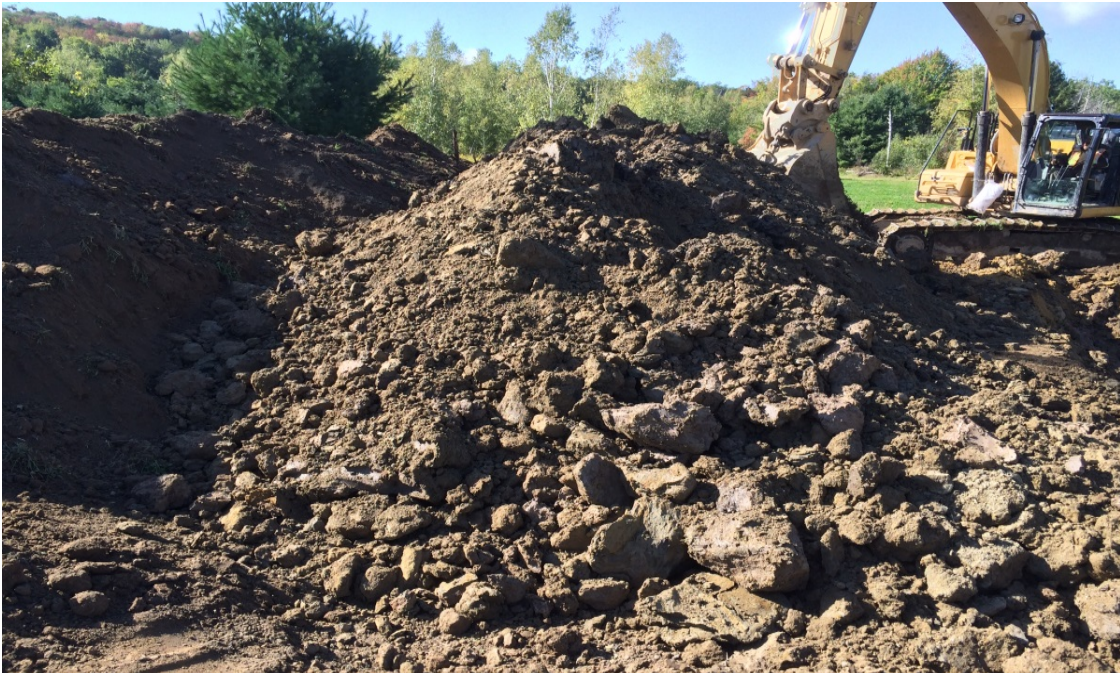
Excavation dirt pile with clumps of clay and no rocks. Expanded excavation to locate weld 0193.

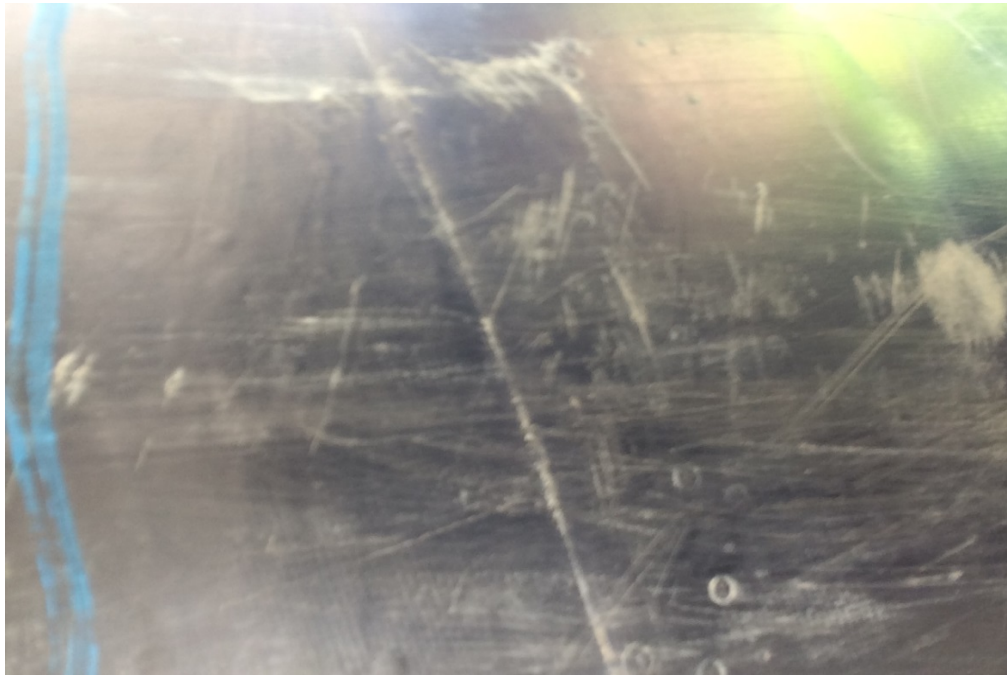
Close up picture of station 565+85 at the 4:00/4:30 location. No coating damage or dent detected
