Vermont Gas Systems Addison Natural Gas Project
Road Crossing Observation Report

Krebs & Lansing Consulting Engineers, Inc.
164 Main Street | Colchester, Vermont 05446
(802) 878-0375

March 30th, 2021

ADDENDUM 1: FINAL OBSERVATIONS

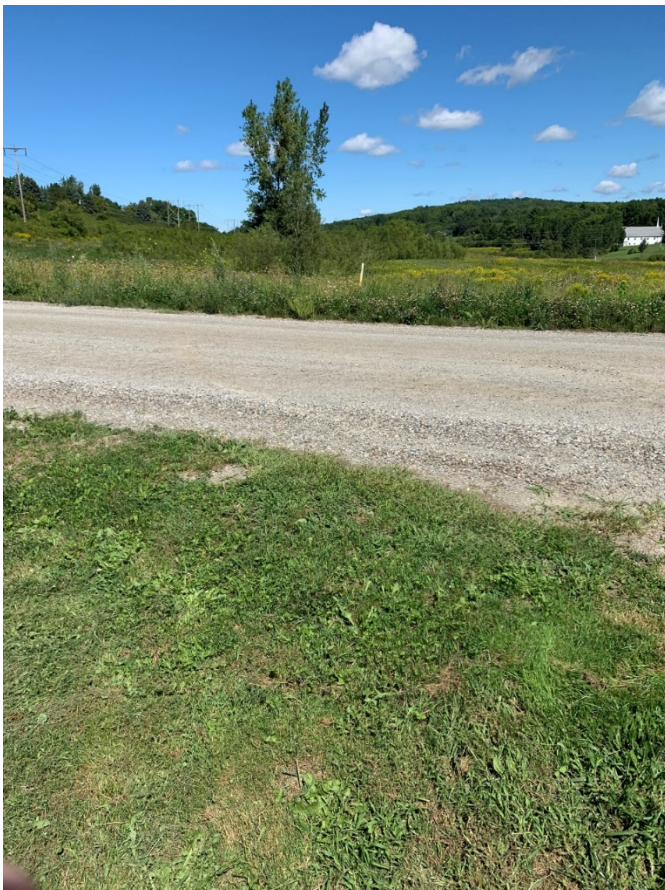
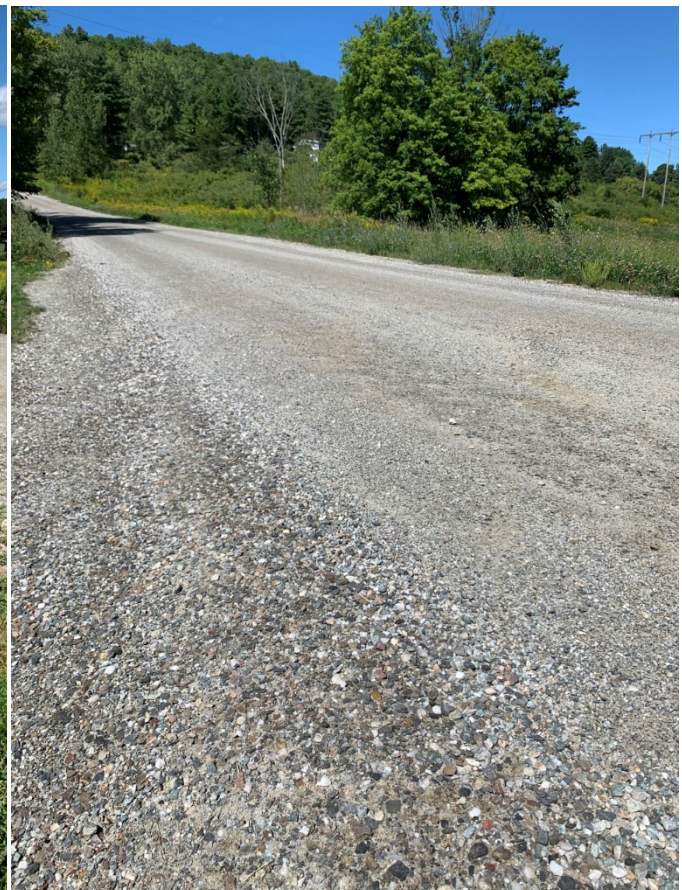
Location: Lincoln Road (STA 755+95)

- No visible evidence of poor roadbed performance, erosion or settlement of road above gas line.

- None.

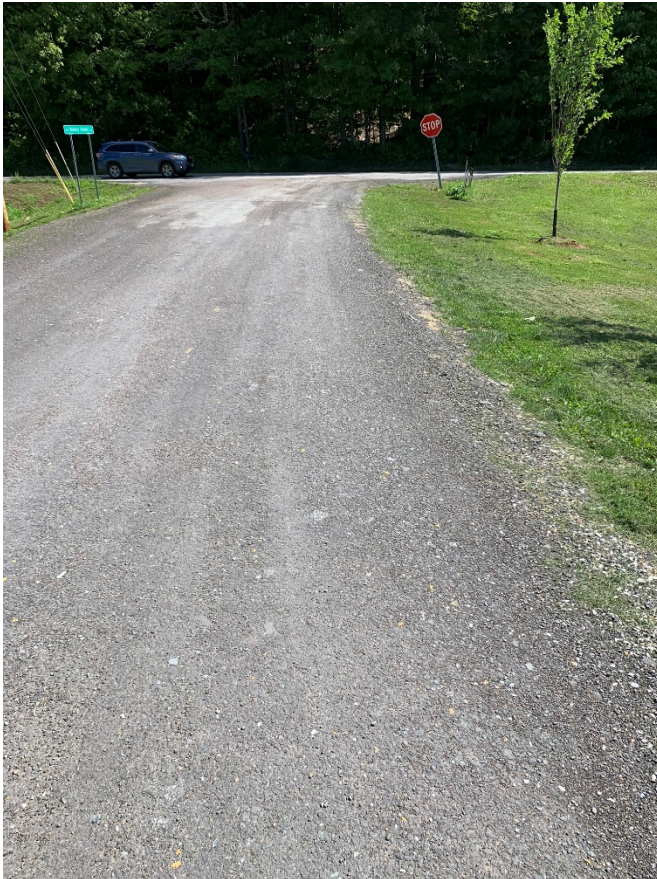
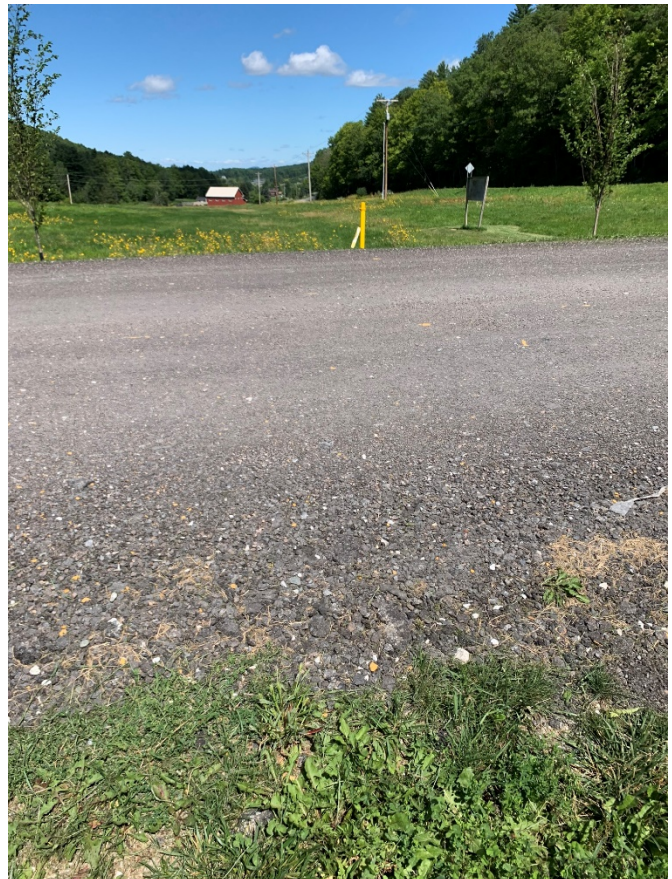
Location: Breezy Valley Lane (STA 788+10)

- No visible evidence of poor roadbed performance, erosion or settlement of road above gas line.

- None.

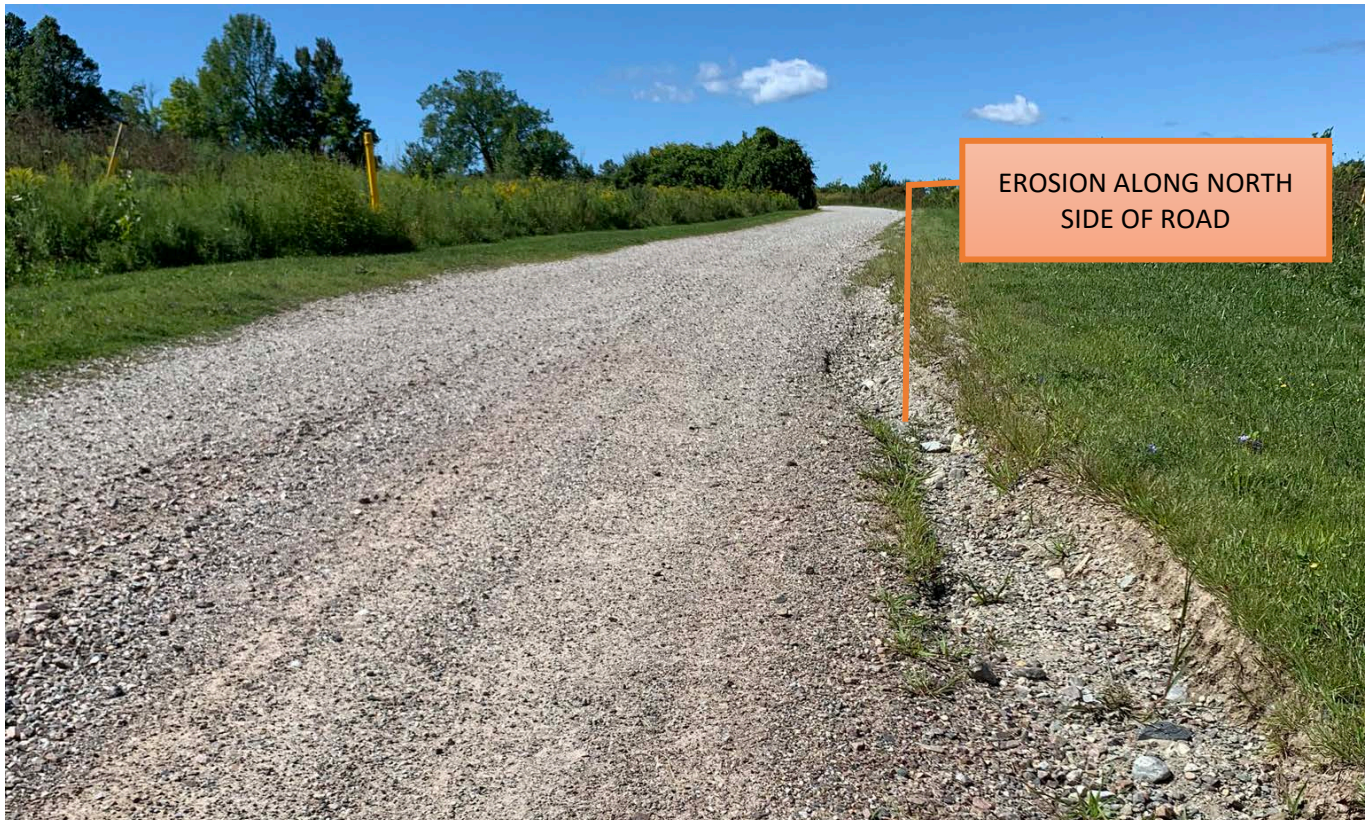
Location: Hickory Place (STA 947+95)

- 1"-2" of settlement in road above gas line.
- Settlement appeared to cause stormwater to channel and create erosion along the north side of the road.

- See February 2021 recommendations.

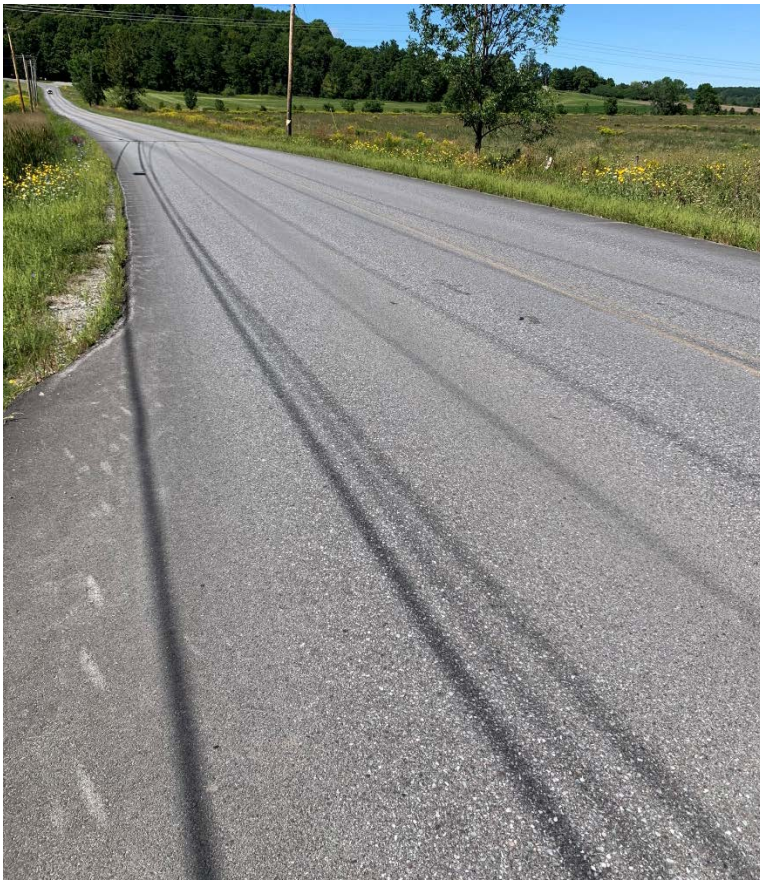
Location: Charlotte Road (STA 1048+25)

- Paved road.
- No visible evidence of pavement degradation, erosion, or settlement of road above gas line.

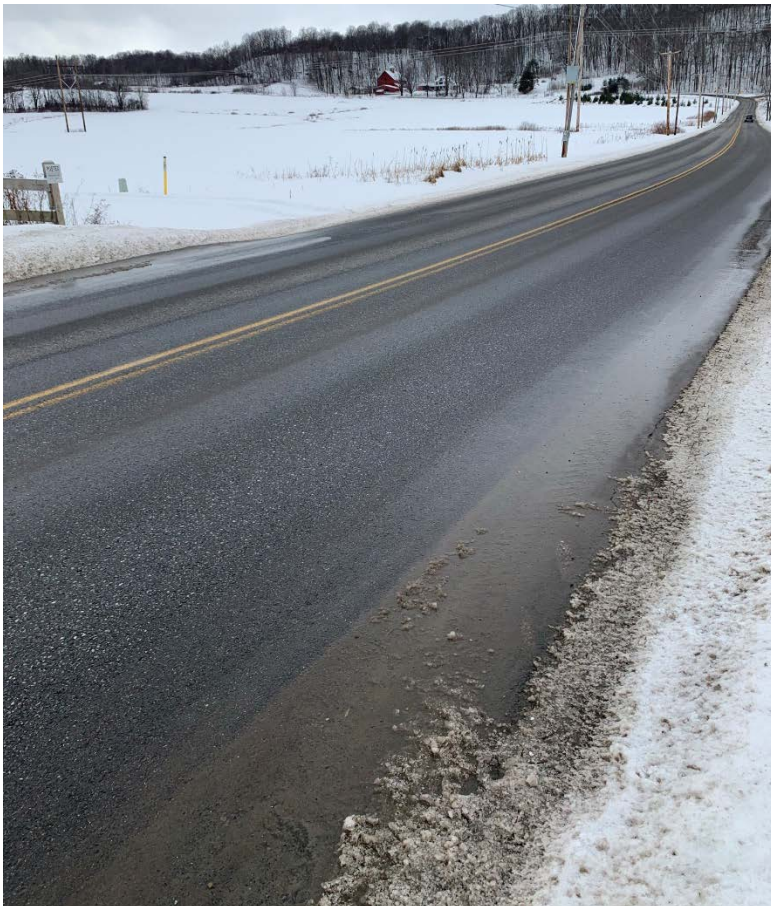
Location: Charlotte Road (STA 1048+25)

- Paved road.
- No visible evidence of pavement degradation, erosion, or settlement of road above gas line.

- Revisit the site in the spring, after the final freeze-thaw cycle of the season.

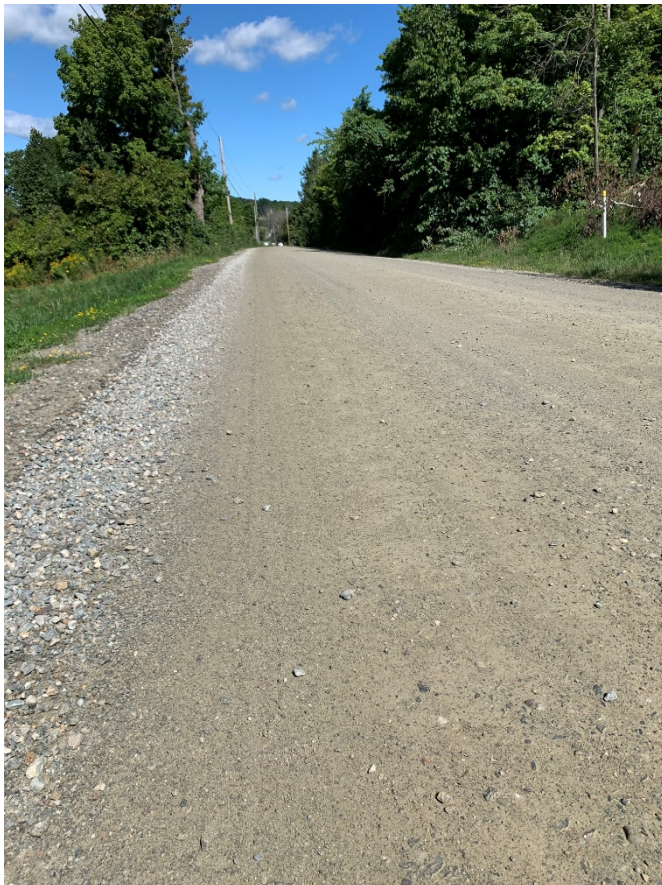
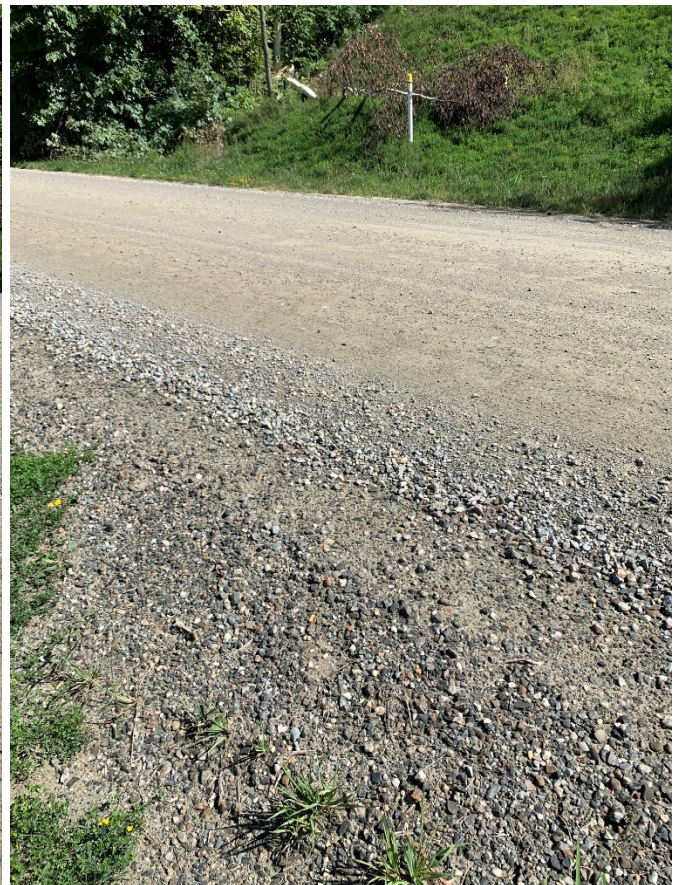
Location: Baldwin Road (STA 1114+40)

- No visible evidence of poor roadbed performance, erosion, or settlement of road above gas line.

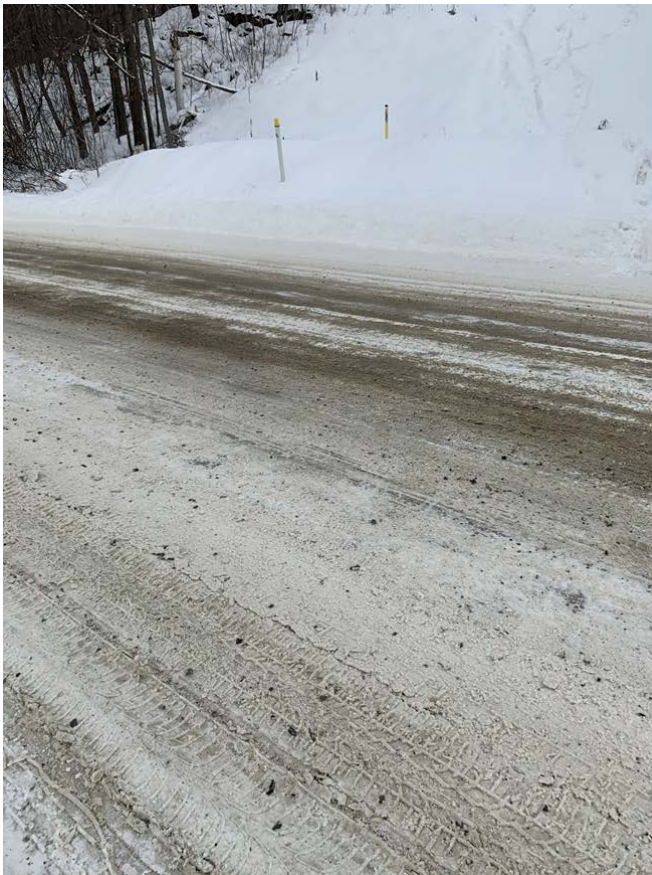
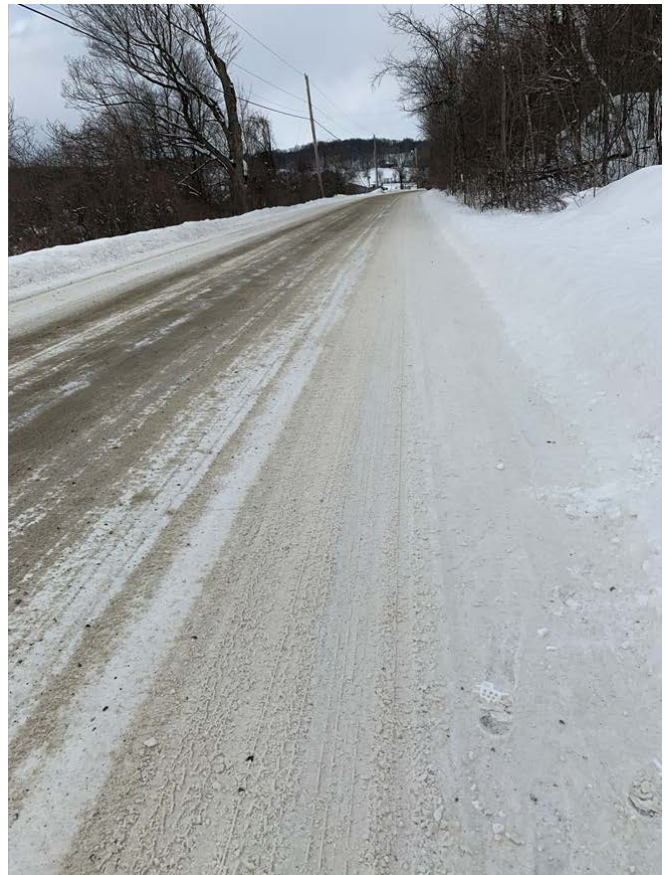
Location: Baldwin Road (STA 1114+40)

- No visible evidence of poor roadbed performance, erosion, or settlement of road above gas line.

- Revisit the site in the spring, after the final freeze-thaw cycle of the season.

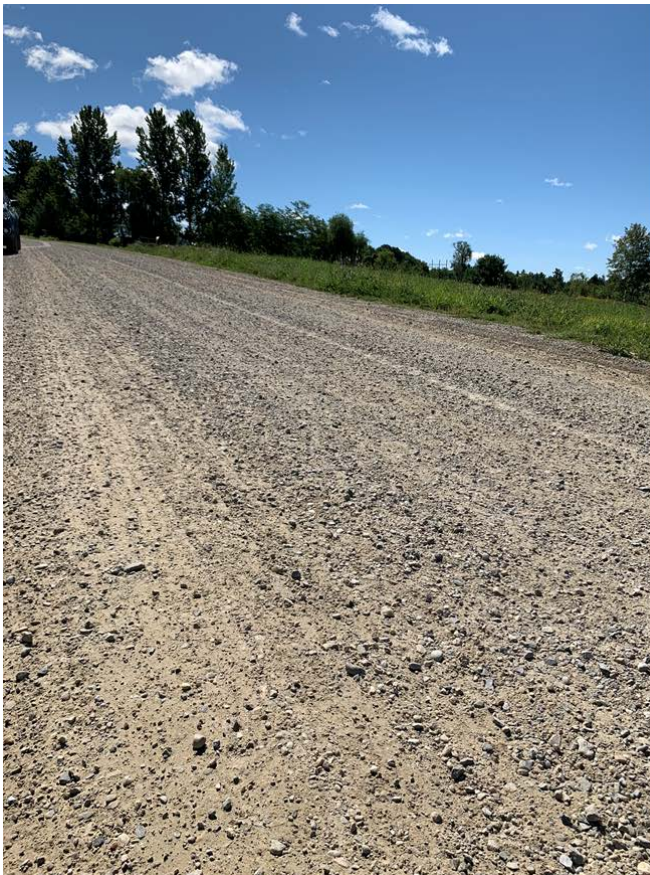
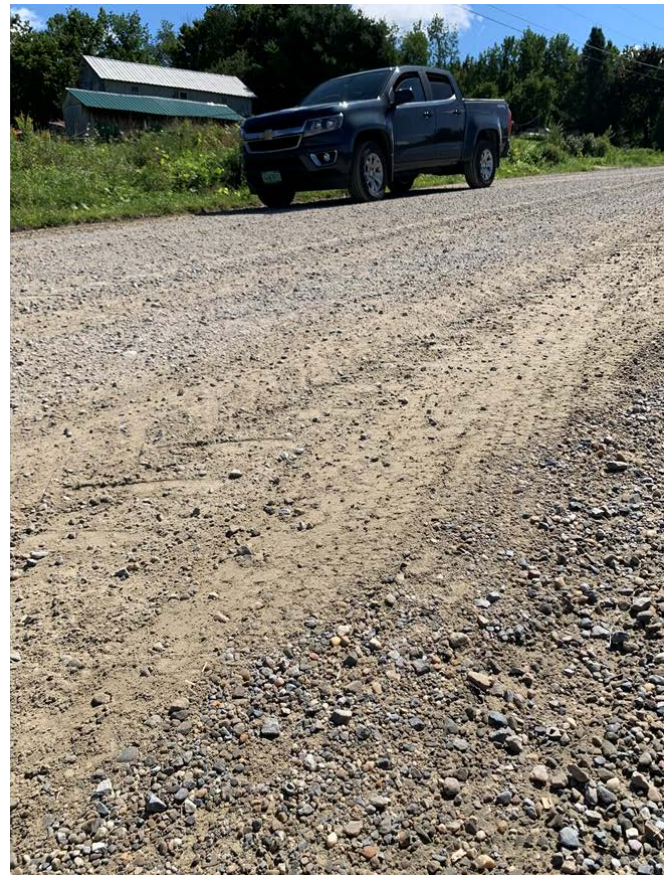
Location: Rotax Road (STA 1293+85)

- No visible evidence of poor roadbed performance, erosion, or settlement of road above gas line.

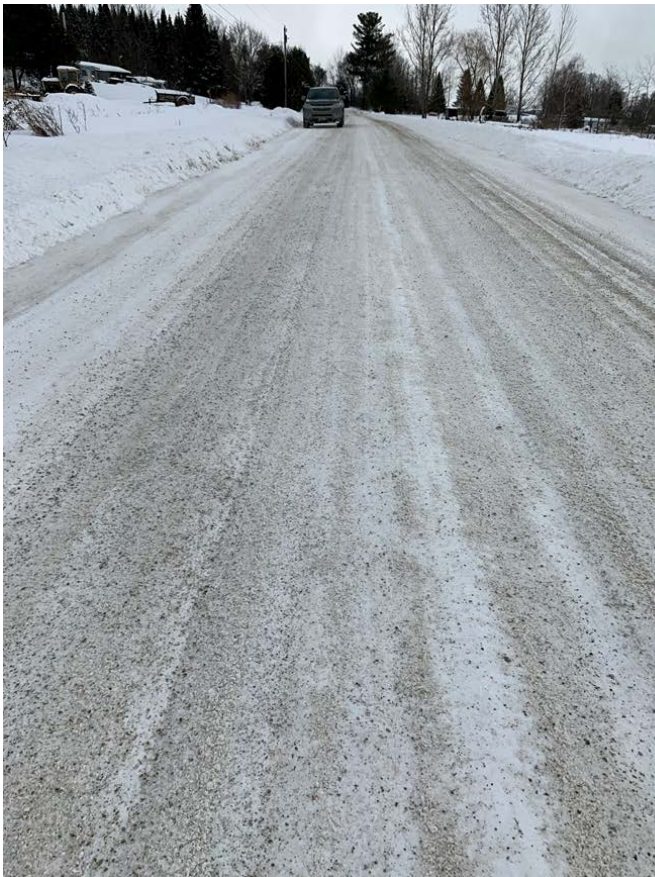
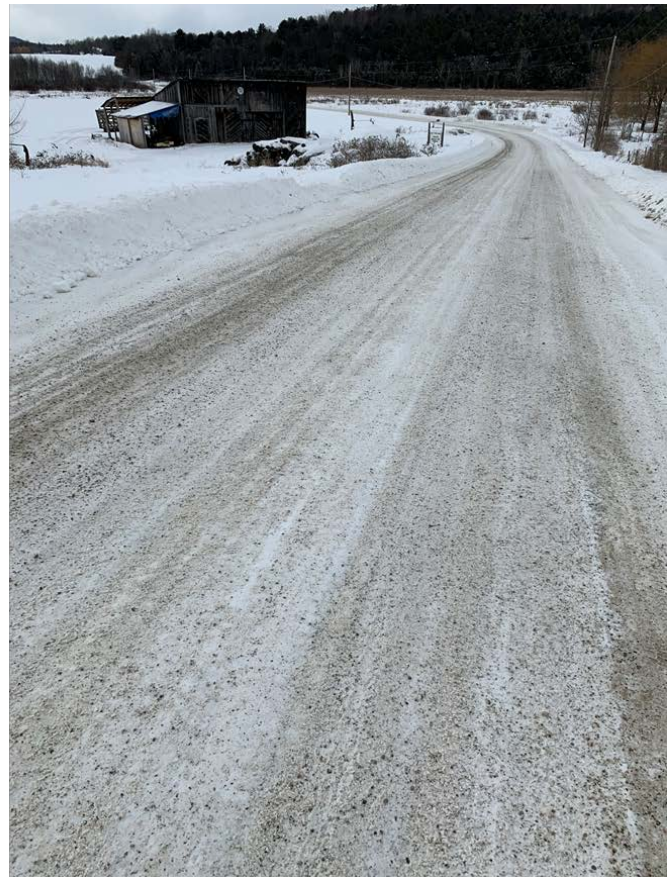
Location: Rotax Road (STA 1293+85)

- No visible evidence of poor roadbed performance, erosion, or settlement of road above gas line.
- Road was plowed with small layer of snow on top.
- No heaving evident.

- Revisit the site in the spring, after the final freeze-thaw cycle of the season.

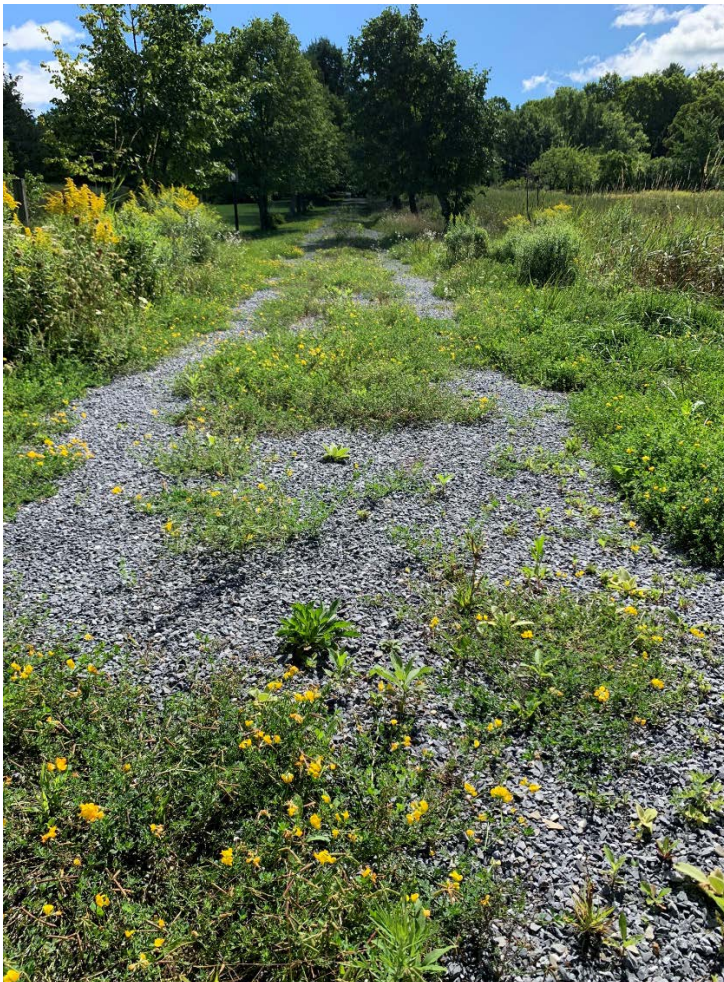
Location: Stillson Road/Cedar Lane (STA 1379+10)

- No visible evidence of poor roadbed performance, erosion, or settlement of road above gas line.

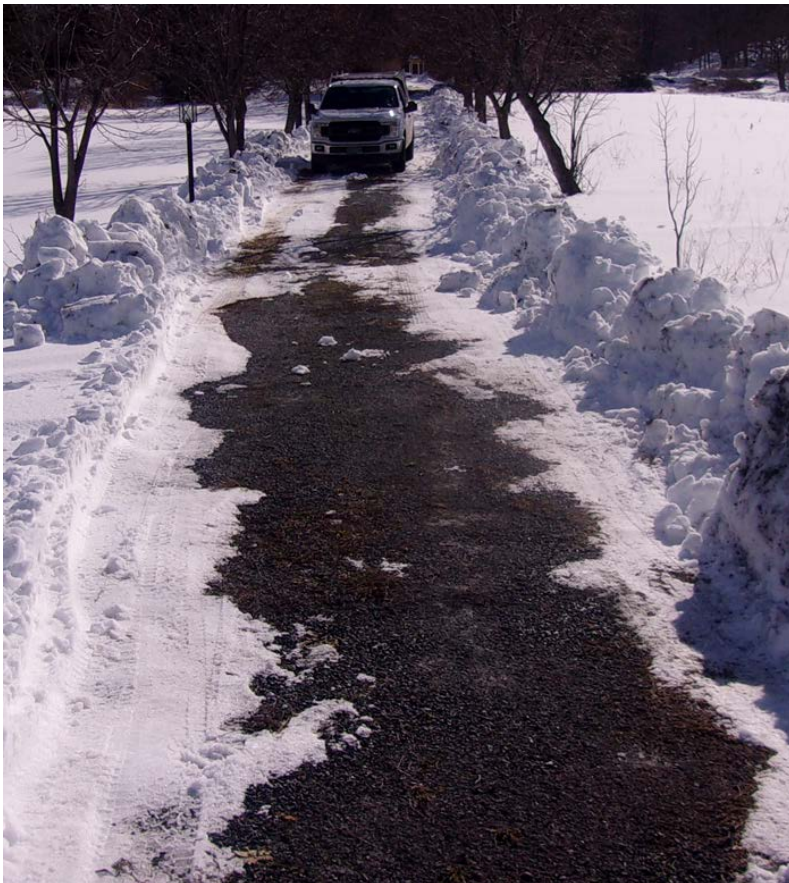
Location: Stillson Road/Cedar Lane (STA 1379+10)

- No visible evidence of poor roadbed performance, erosion, or settlement of road above gas line.
- Road was plowed with small layer of snow on top.
- No heaving evident.

- Revisit the site in the spring, after the final freeze-thaw cycle of the season.

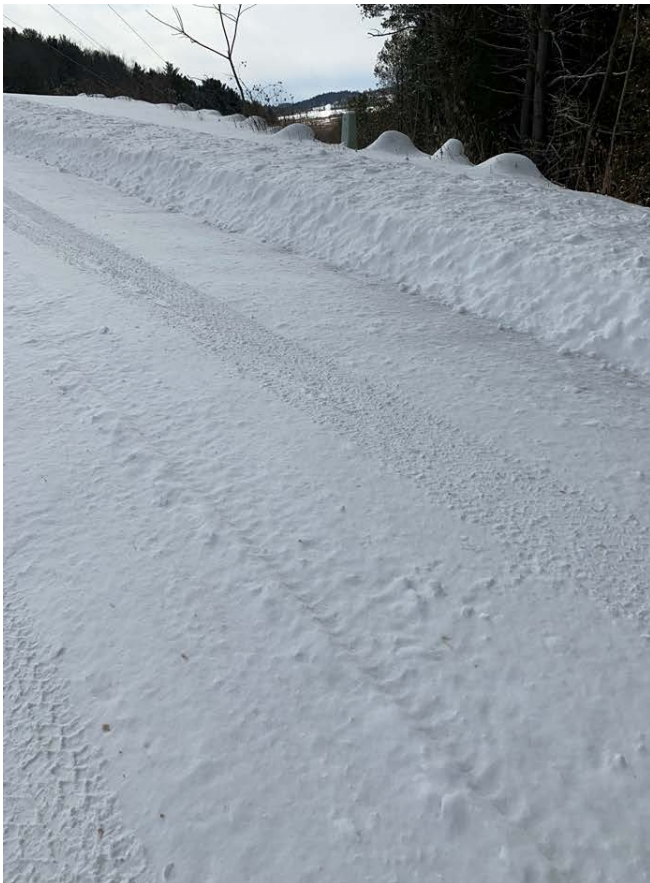
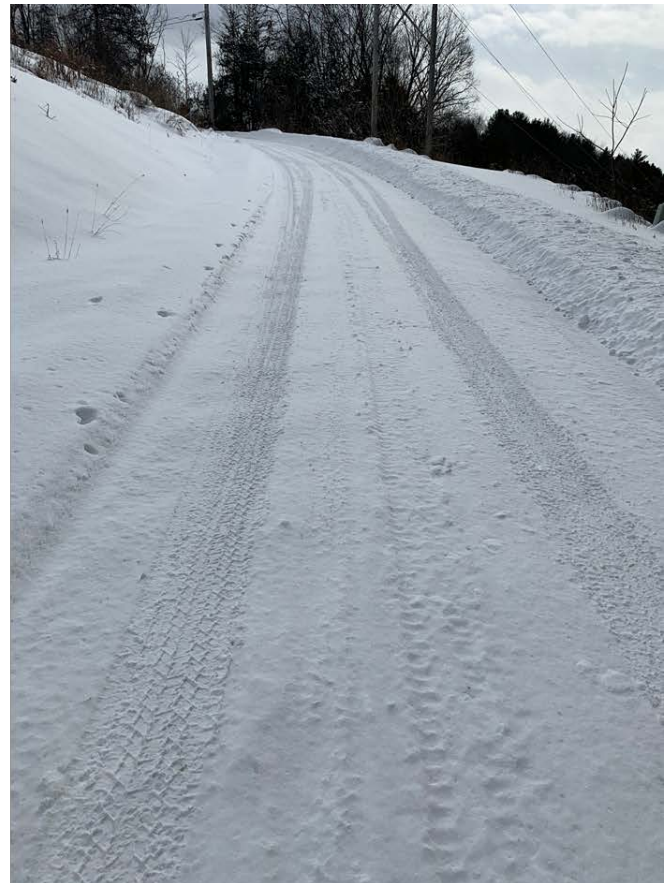
Location: Post Road (STA 1424+25)

- No visible evidence of erosion or settlement of road above gas line.
- Road was plowed with small layer of snow on top.
- No heaving evident.

- Revisit the site in the spring, after the final freeze-thaw cycle of the season.

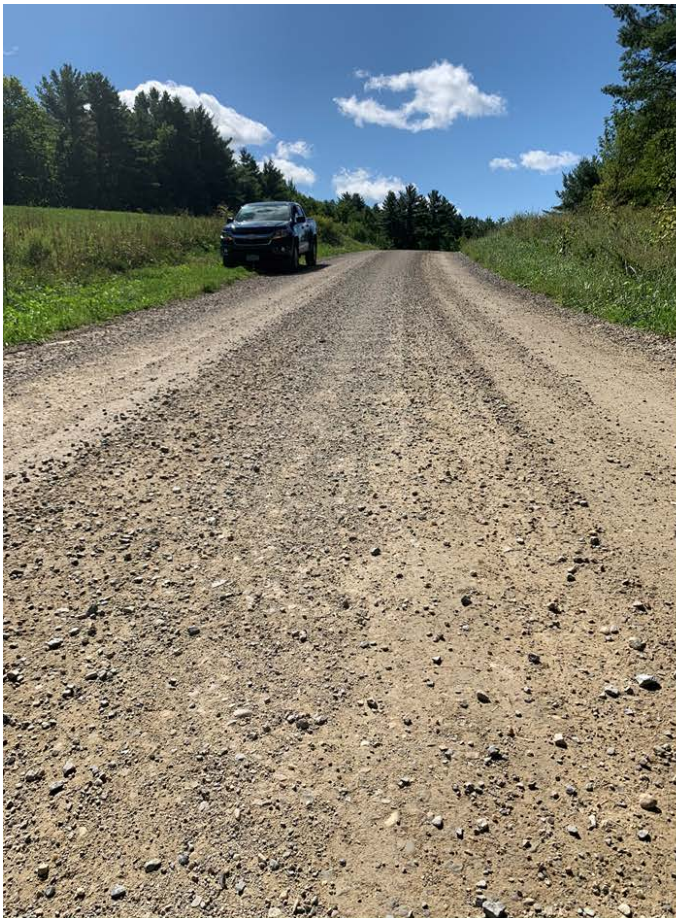
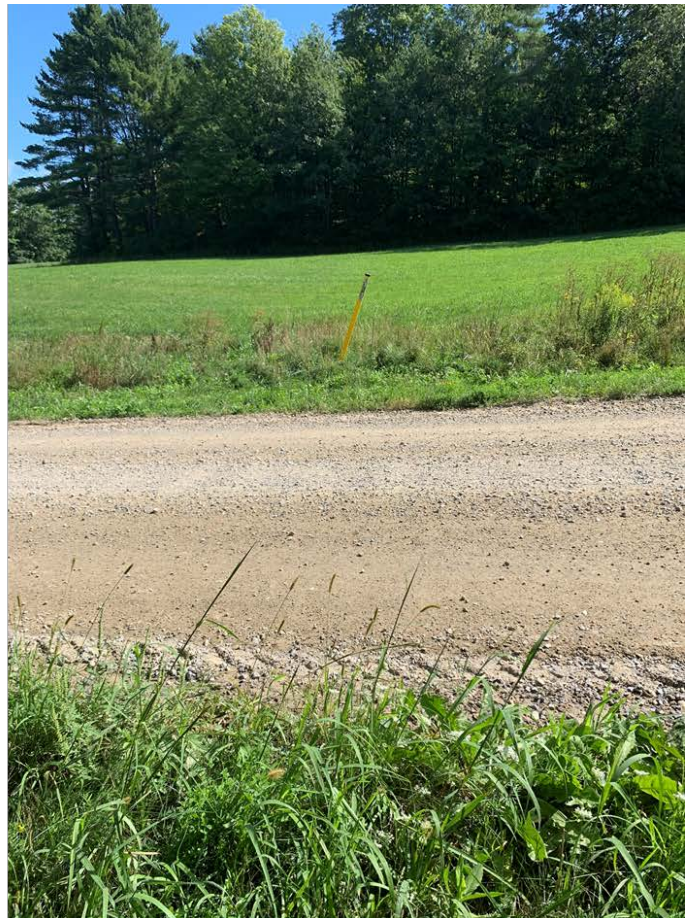
Location: Old Stage Road (STA 1547+60)

- No visible evidence of poor roadbed performance, erosion, or settlement of road above gas line.

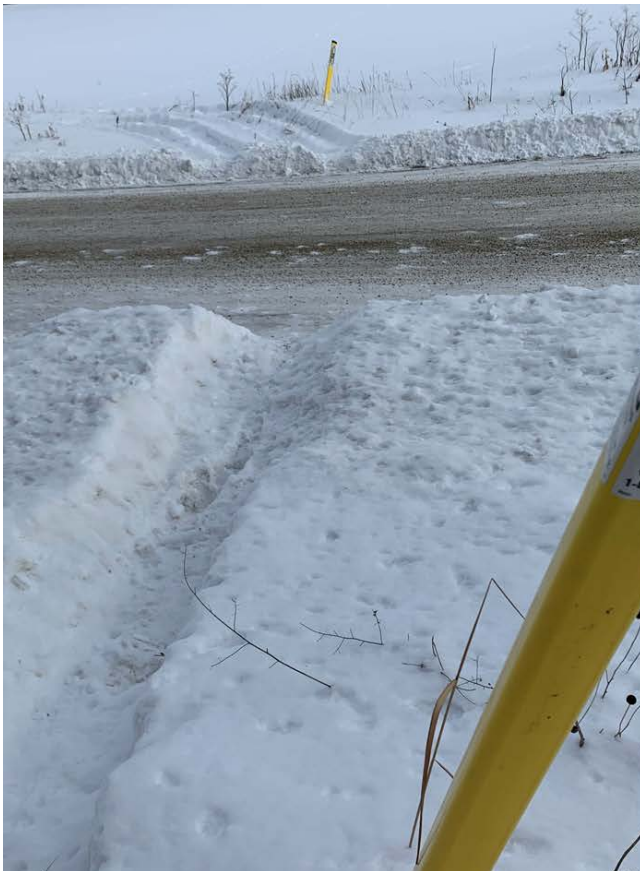
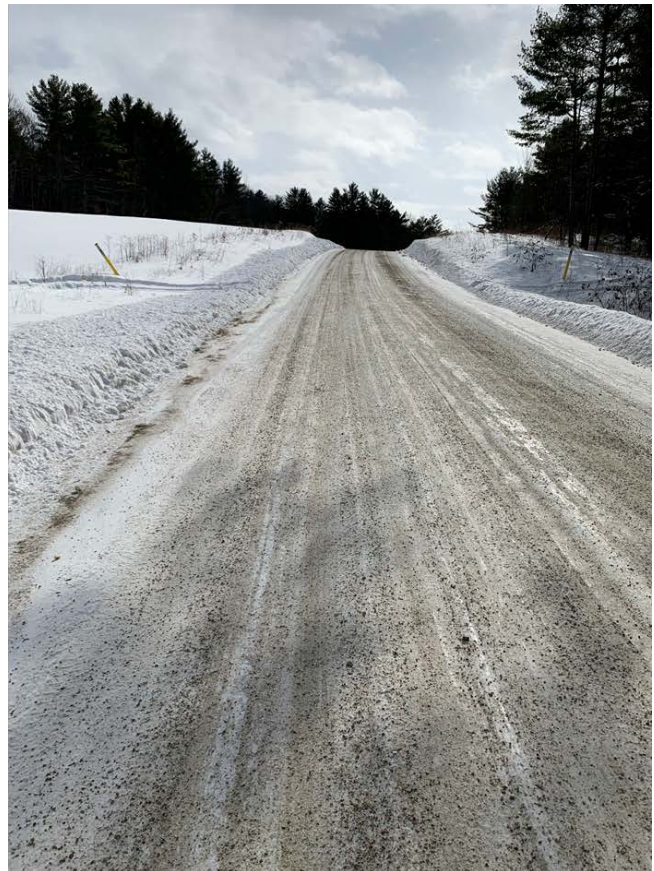
Location: Old Stage Road (STA 1547+60)

- No visible evidence of poor roadbed performance, erosion, or settlement of road above gas line.
- Road was plowed with small layer of snow on top.
- No heaving evident.

- Revisit the site in the spring, after the final freeze-thaw cycle of the season.

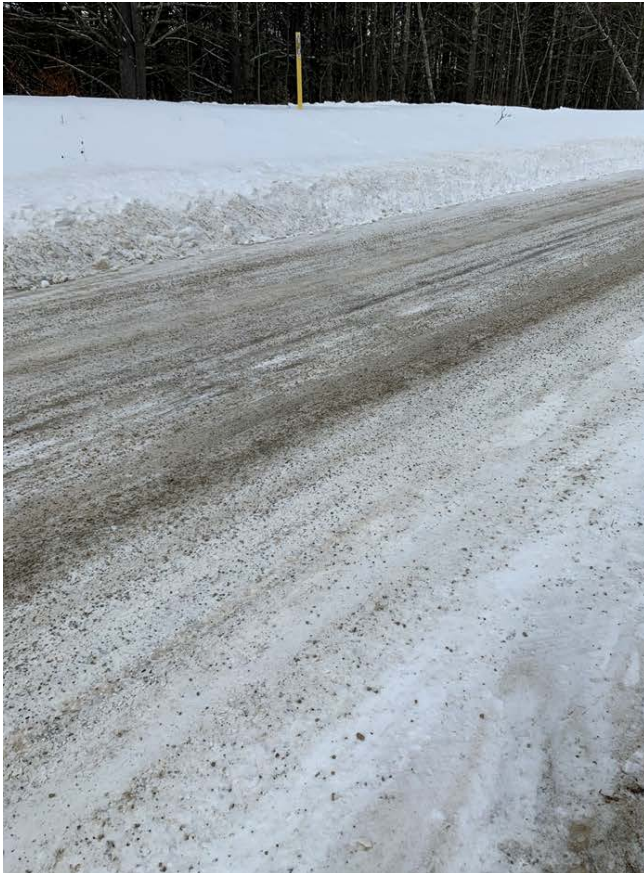
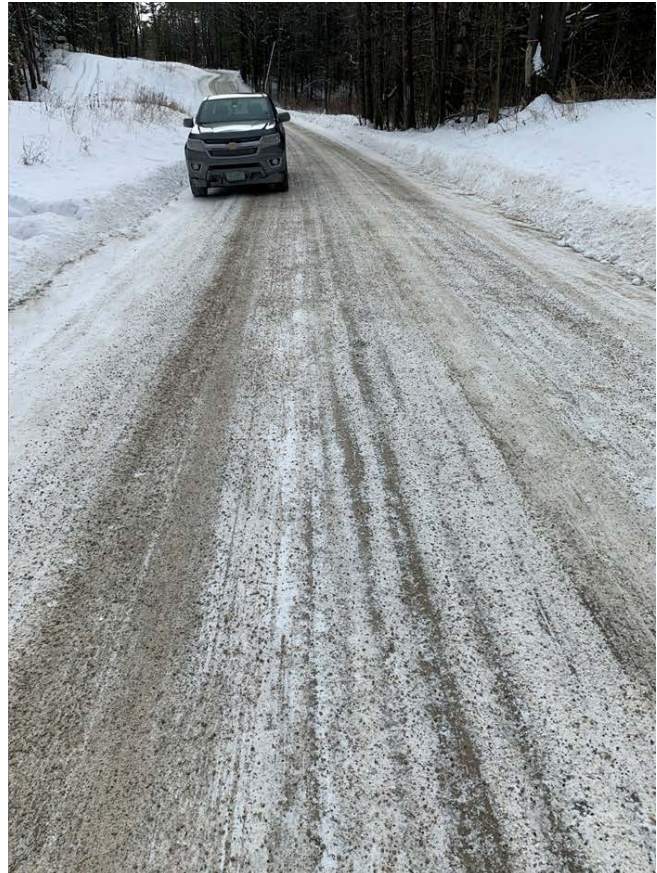
Location: Old Stage Road (STA 1553+55)

- No visible evidence of poor roadbed performance, erosion, or settlement of road above gas line
- Road was plowed with small layer of snow on top.
- No heaving evident.

- Revisit the site in the spring, after the final freeze-thaw cycle of the season.

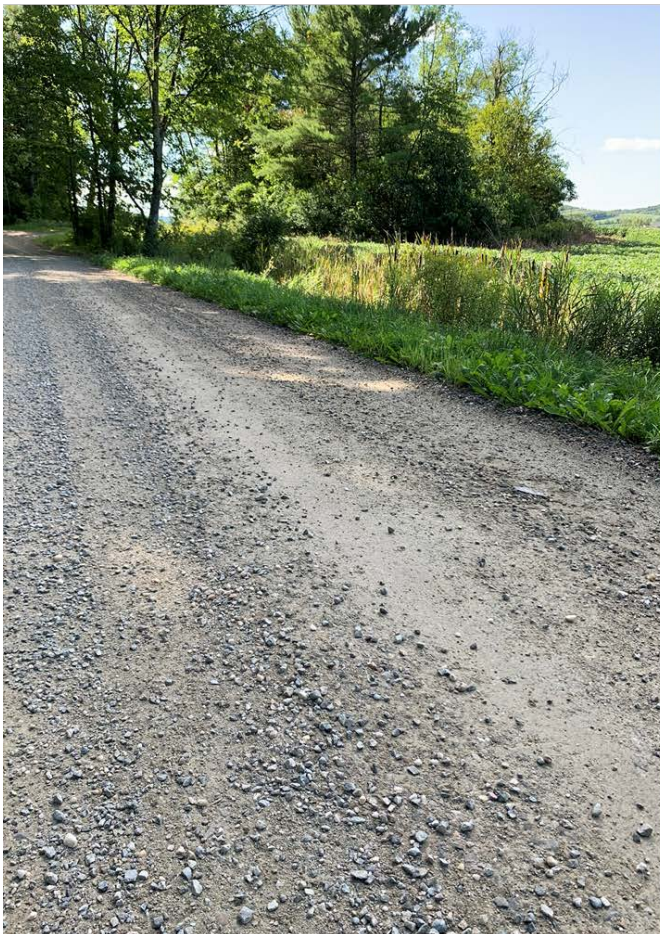
Location: Old Stage Road (STA 1565+50)

- No visible evidence of poor roadbed performance, erosion, or settlement of road above gas line.

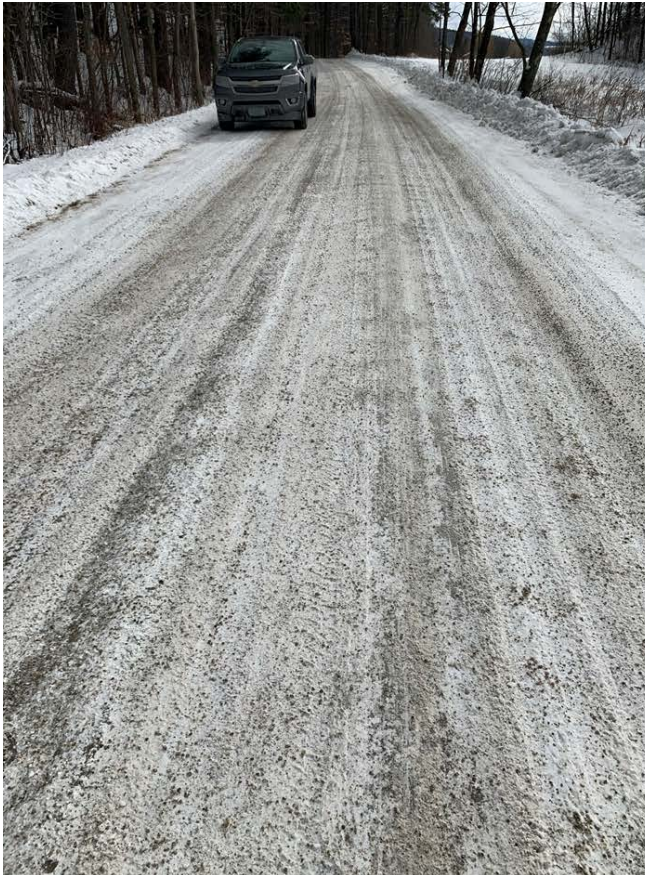
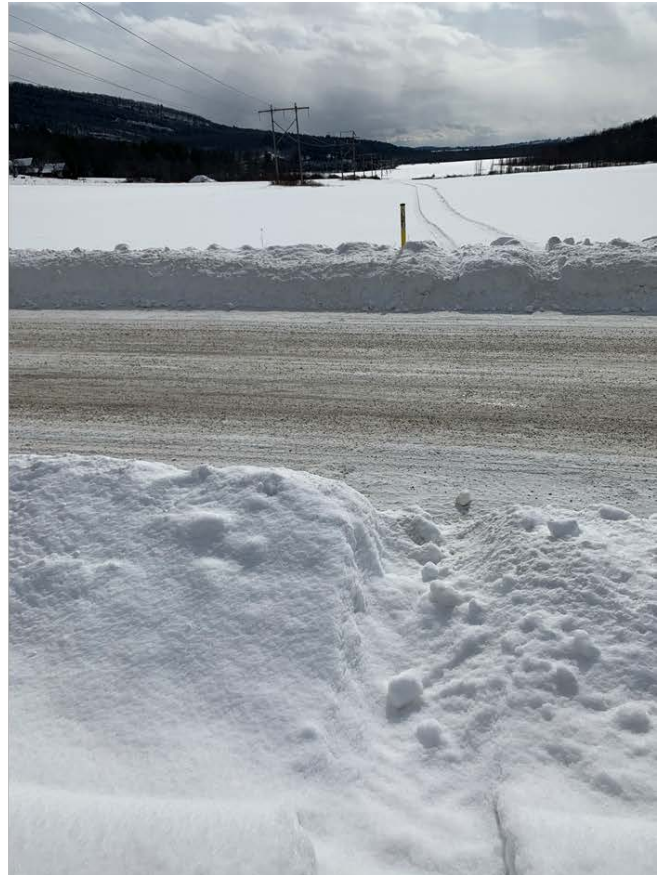
Location: Old Stage Road (STA 1565+50)

- No visible evidence of poor roadbed performance, erosion, or settlement of road above gas line.
- Road was plowed with small layer of snow on top.
- No heaving evident.

- Revisit the site in the spring, after the final freeze-thaw cycle of the season.

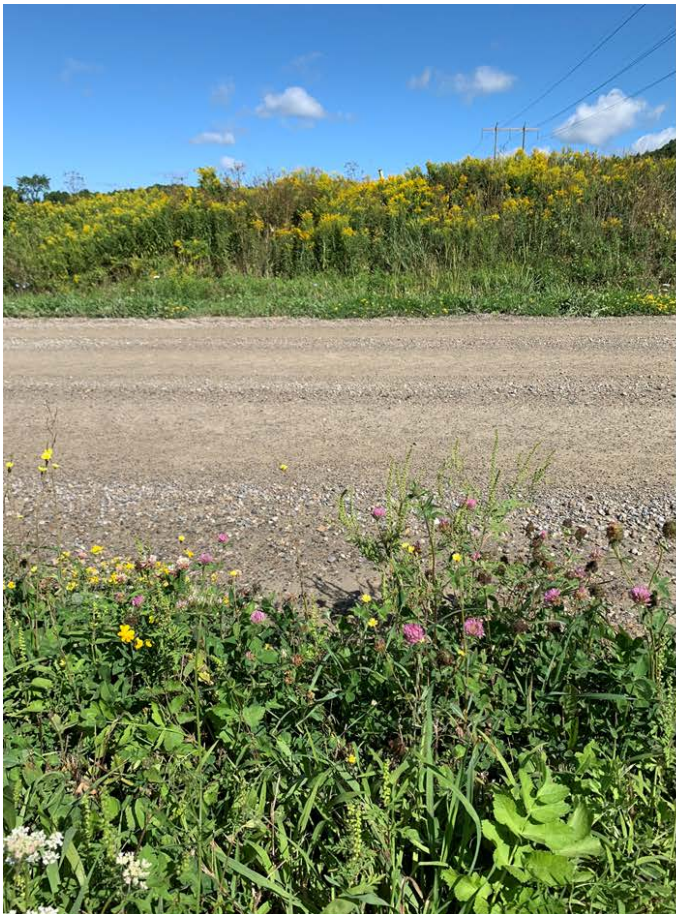
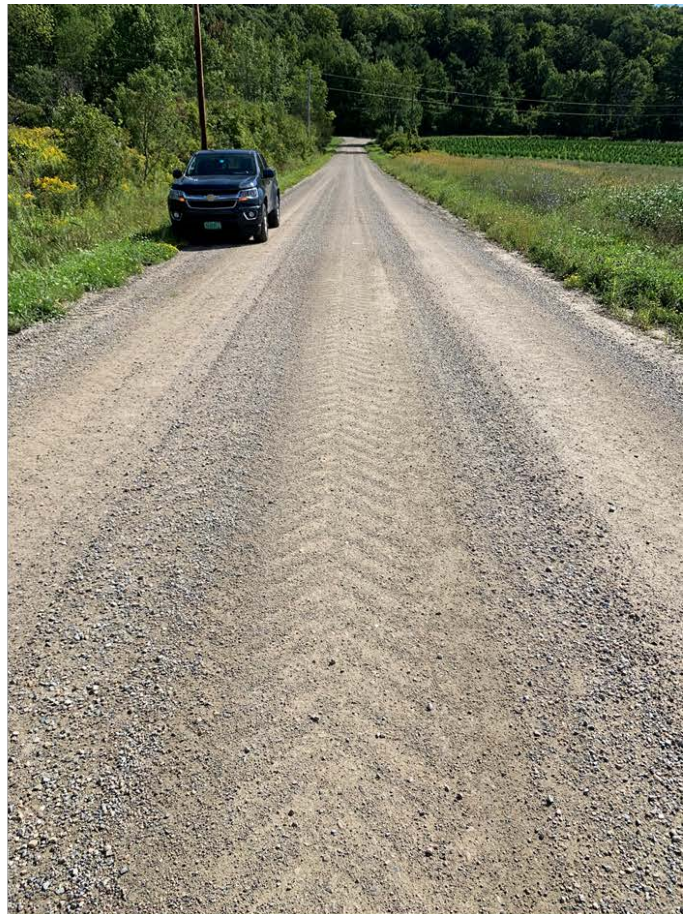
Location: Parks Hurlburt Road (STA 1588+45)

- No visible evidence of poor roadbed performance, erosion, or settlement of road above gas line.

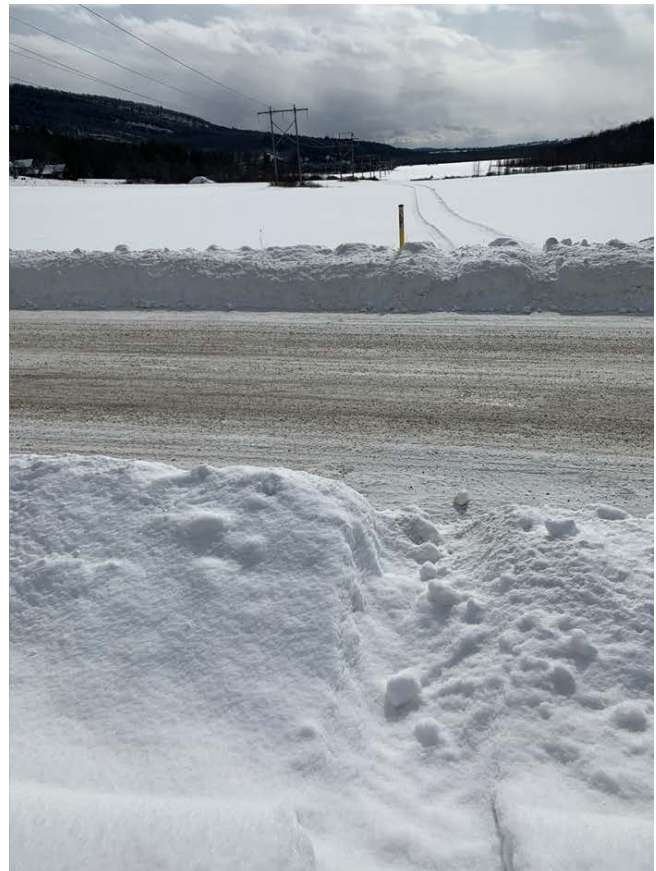
Location: Parks Hurlburt Road (STA 1588+45)

- No visible evidence of poor roadbed performance, erosion, or settlement of road above gas line.
- Road was plowed with small layer of snow on top.
- No heaving evident.

- Revisit the site in the spring, after the final freeze-thaw cycle of the season.

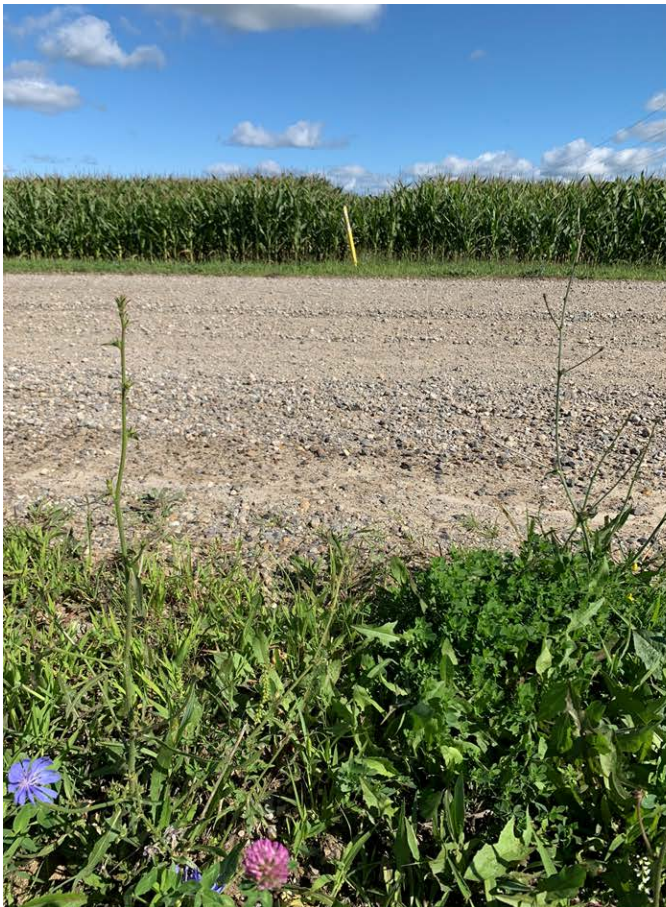
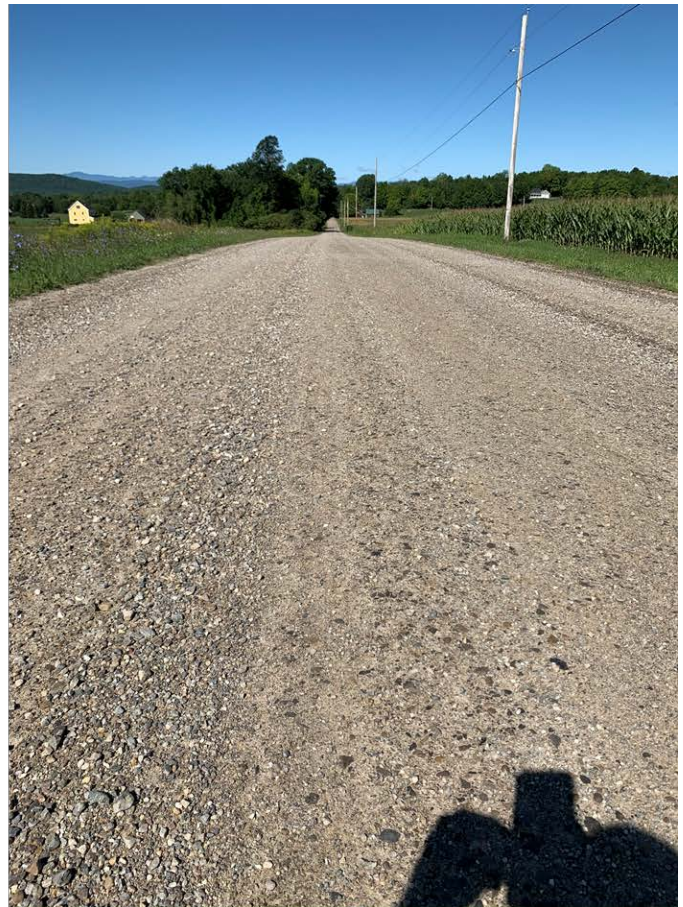
Location: Quarry Road (STA 1768+45)

- No visible evidence of poor roadbed performance, erosion, or settlement of road above gas line.

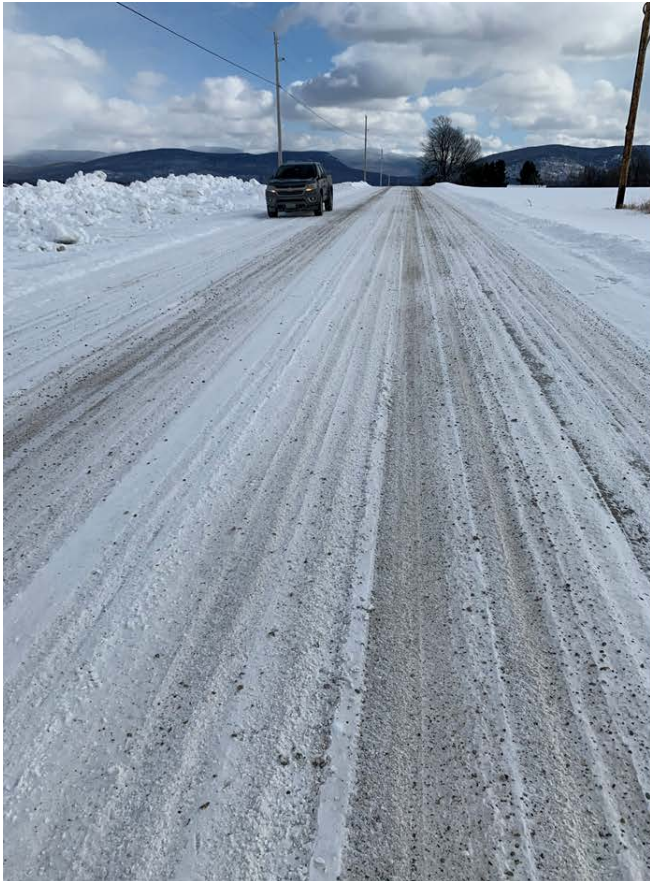
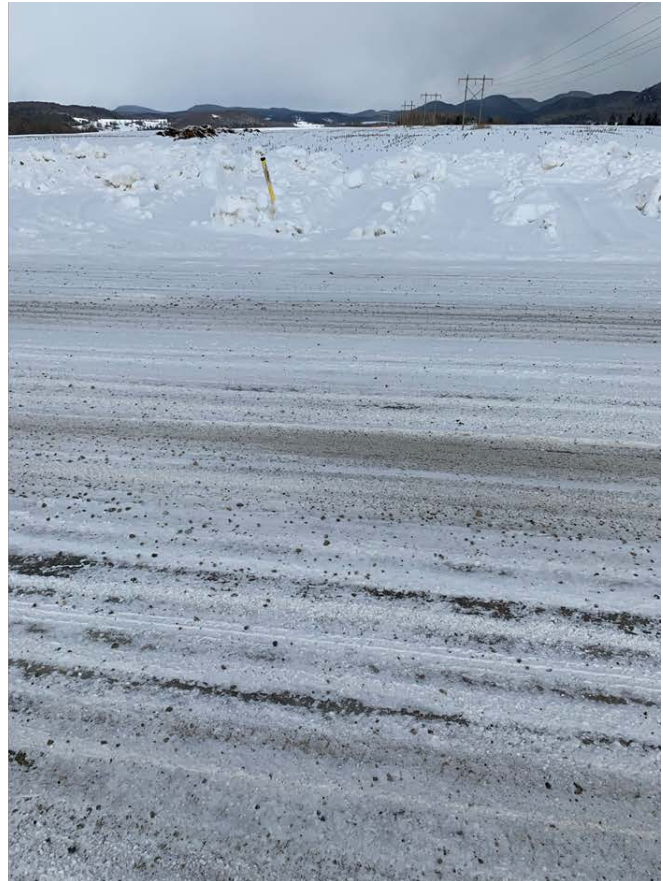
Location: Quarry Road (STA 1768+45)

- No visible evidence of poor roadbed performance, erosion, or settlement of road above gas line.
- Road was plowed with small layer of snow on top.
- No heaving evident.

- Revisit the site in the spring, after the final freeze-thaw cycle of the season.
