Vermont Gas Systems Addison Natural Gas Project
Road Crossing Observation Report

Krebs & Lansing Consulting Engineers, Inc.
164 Main Street | Colchester, Vermont 05446
(802) 878-0375

March 30th, 2021

ADDENDUM 1: FINAL OBSERVATIONS

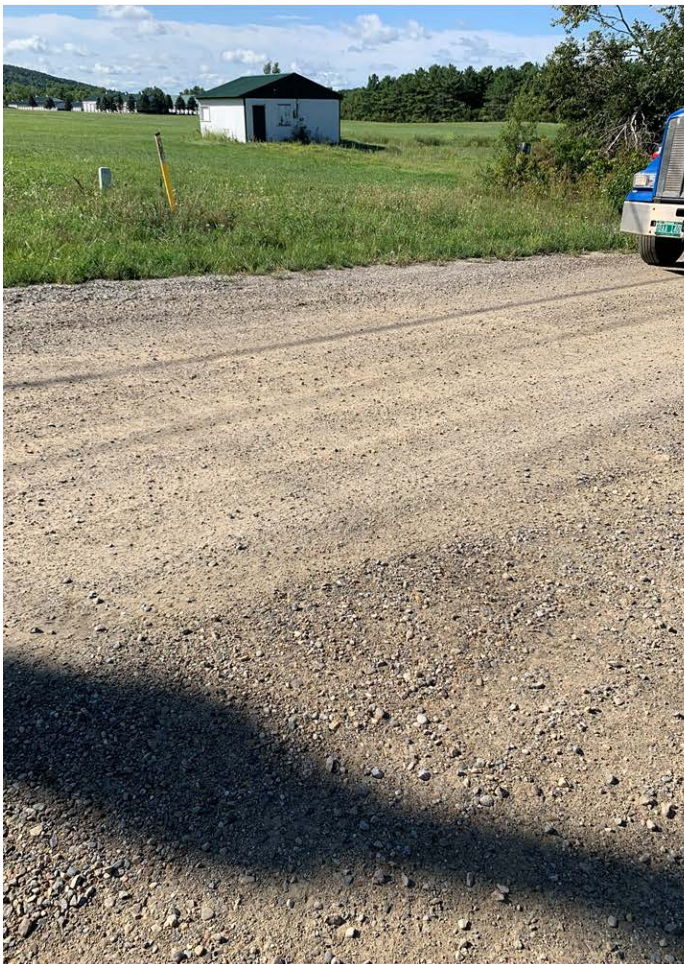
Location: Belden Falls Road (STA 2129+45)

- No visible evidence of poor roadbed performance, erosion, or settlement of road above gas line.

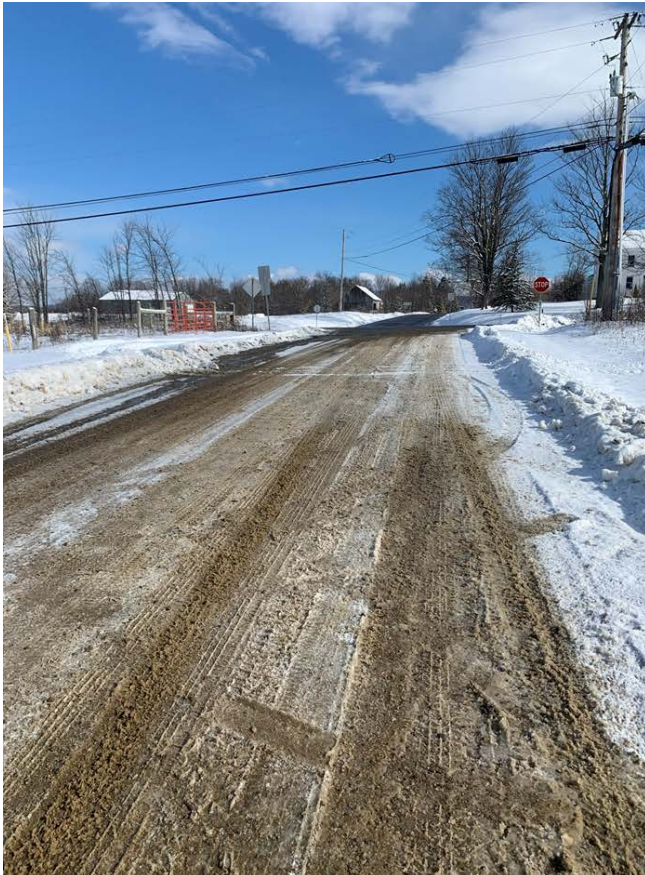
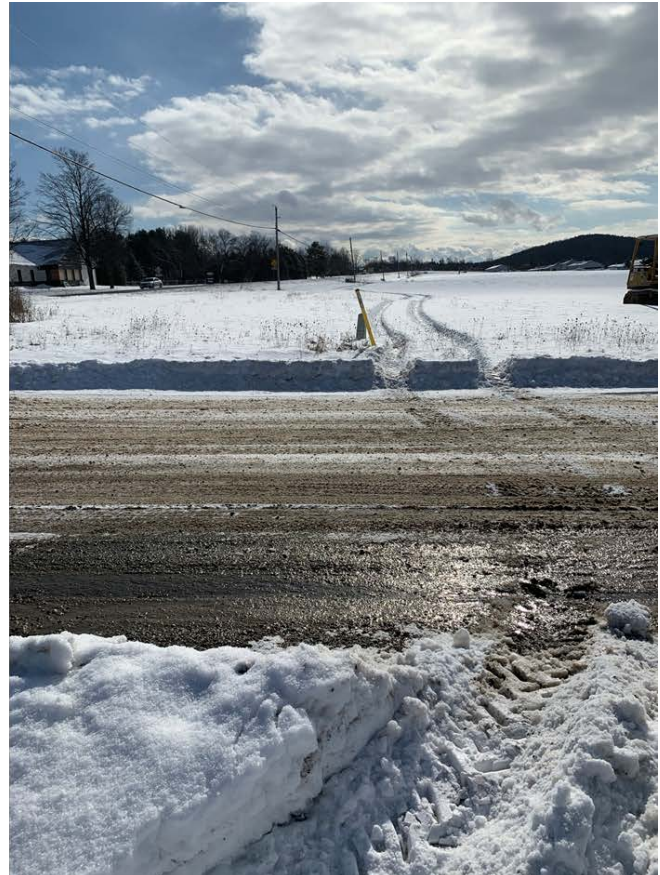
Location: Belden Falls Road (STA 2129+45)

- No visible evidence of poor roadbed performance, erosion, or settlement of road above gas line.
- Road was plowed with small layer of snow on top.
- No heaving evident.

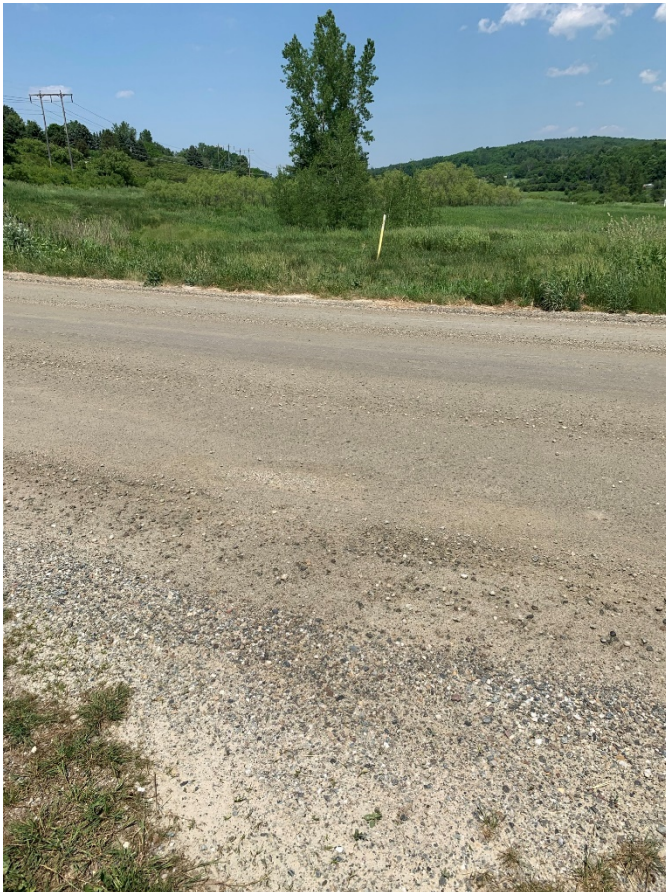
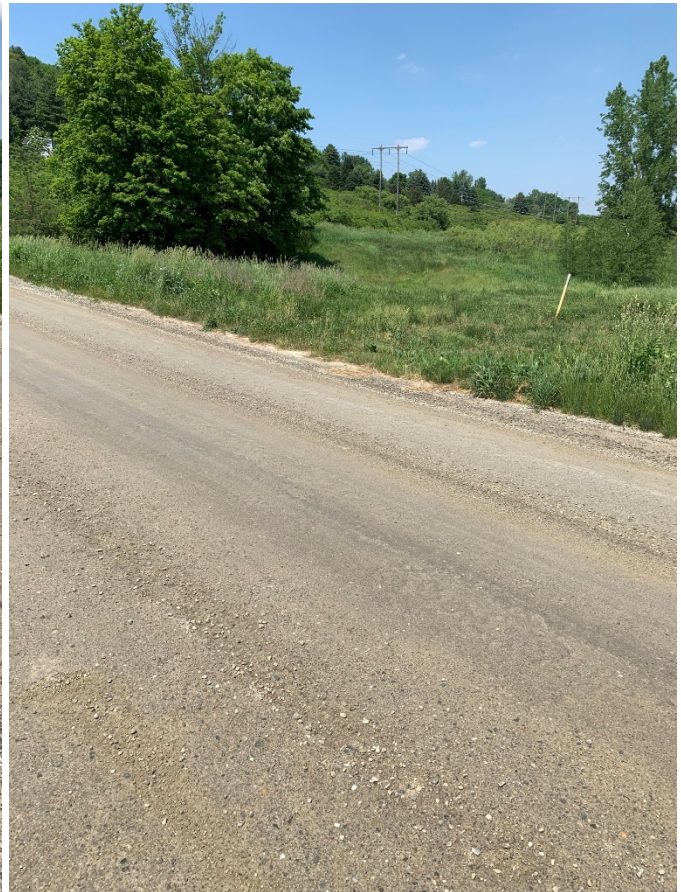
Location: Lincoln Road (STA 755+95)

- No visible evidence of poor roadbed performance, erosion or settlement of road above gas line.

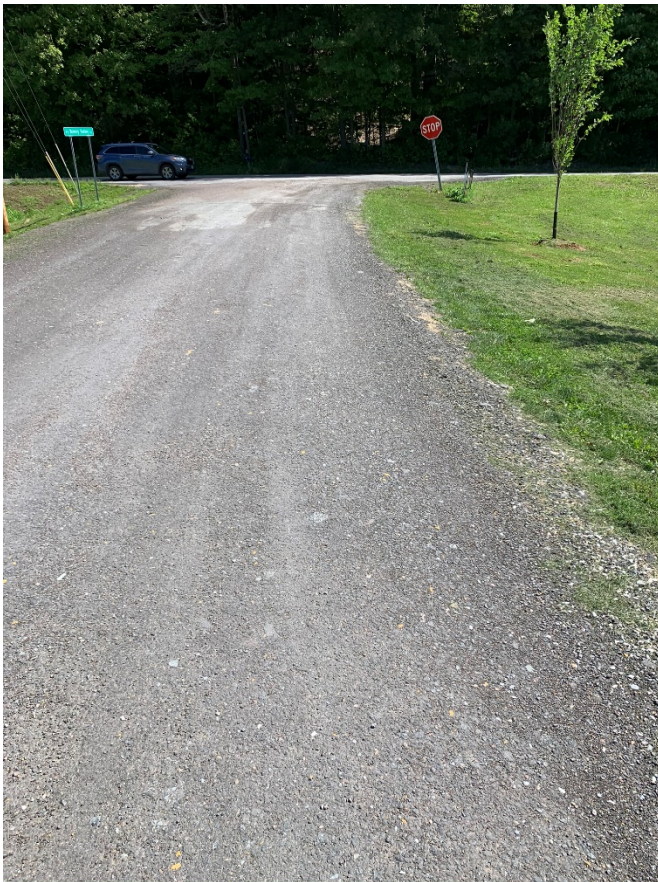
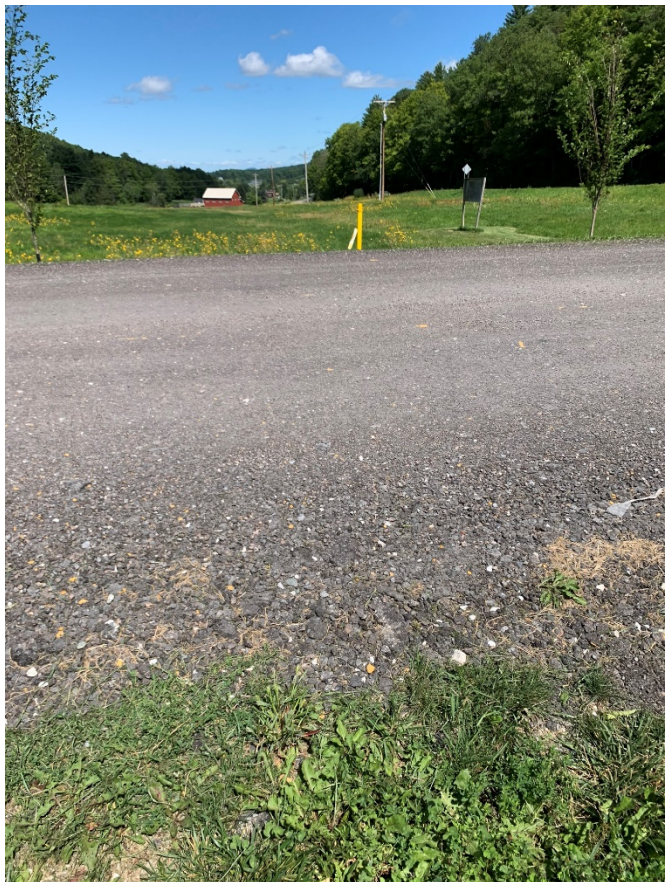
Location: Breezy Valley Lane (STA 788+10)

- No visible evidence of poor roadbed performance, erosion, or settlement of road above gas line.
- Road has been paved.

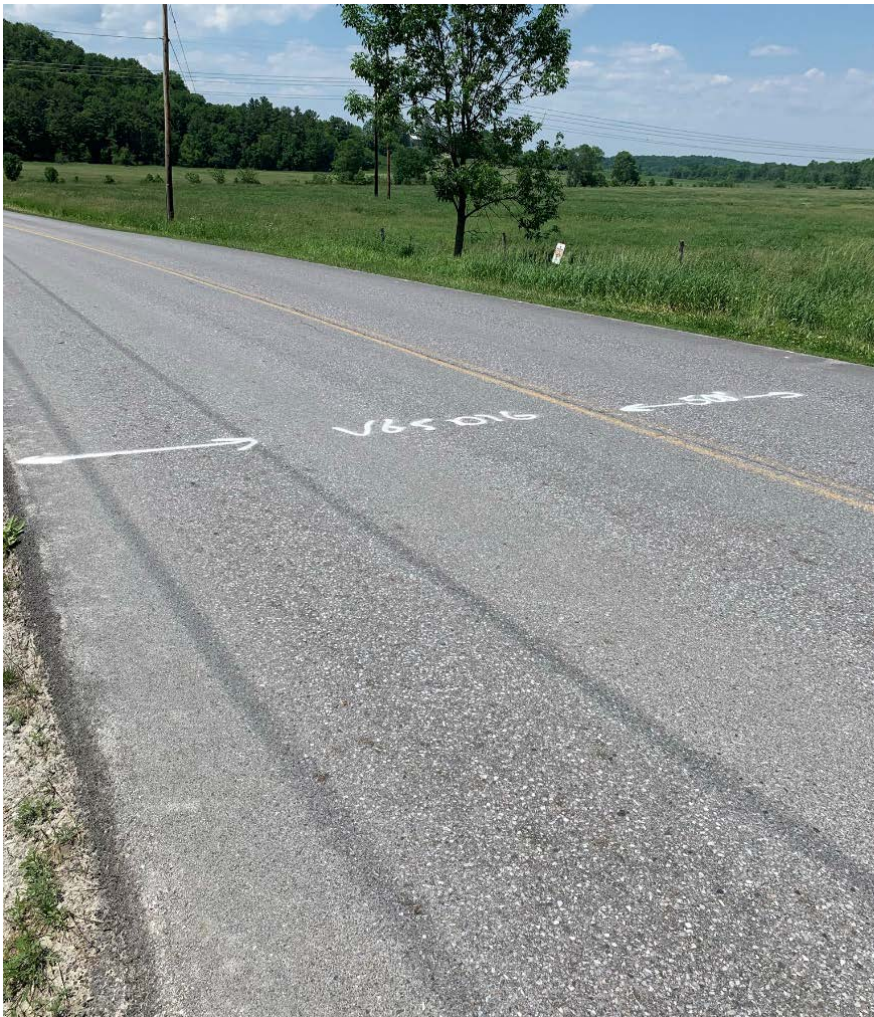
Location: Charlotte Road (STA 1048+25)

- No visible evidence of pavement degradation, erosion, or settlement of road above gas line.
- Paved road.

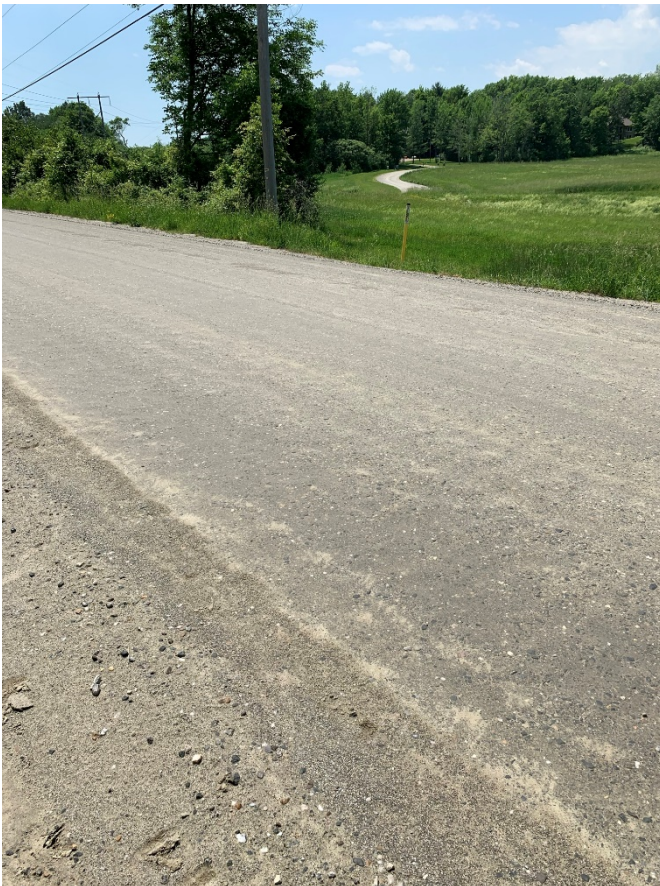
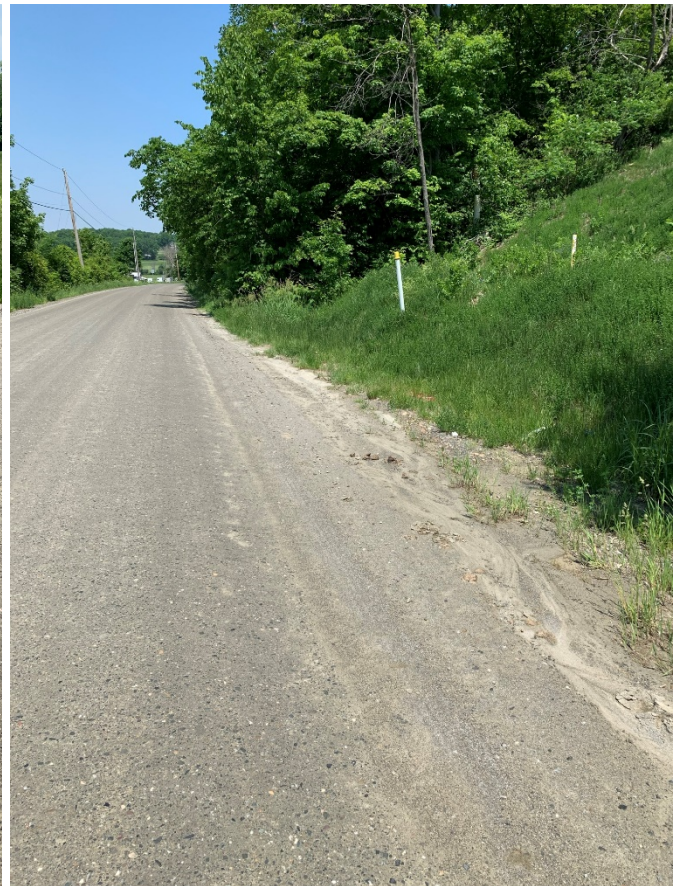
- No visible evidence of poor roadbed performance, erosion, or settlement of road above gas line.

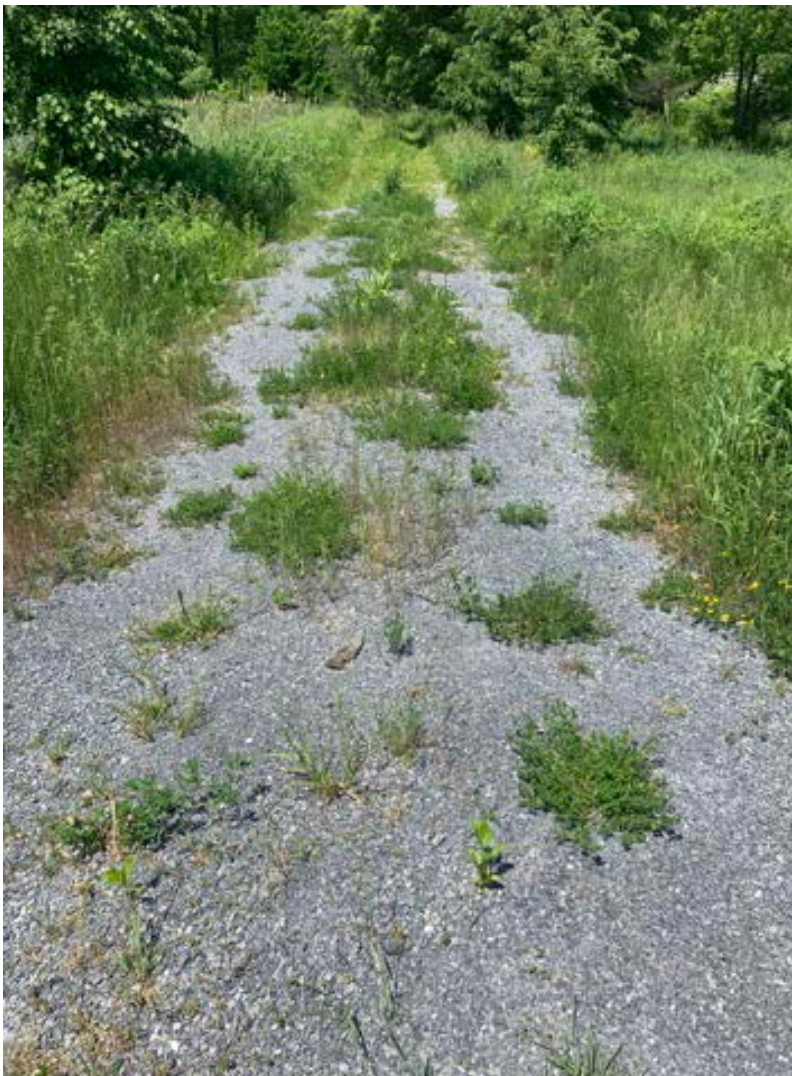
- No visible evidence of poor roadbed performance, erosion, or settlement of road above gas line.

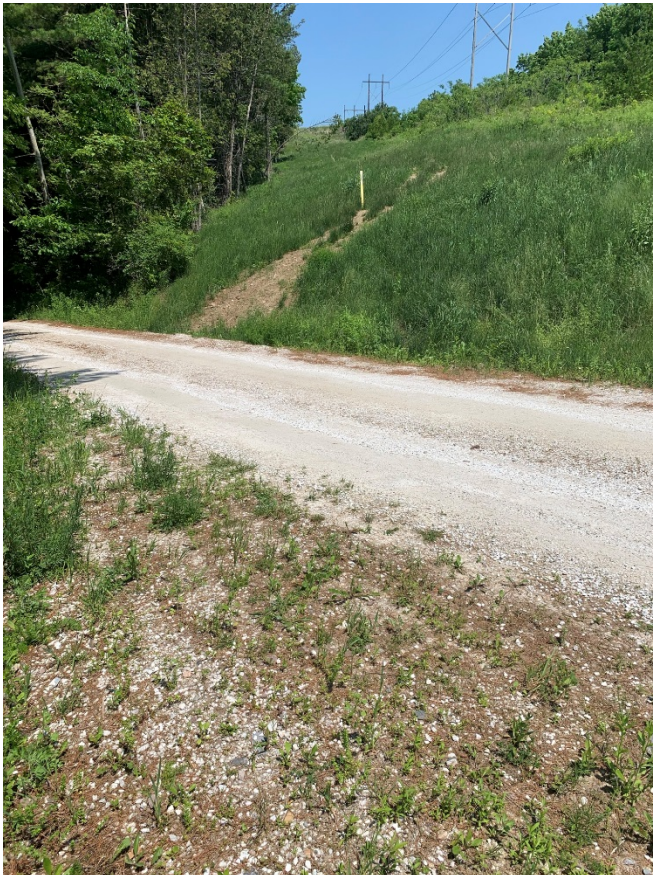
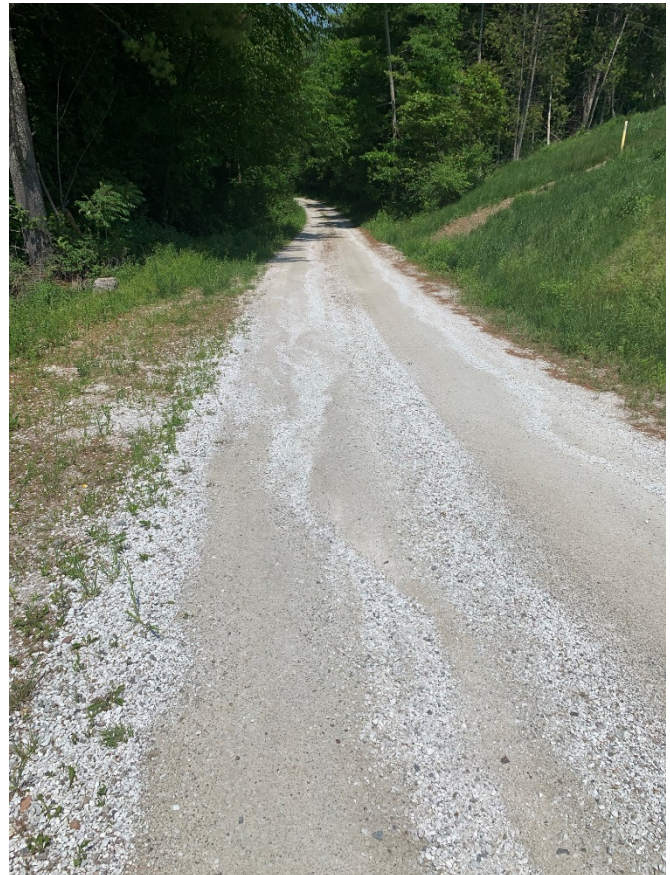
- The washout remains in the middle of the road. It extends uphill of the gas line crossing and continues downslope of the crossing. The erosion is not from the gas line installation but from improper road grading.
- No visible evidence of poor roadbed performance or settlement of road above gas line.

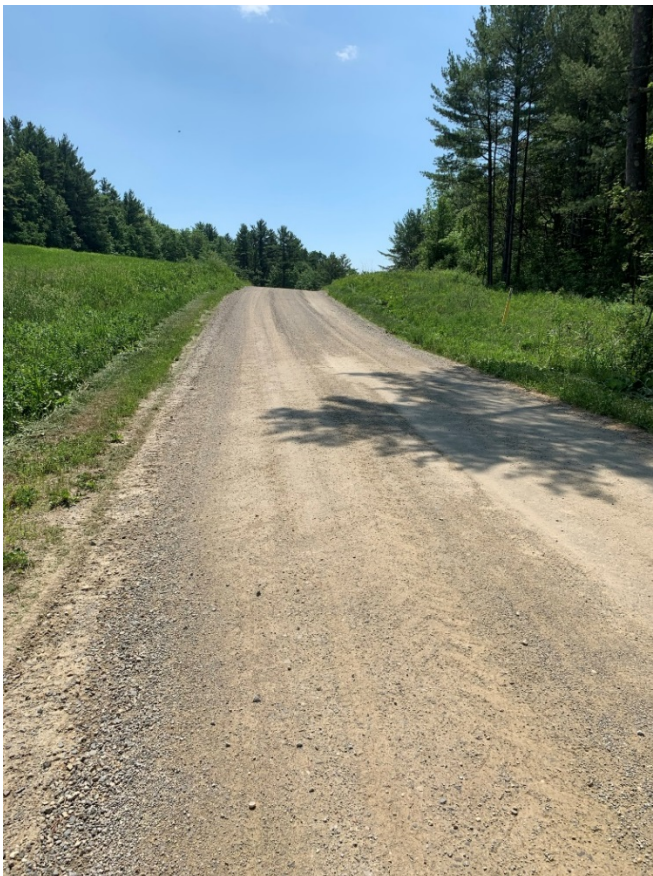
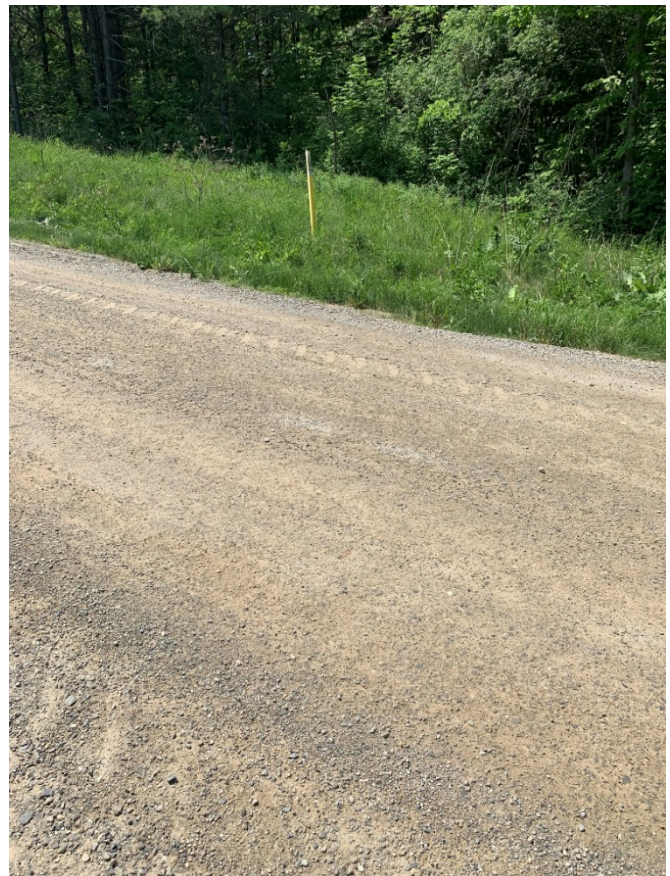
- No visible evidence of poor roadbed performance, erosion, or settlement of road above gas line.

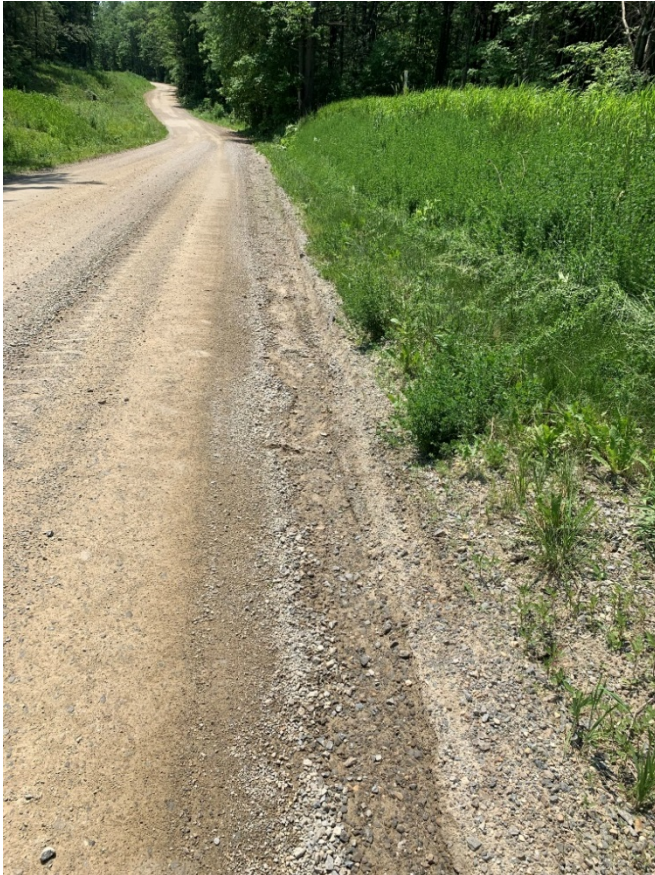
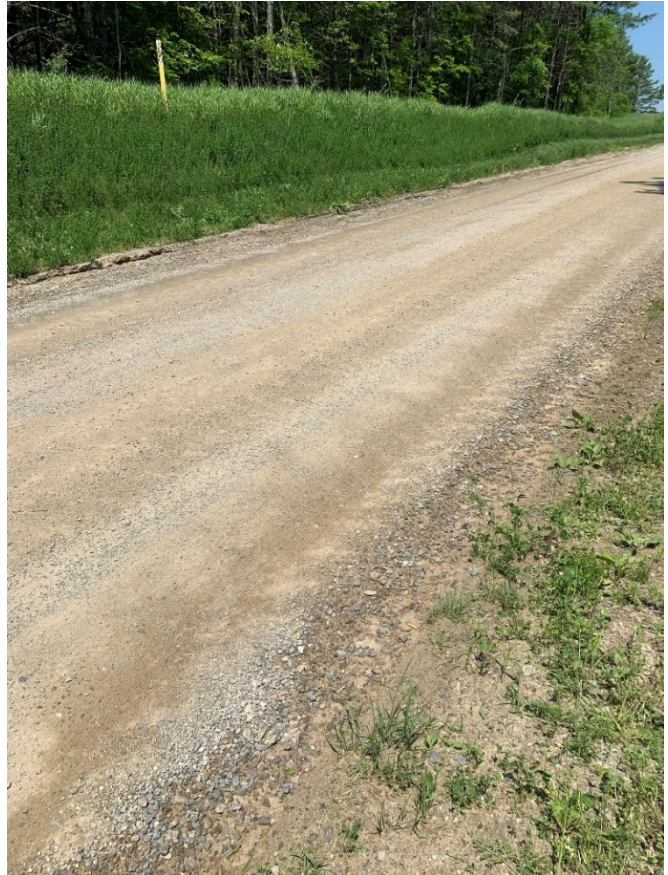
- The road appears to have been regraded in the Spring. The roadside swale along the west side of the road appears to have been filled in during the road regrading. This is causing erosion down the west side of the crowned road as there is no defined area for stormwater to flow. Erosion is not from the gas line installation.
- No visible evidence of poor roadbed performance or settlement of road above gas line.

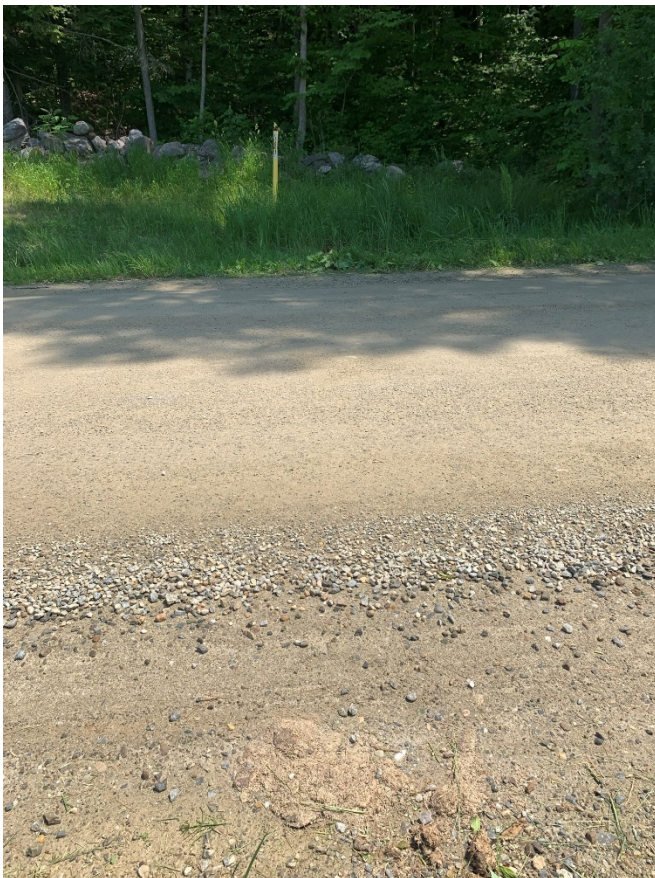
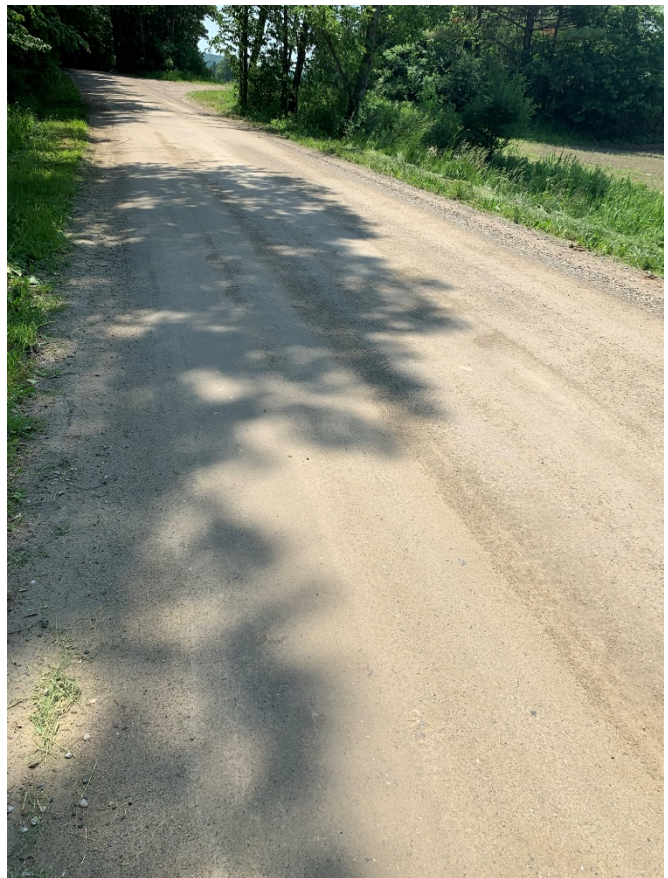
- No visible evidence of poor roadbed performance, erosion, or settlement of road above gas line.

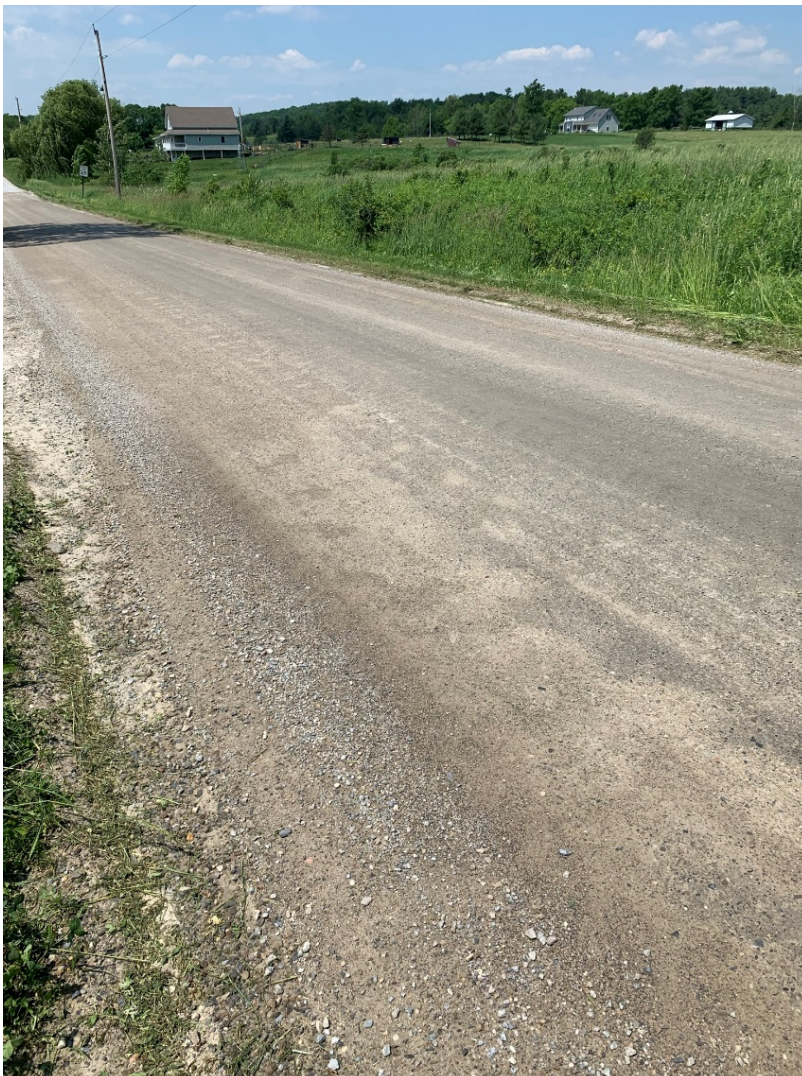
- No visible evidence of poor roadbed performance, erosion, or settlement of road above gas line.

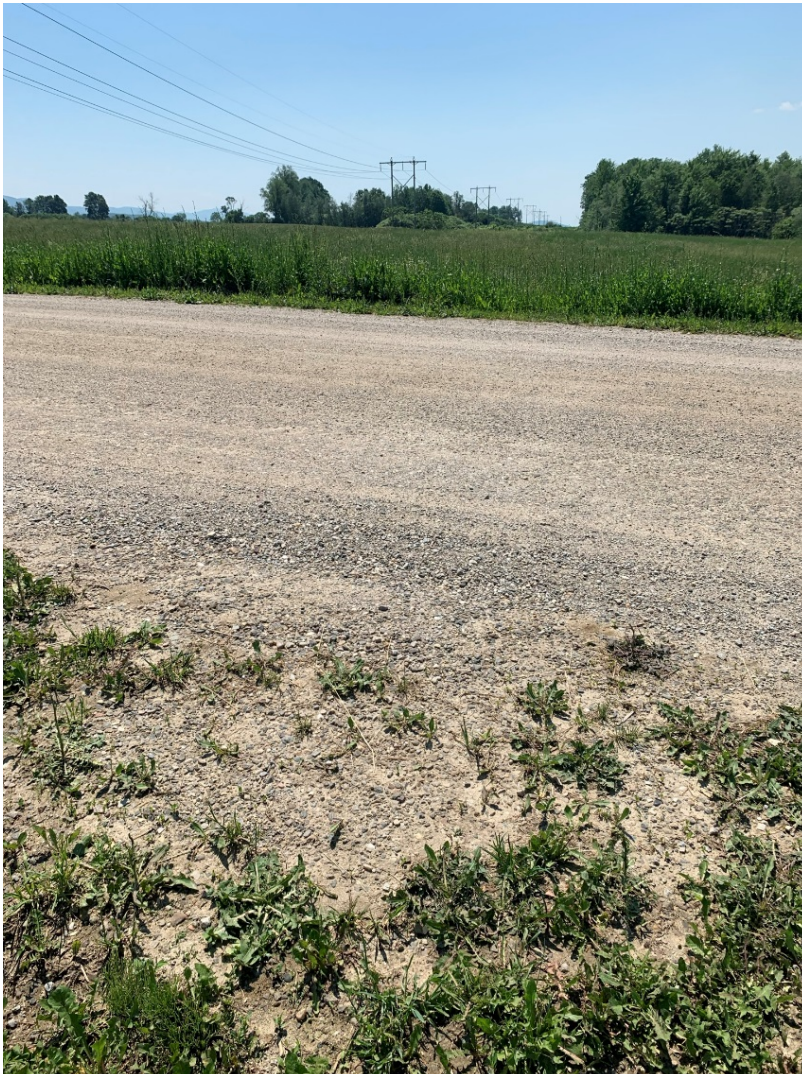
- No visible evidence of poor roadbed performance, erosion, or settlement of road above gas line.

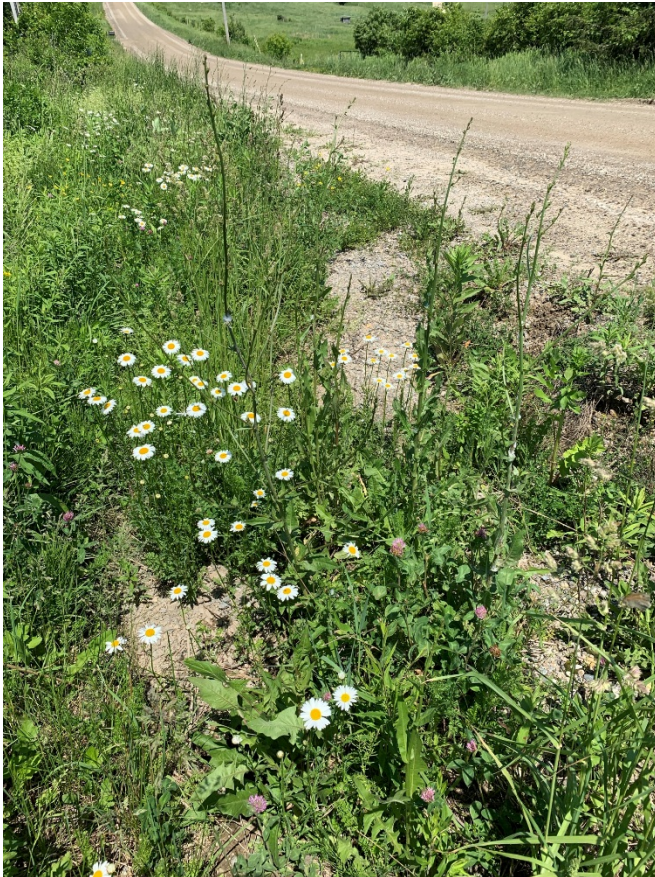
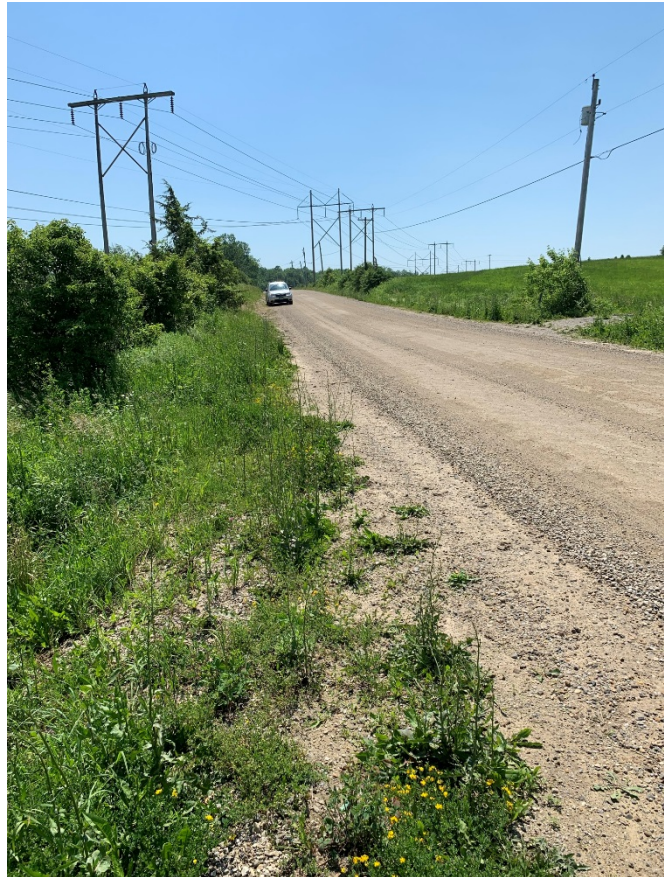
- Small washout located above gas line at southern edge of road.
- VGS should follow up and develop a plan for construction to address the washout above the gas line.

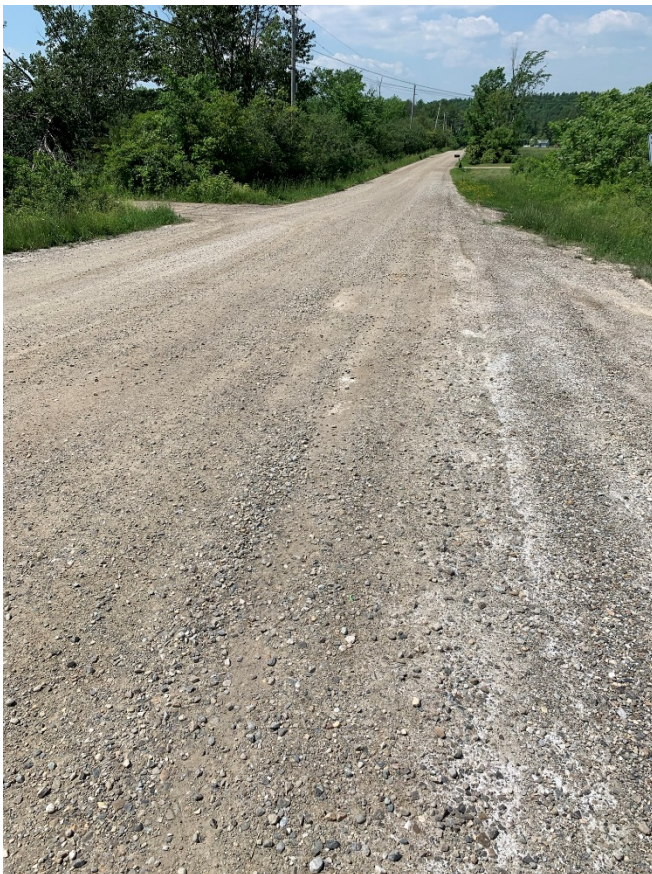
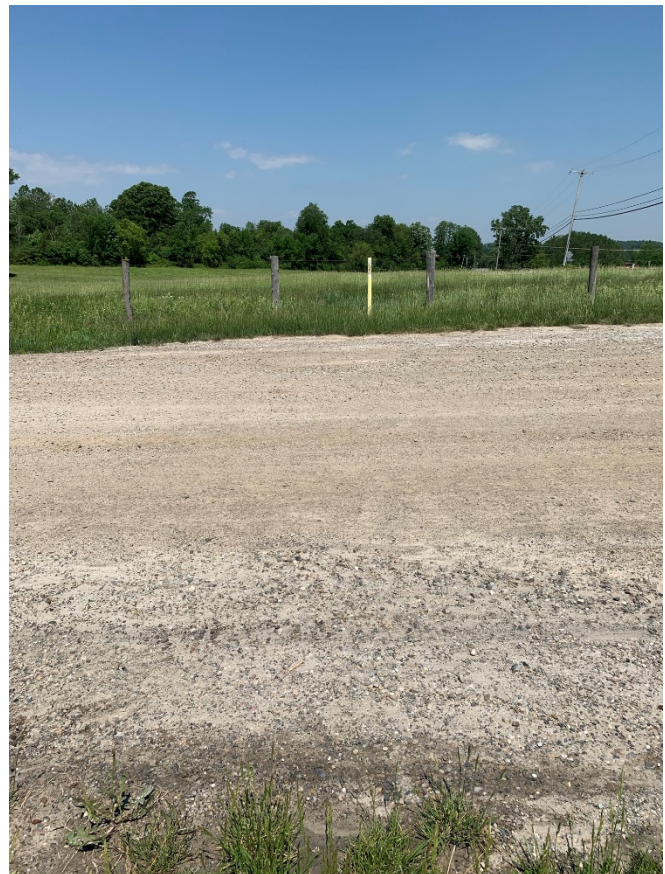
- No visible evidence of poor roadbed performance, erosion, or settlement of road above gas line.
