**STATE OF VERMONT
PUBLIC UTILITY COMMISSION**

Investigation pursuant to 30 V.S.A. §§ 30 and)
 209 regarding the alleged failure of Vermont)
 Gas Systems, Inc. to comply with the) Case No. 17-3550-INV
 certificate of public good in Docket 7970 by)
 burying the pipeline at less than required)
 depth in New Haven, Vermont)

Second Affidavit of Jeffrey A. Nelson

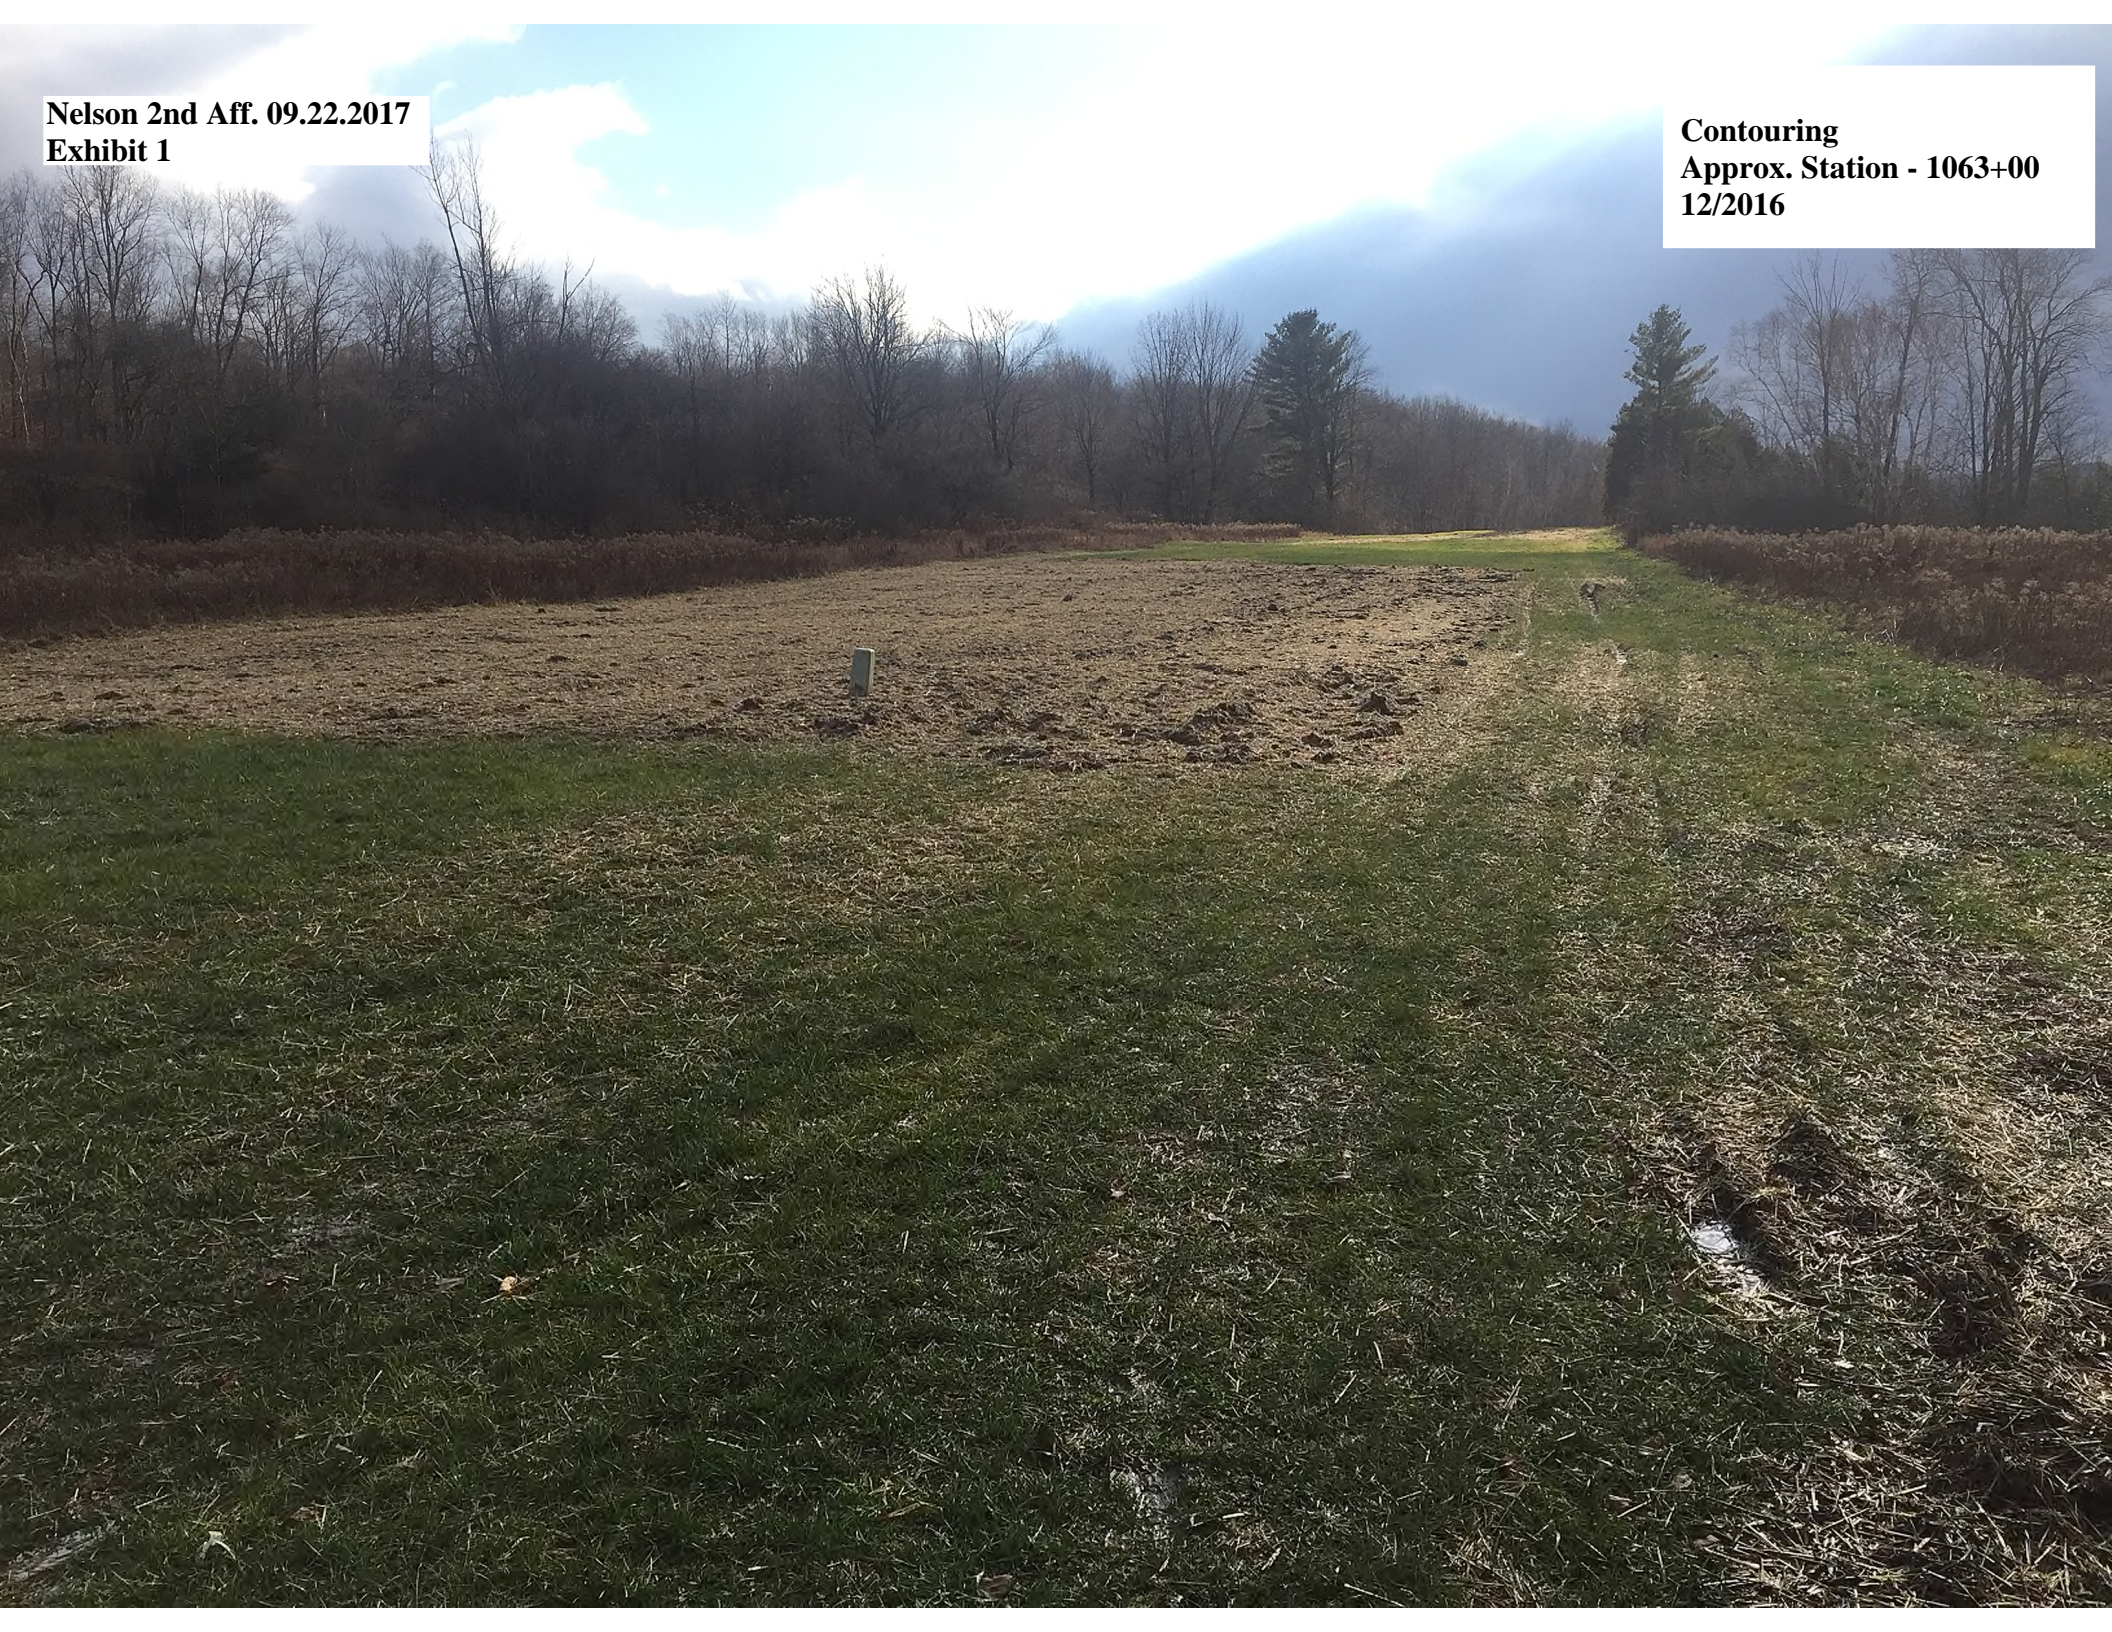
**Nelson 2nd Aff. 09.22.2017
Exhibit 1**

**Contouring
Approx. Station - 1063+00
12/2016**

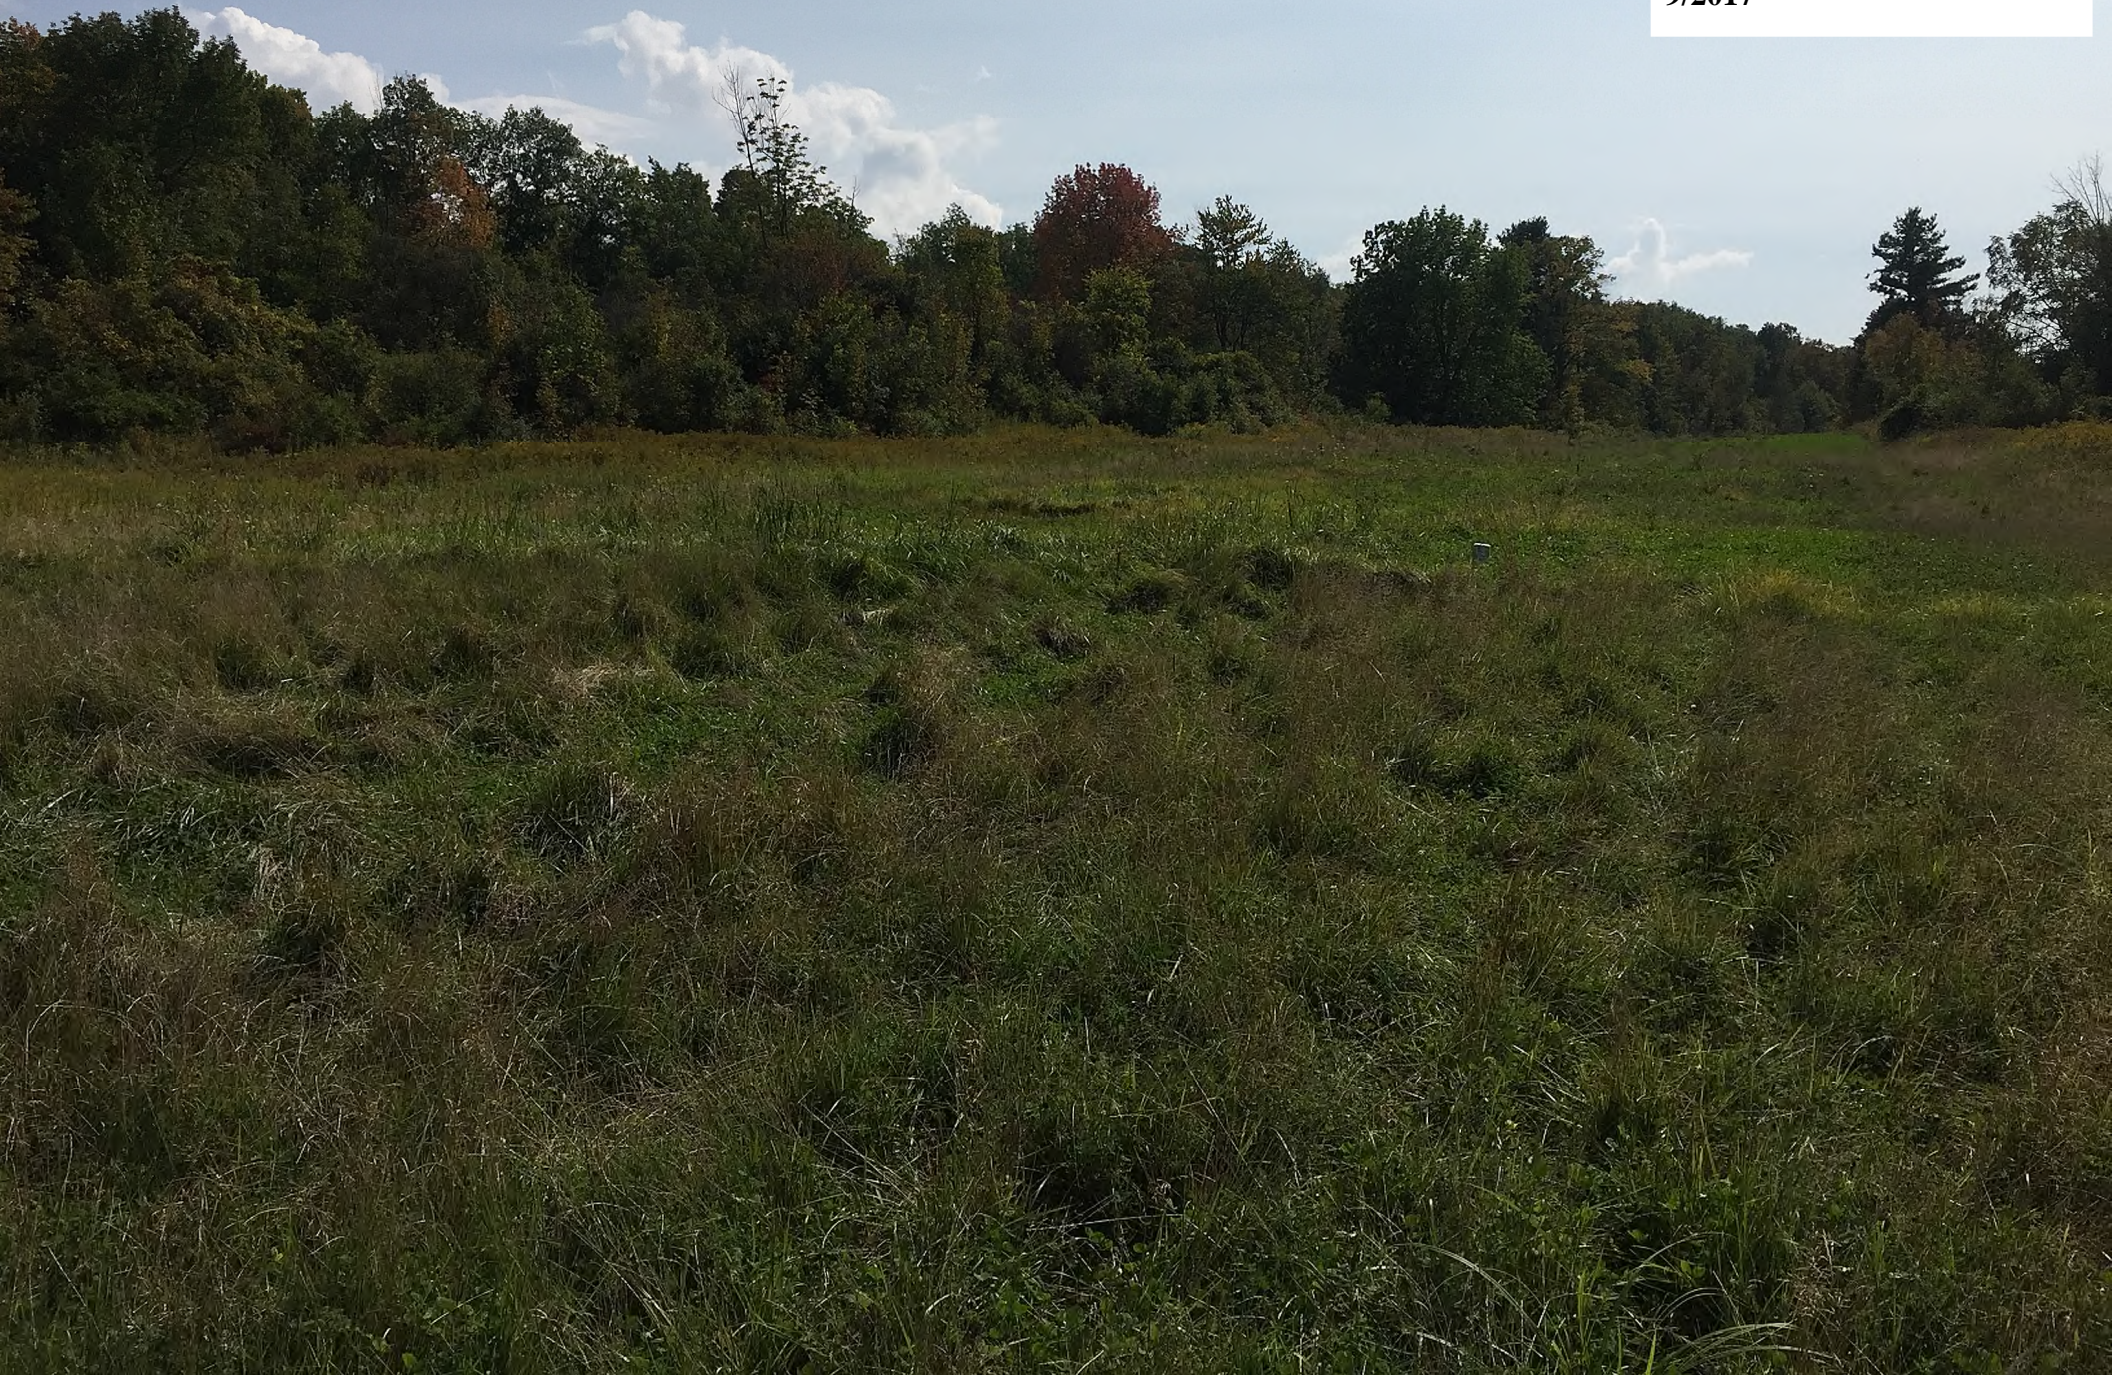
Nelson 2nd Aff. 09.22.2017
Exhibit 2

Revegetation
Approx. Station - 1063+00
9/2017

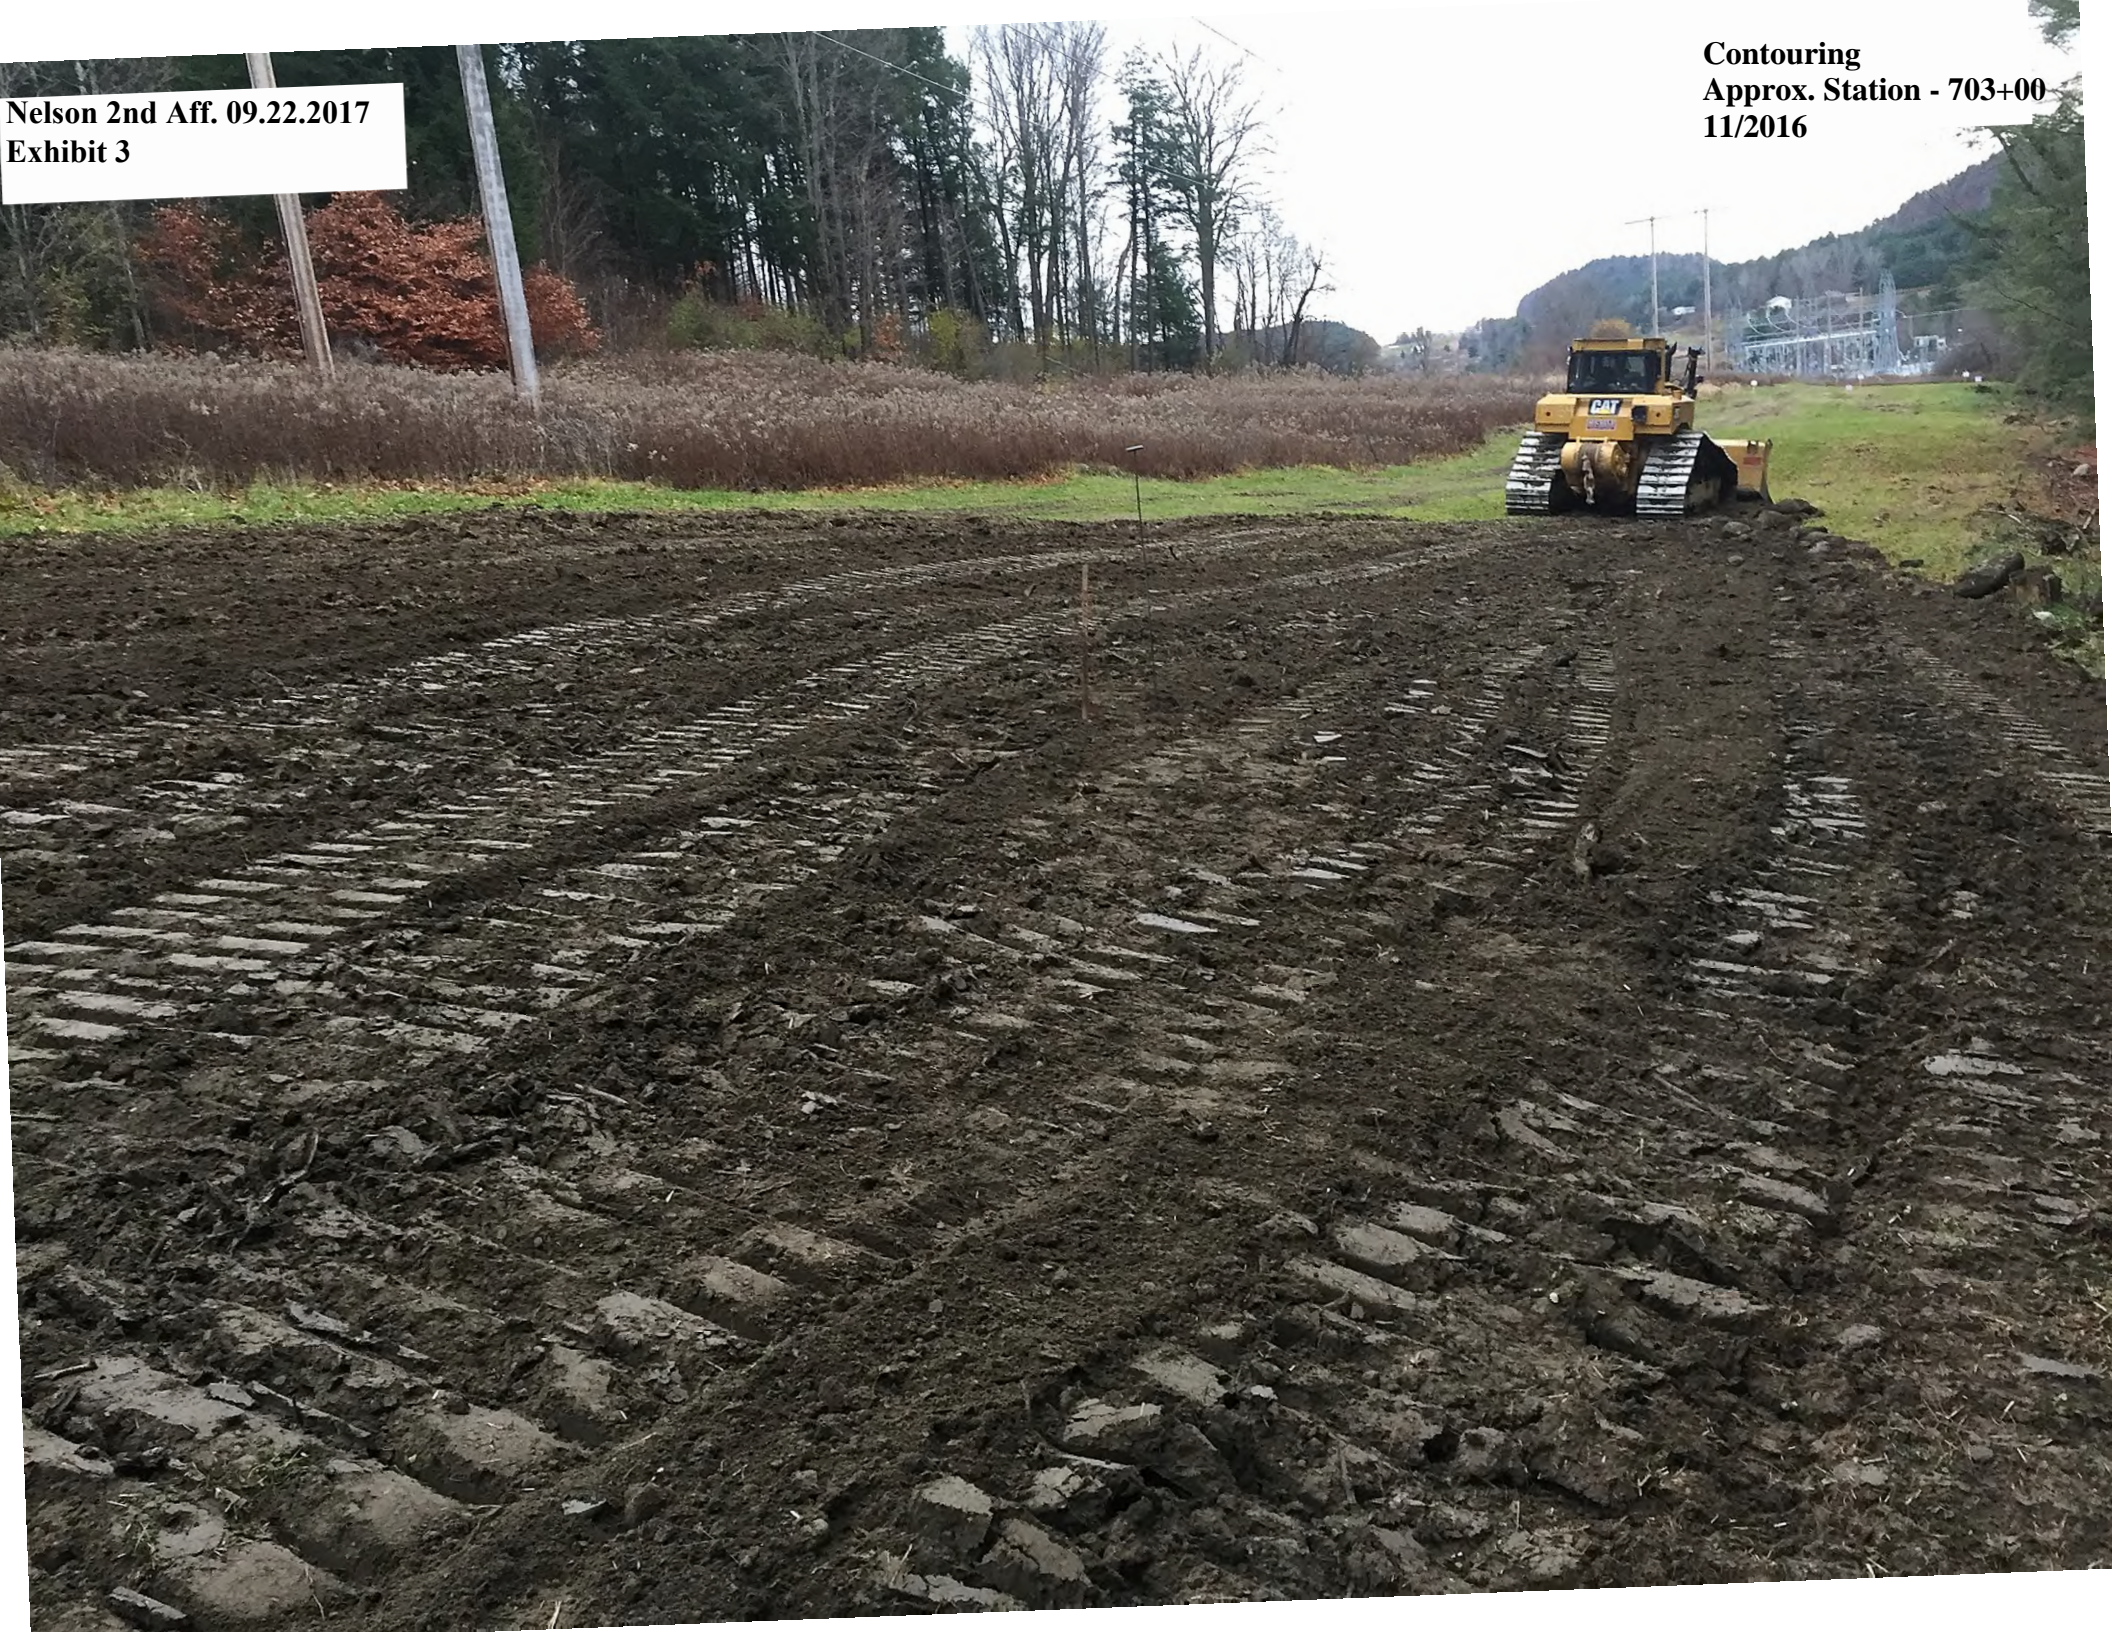
Nelson 2nd Aff. 09.22.2017
Exhibit 3

Contouring
Approx. Station - 703+00
11/2016

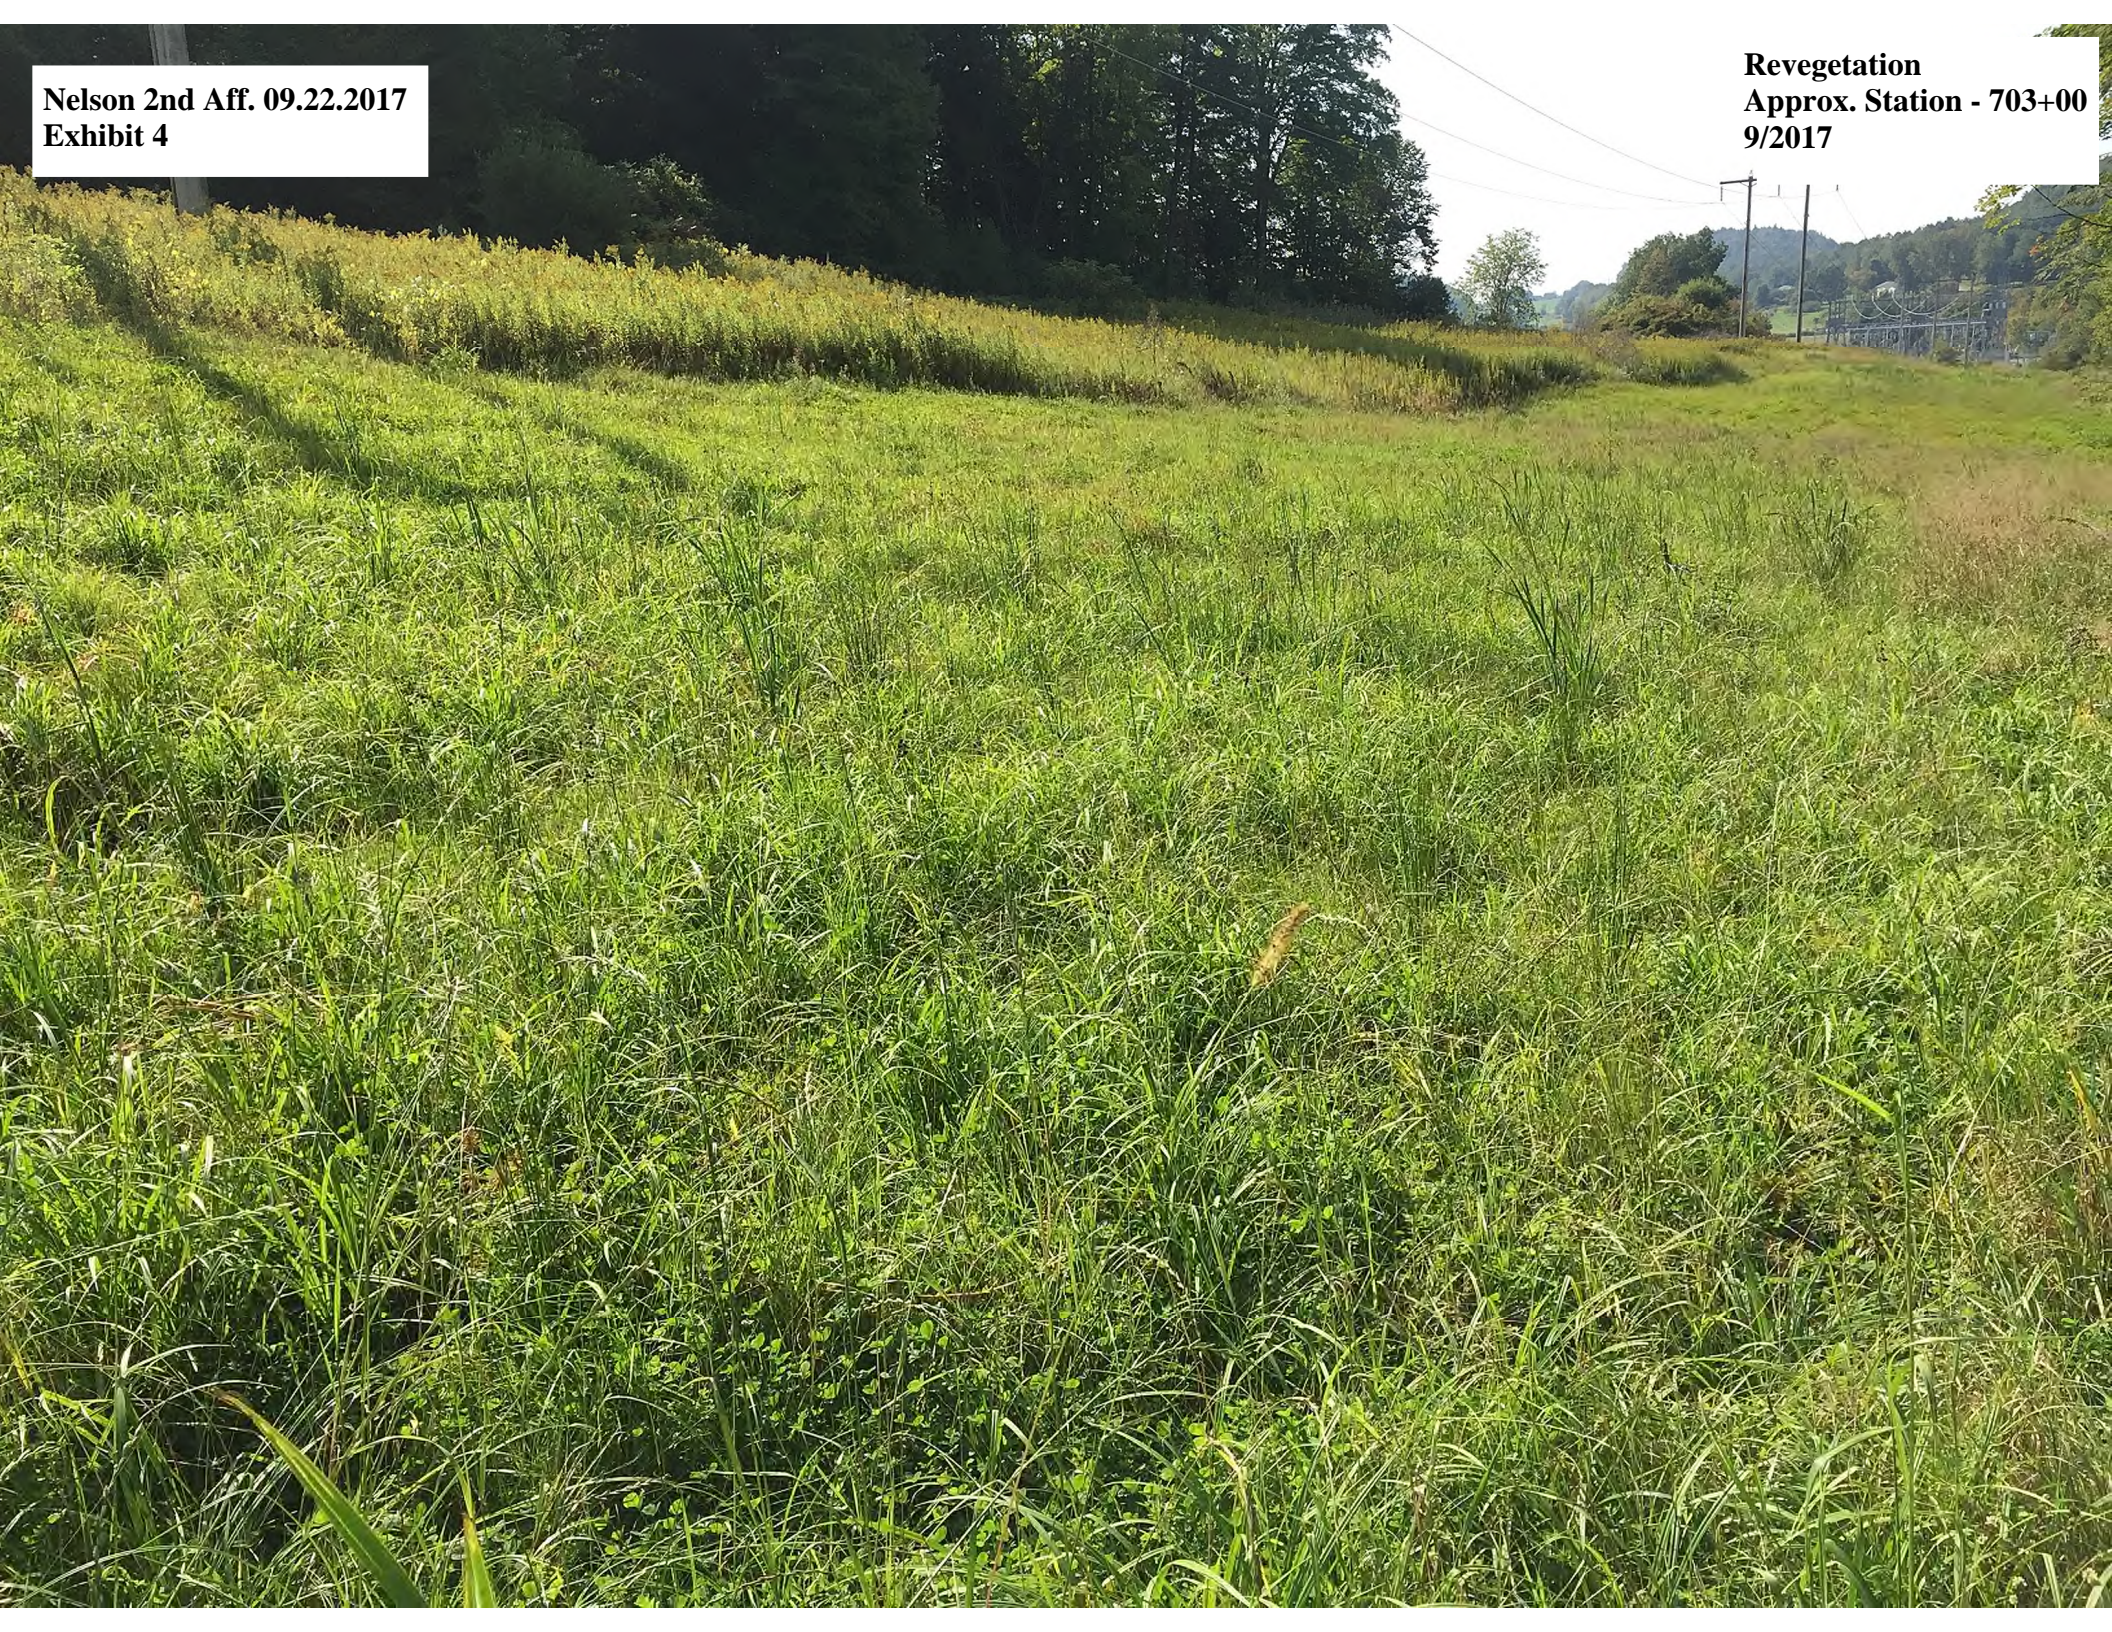
**Nelson 2nd Aff. 09.22.2017
Exhibit 4**

**Revegetation
Approx. Station - 703+00
9/2017**

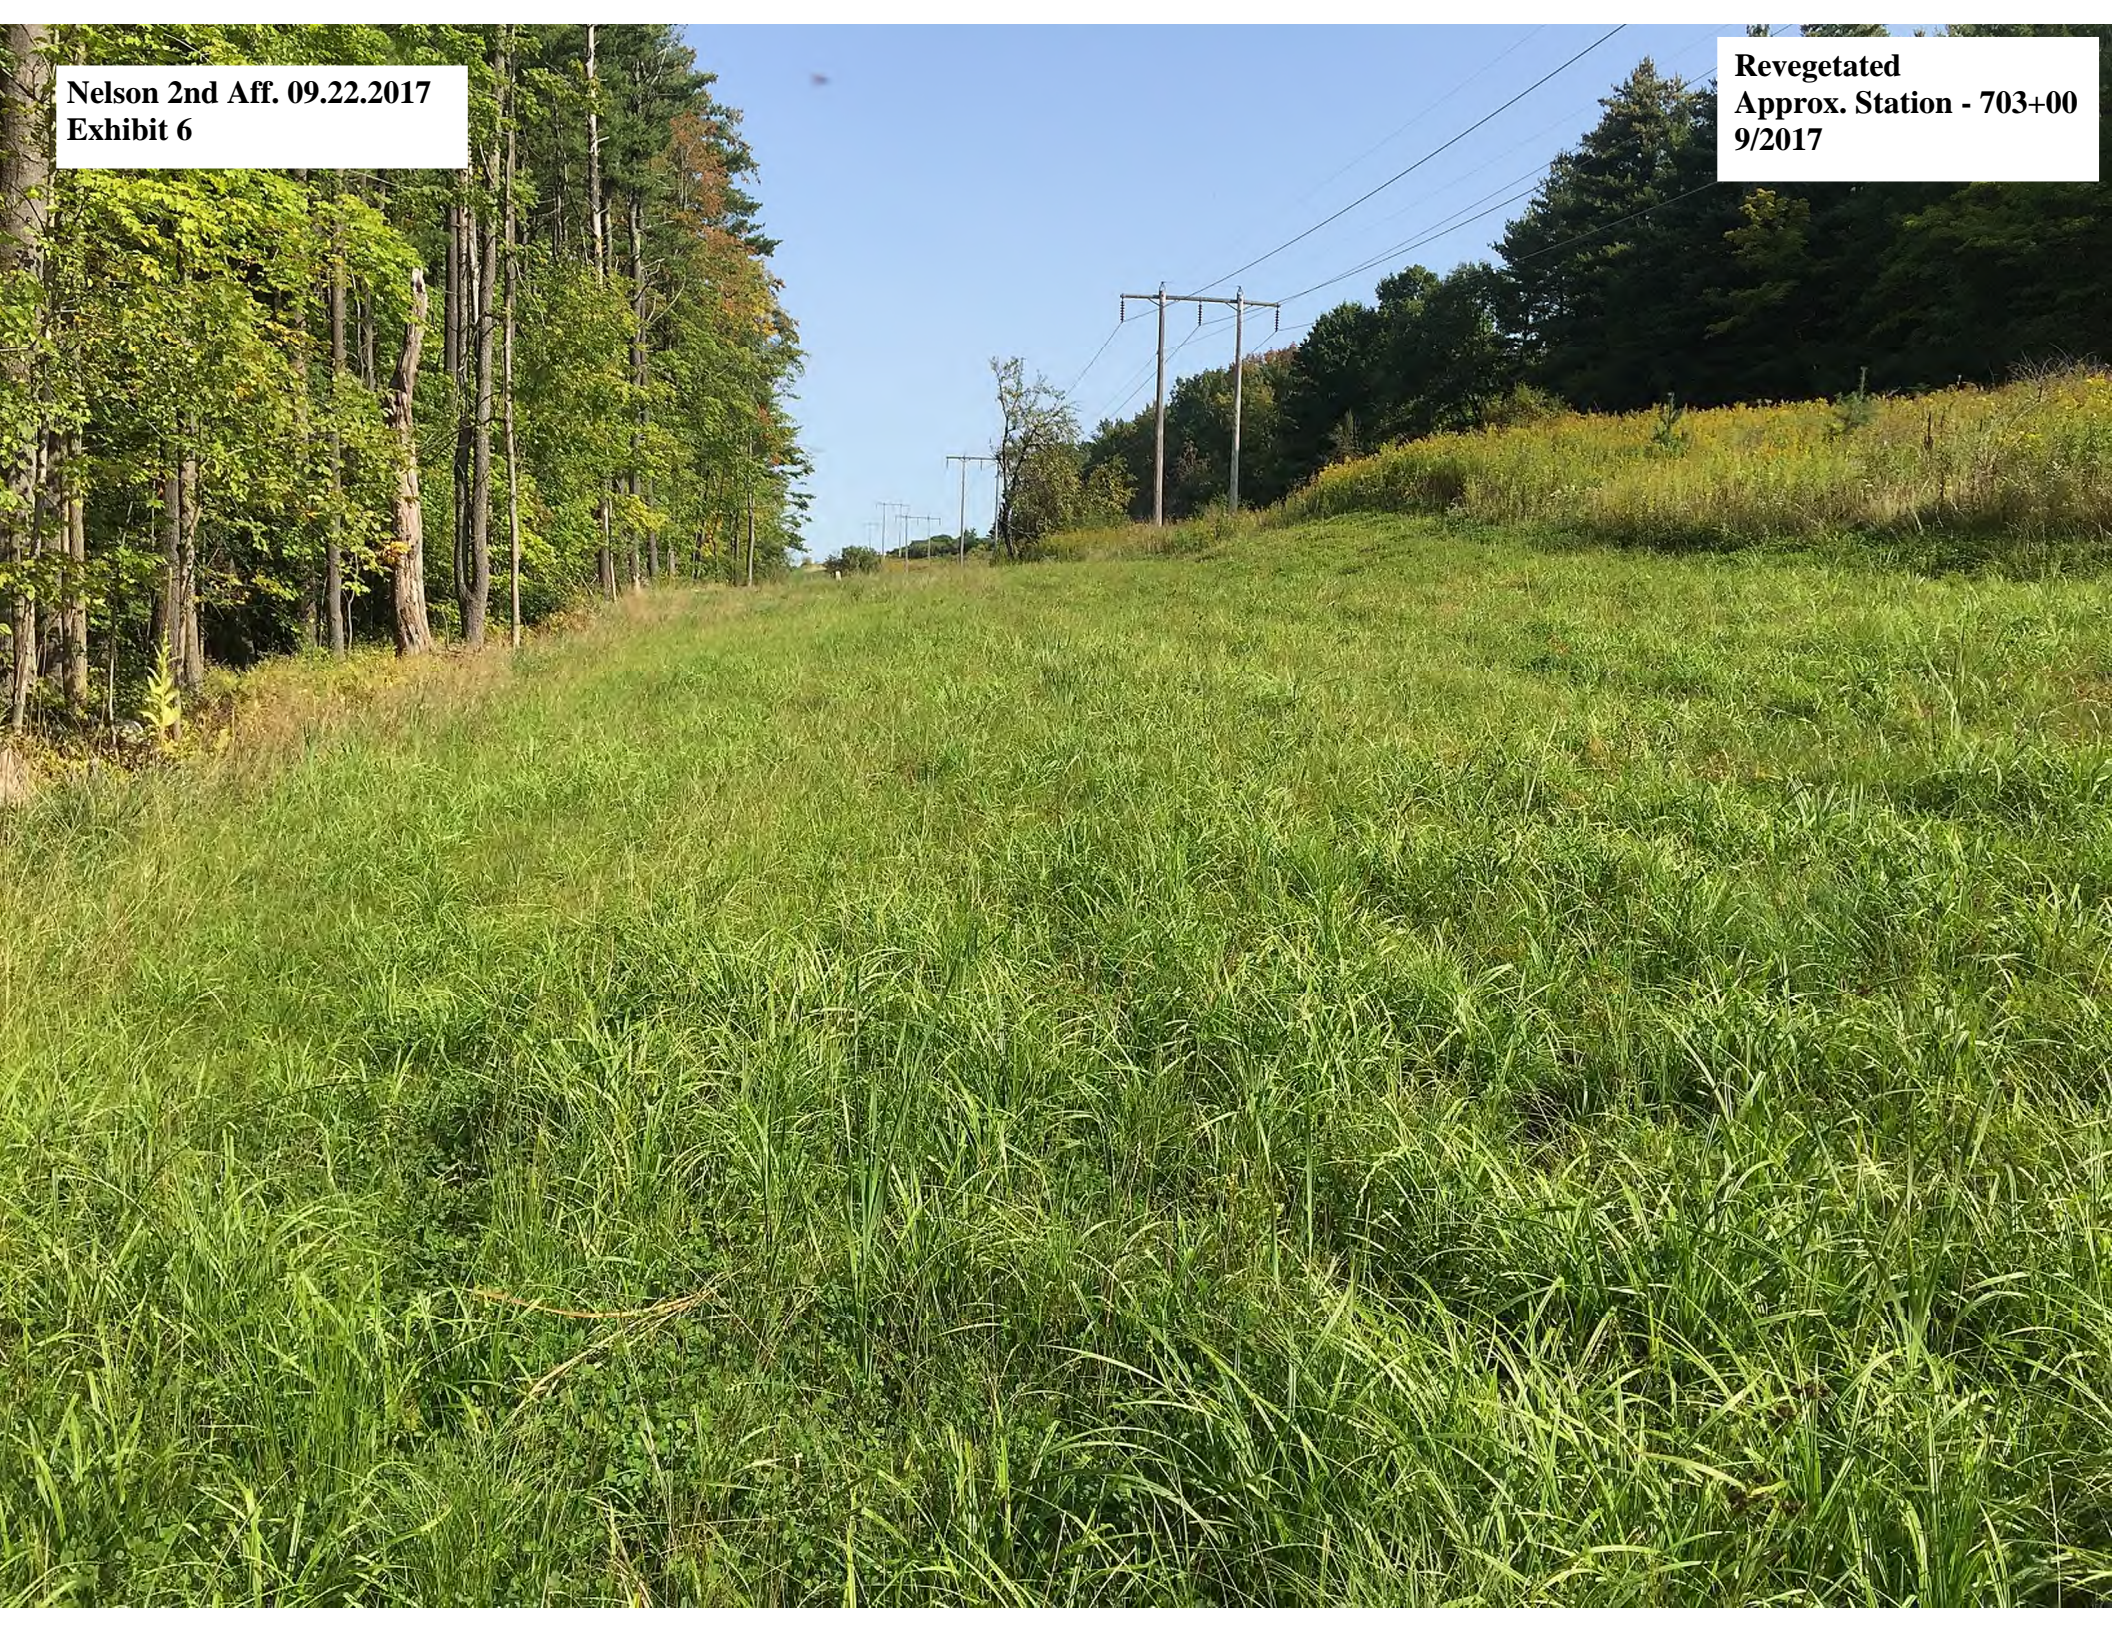
**Nelson 2nd Aff. 09.22.2017
Exhibit 6**

**Revegetated
Approx. Station - 703+00
9/2017**
