Exhibit VGS-AG-097

**STATE OF VERMONT
PUBLIC UTILITY COMMISSION**

Investigation pursuant to 30 V.S.A. §§ 30 and)
 209 regarding the alleged failure of Vermont)
 Gas Systems, Inc. to comply with the) Case No. 17-3550-INV
 certificate of public good in Docket 7970 by)
 burying the pipeline at less than required)
 depth in New Haven, Vermont)

Second Affidavit of Jeffrey A. Nelson

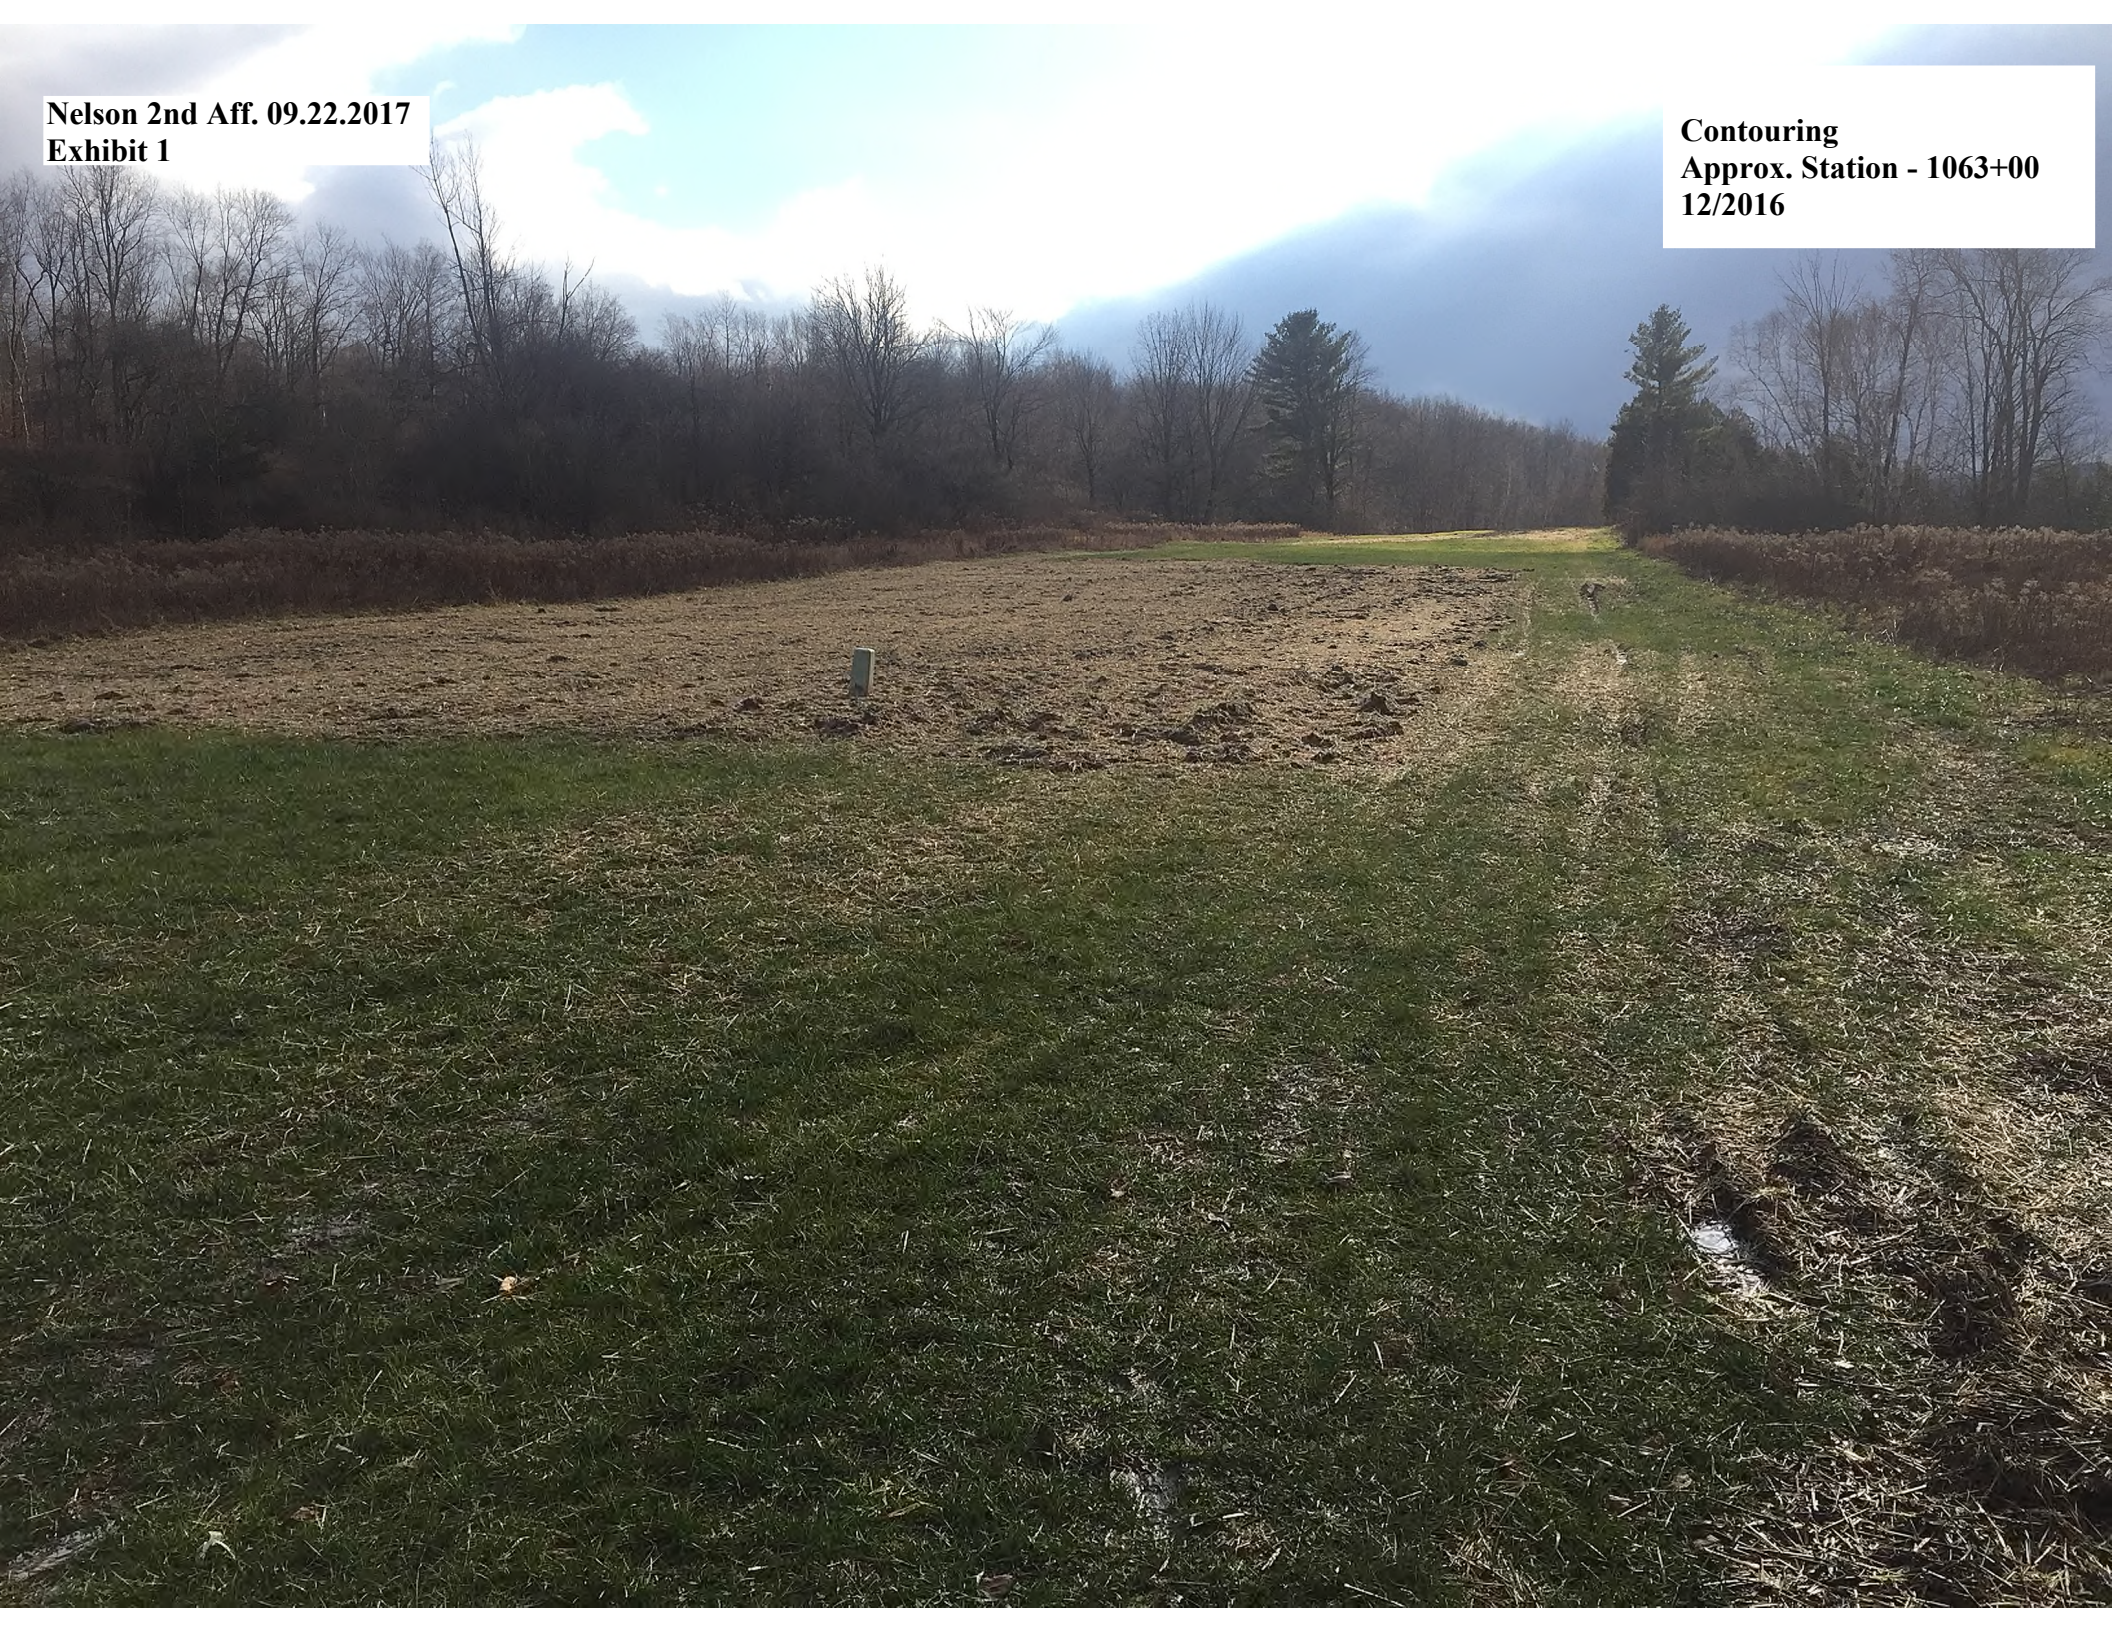
**Nelson 2nd Aff. 09.22.2017
Exhibit 1**

**Contouring
Approx. Station - 1063+00
12/2016**

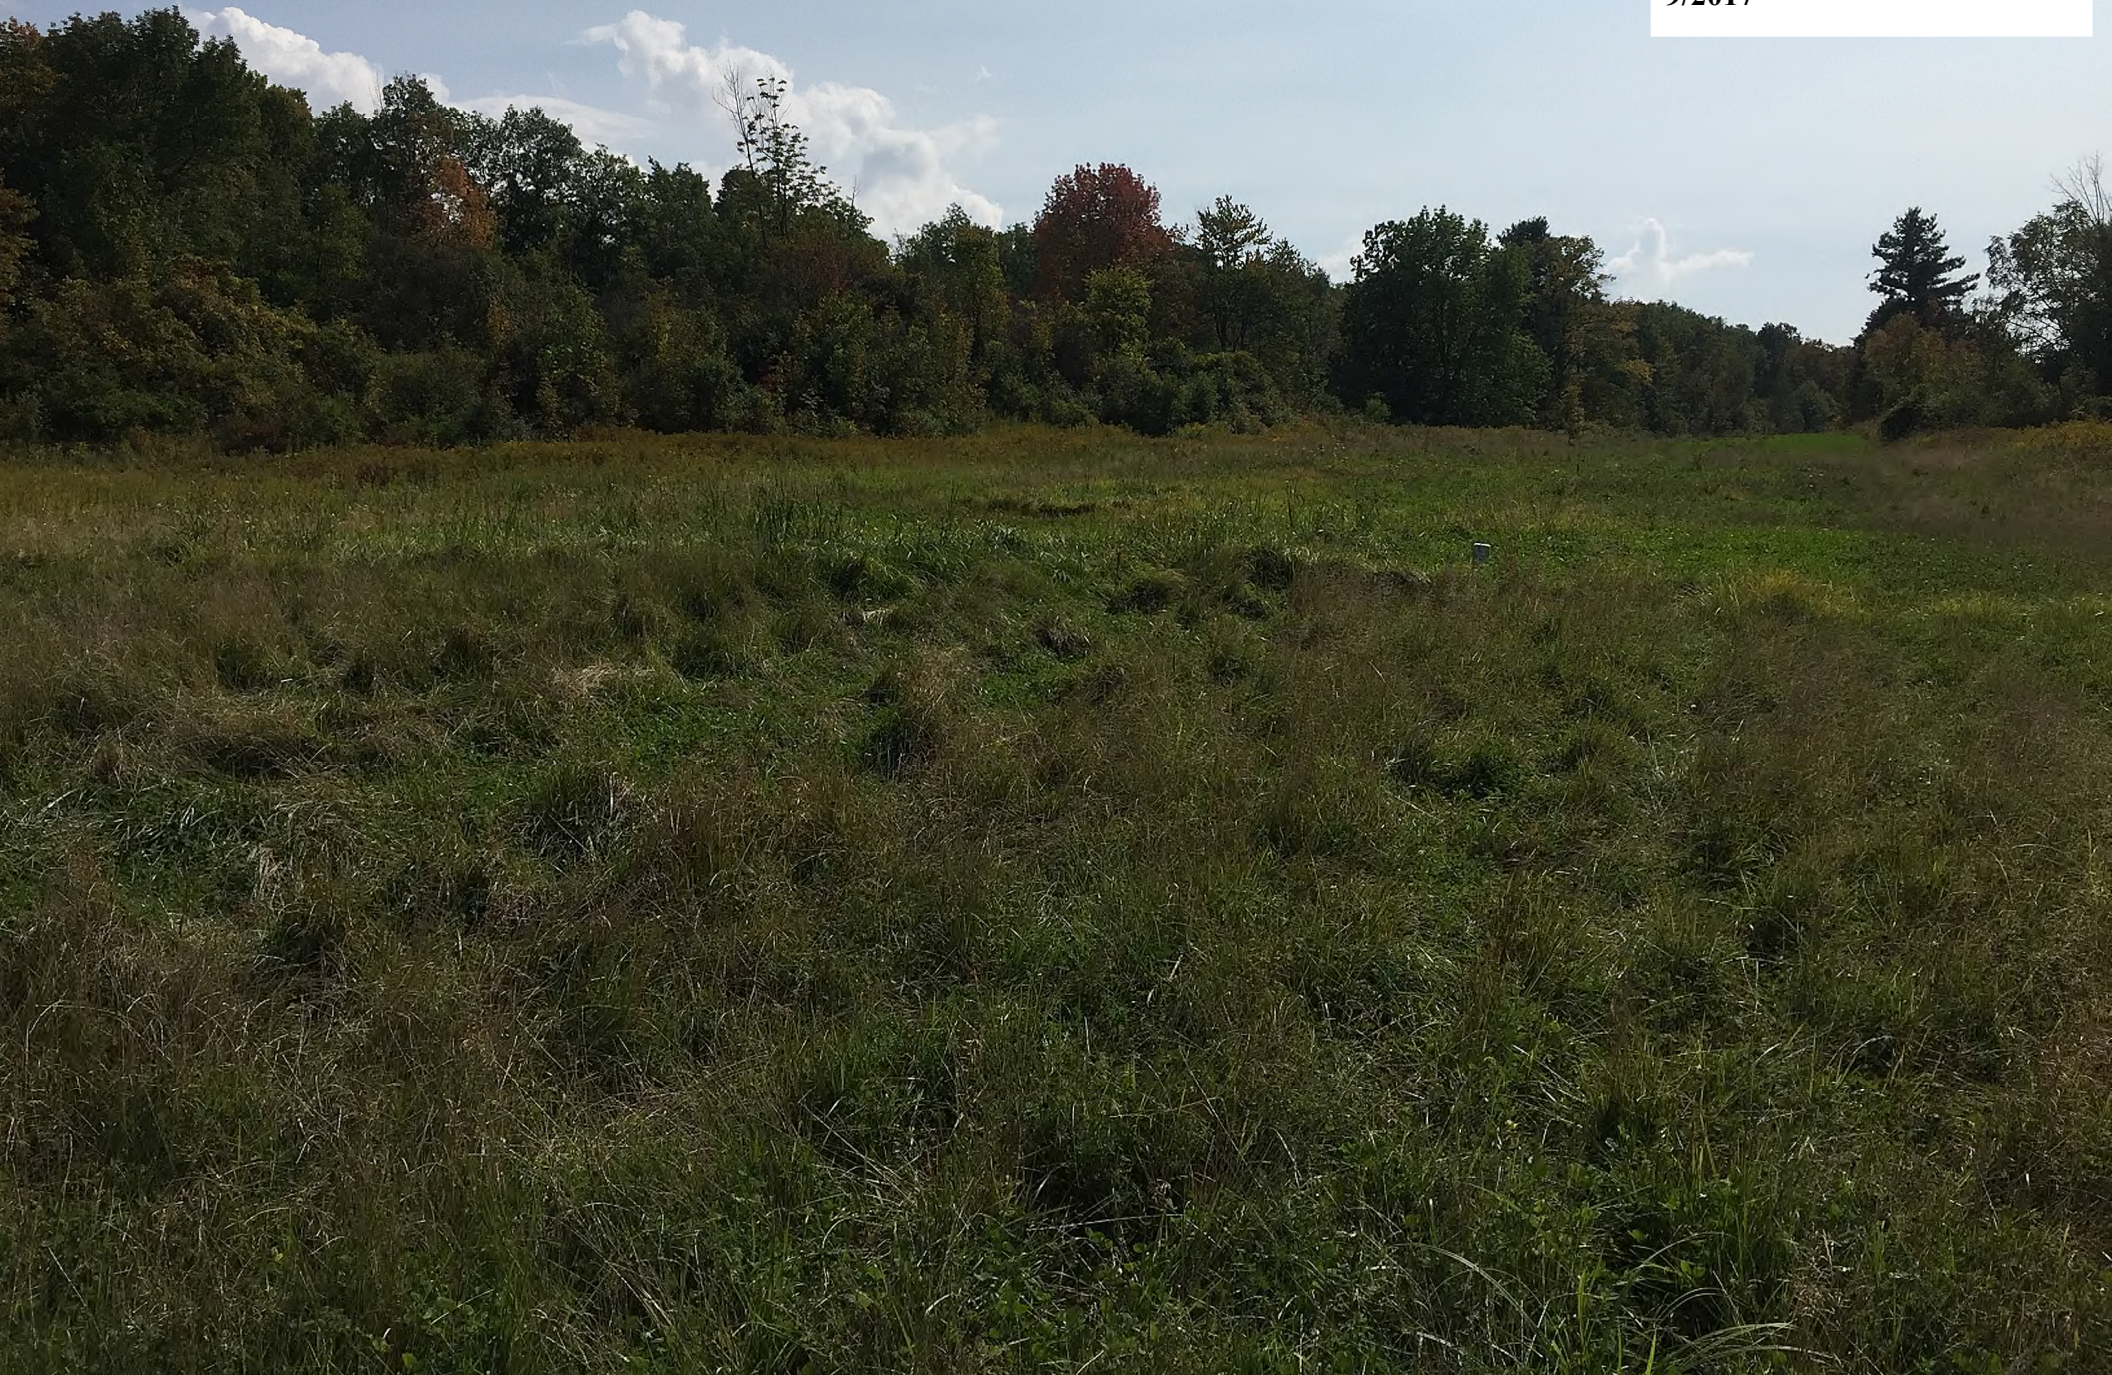
Nelson 2nd Aff. 09.22.2017
Exhibit 2

Revegetation
Approx. Station - 1063+00
9/2017

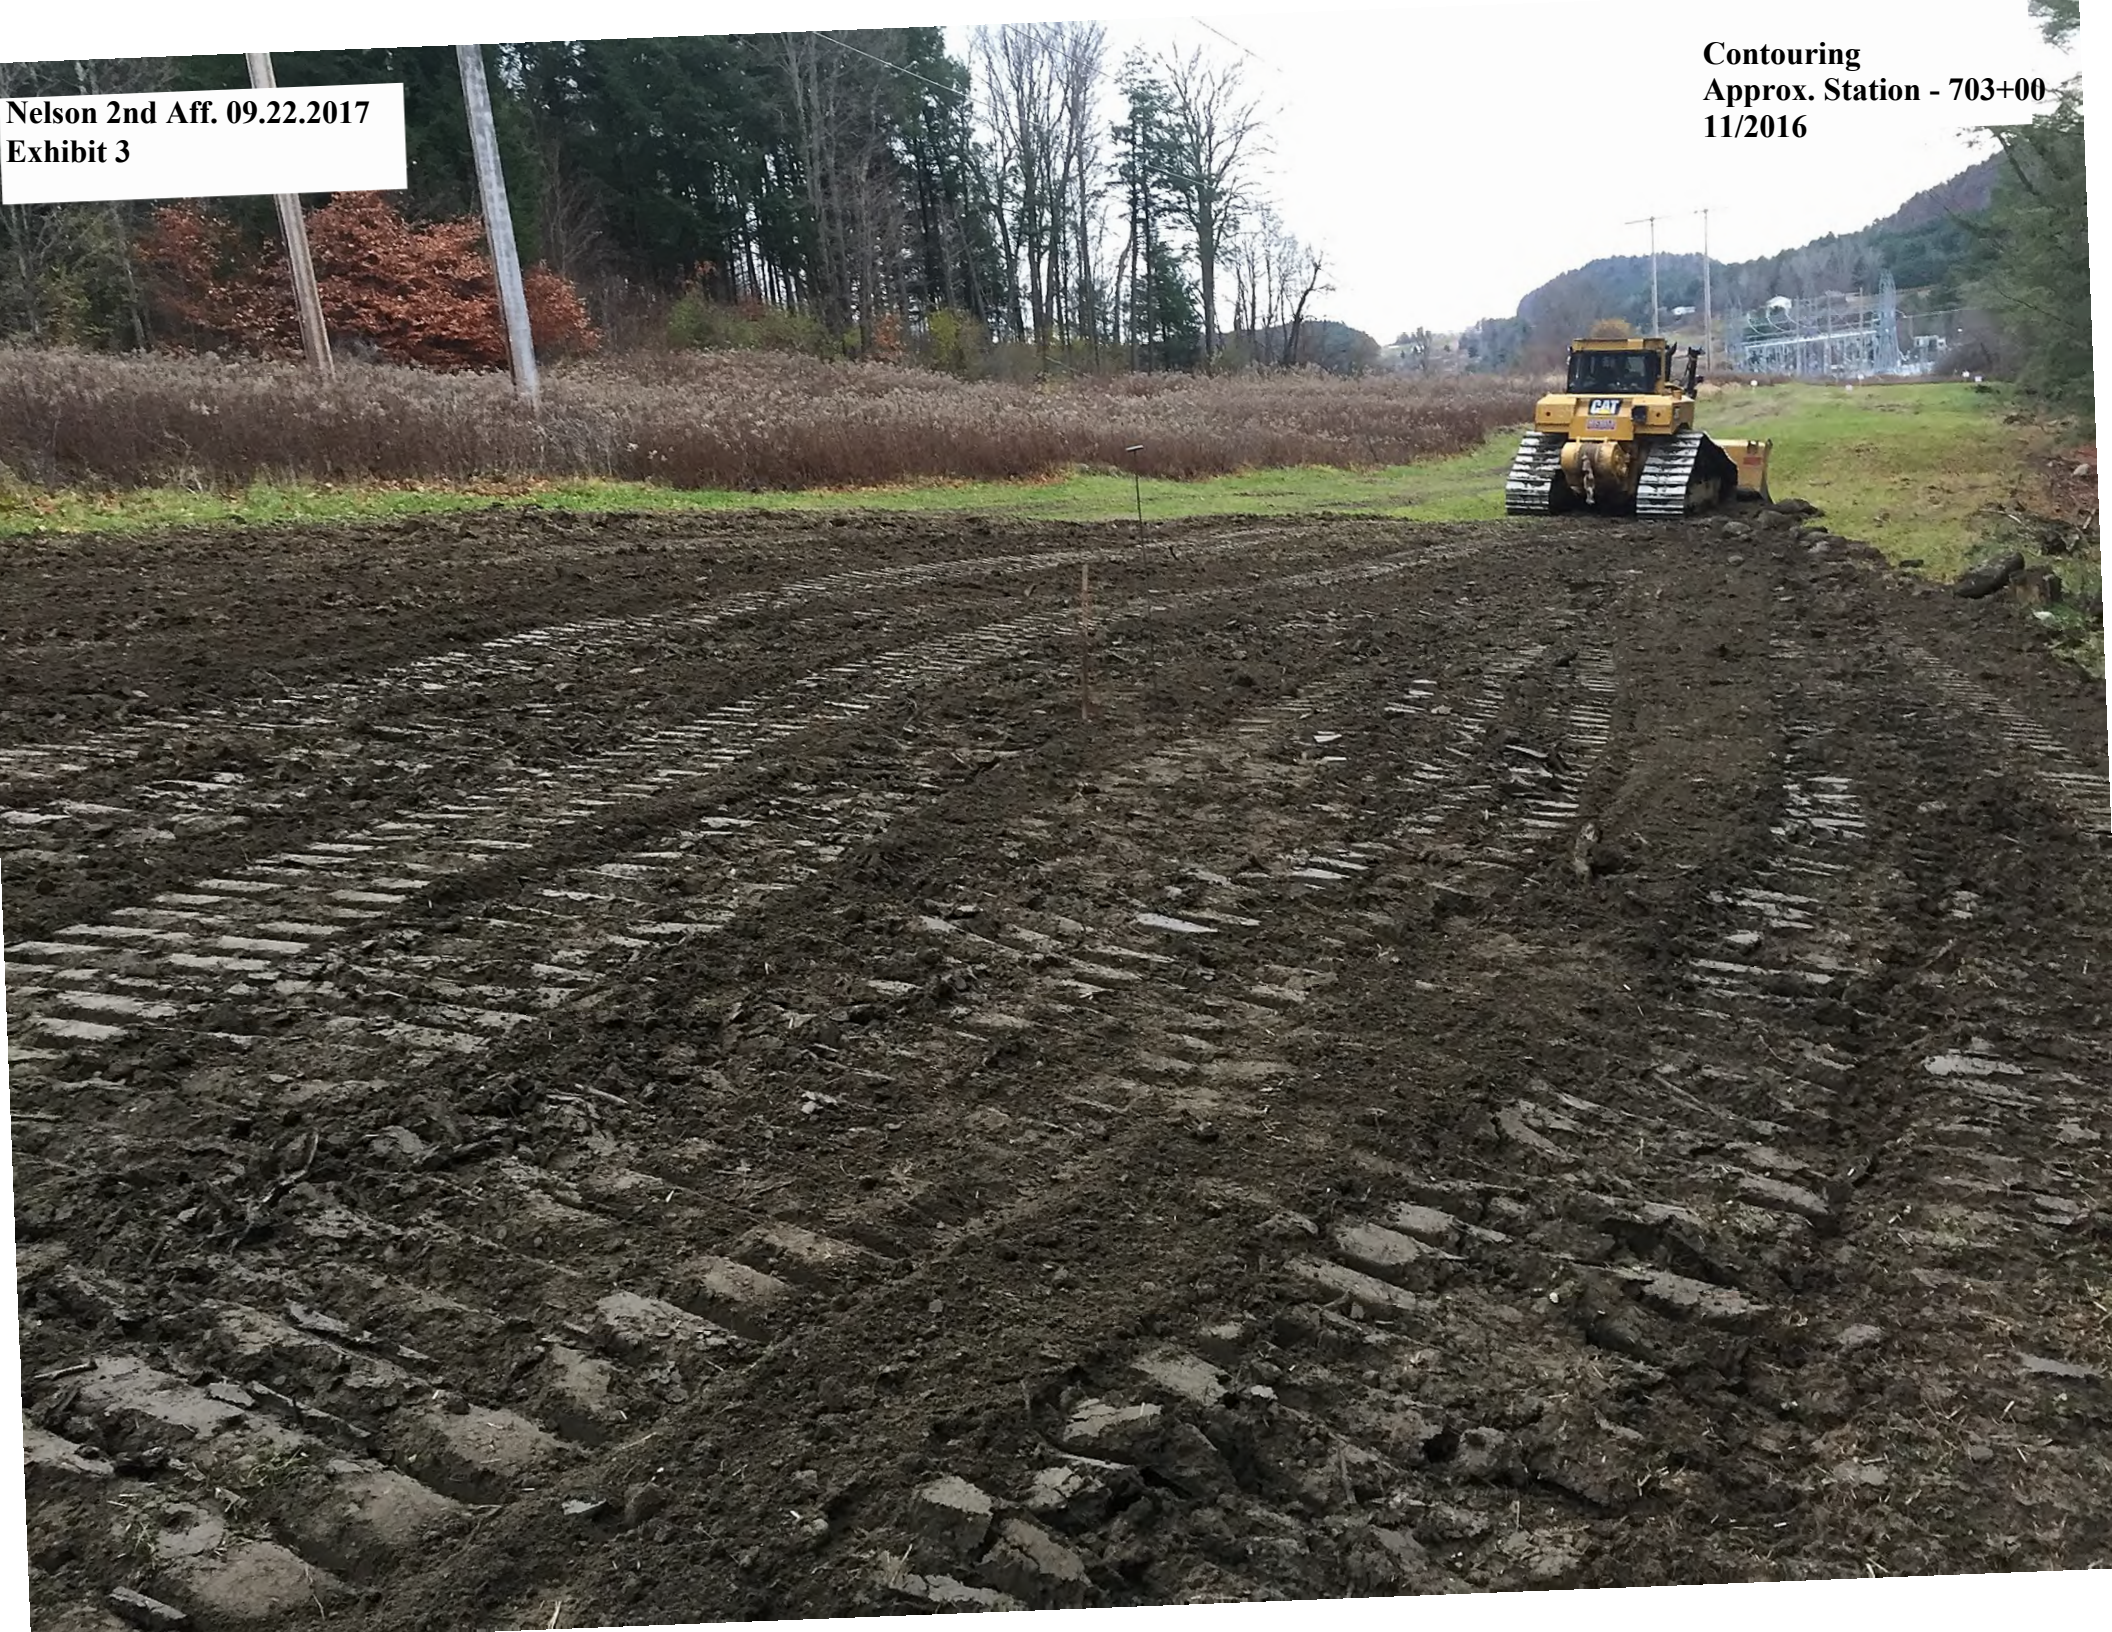
Nelson 2nd Aff. 09.22.2017
Exhibit 3

Contouring
Approx. Station - 703+00
11/2016

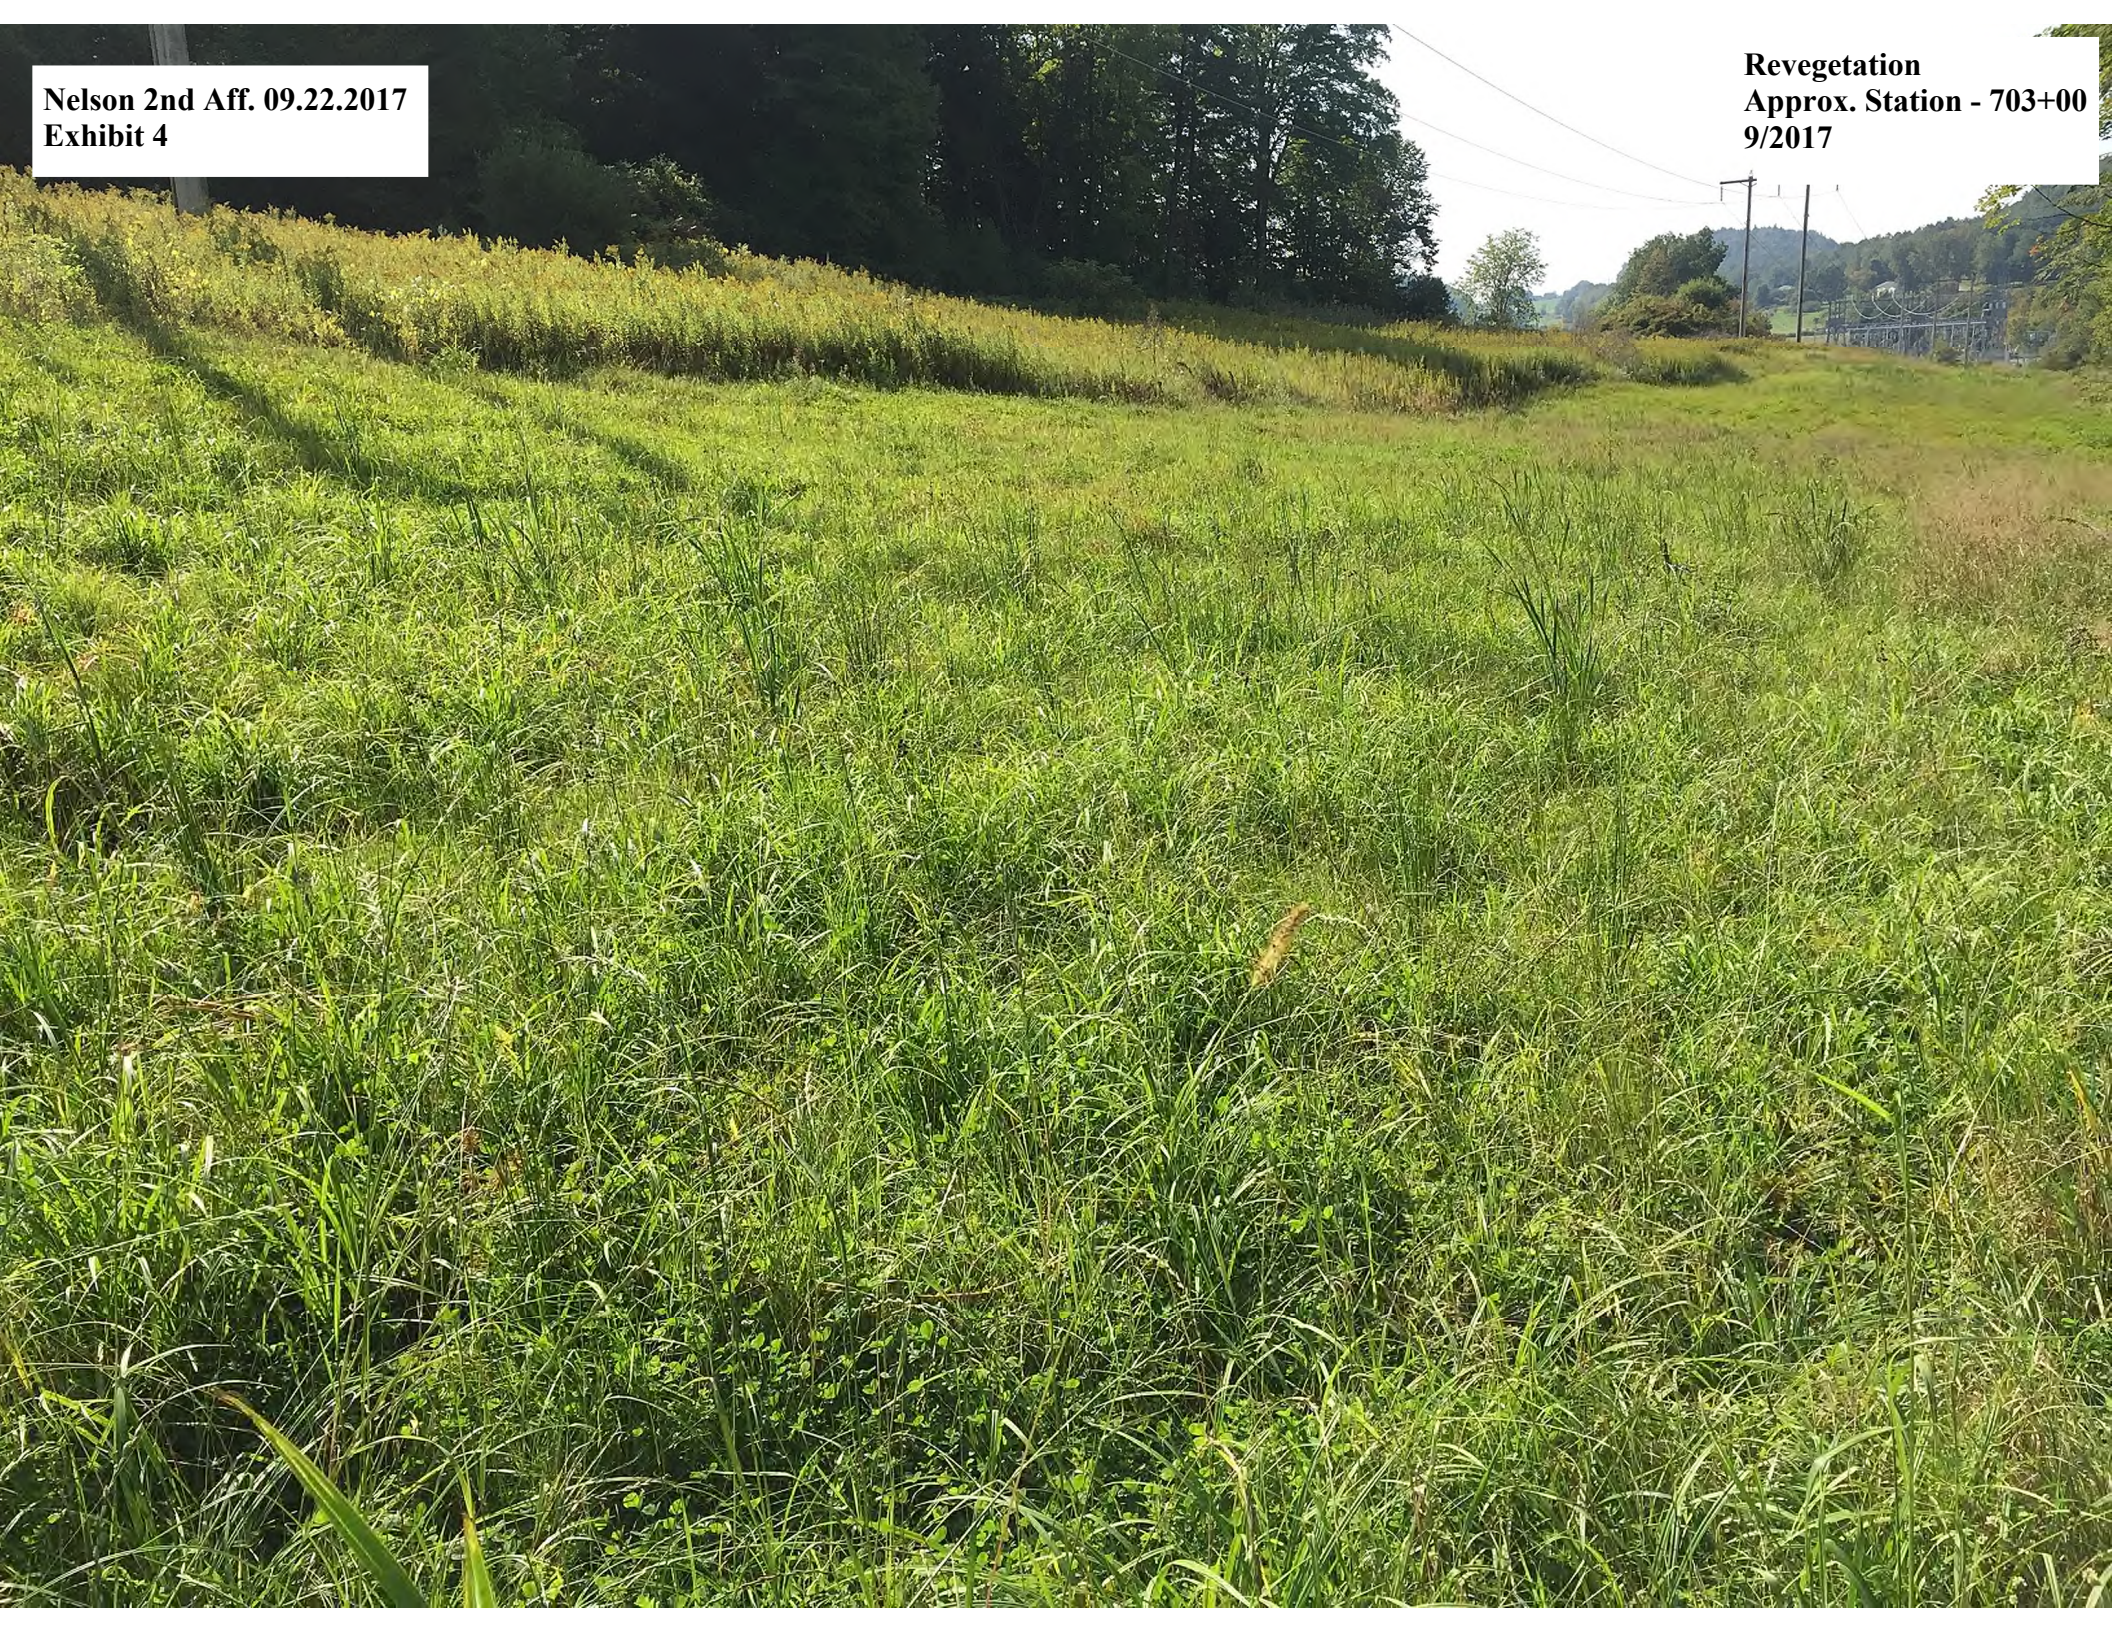
**Nelson 2nd Aff. 09.22.2017
Exhibit 4**

**Revegetation
Approx. Station - 703+00
9/2017**

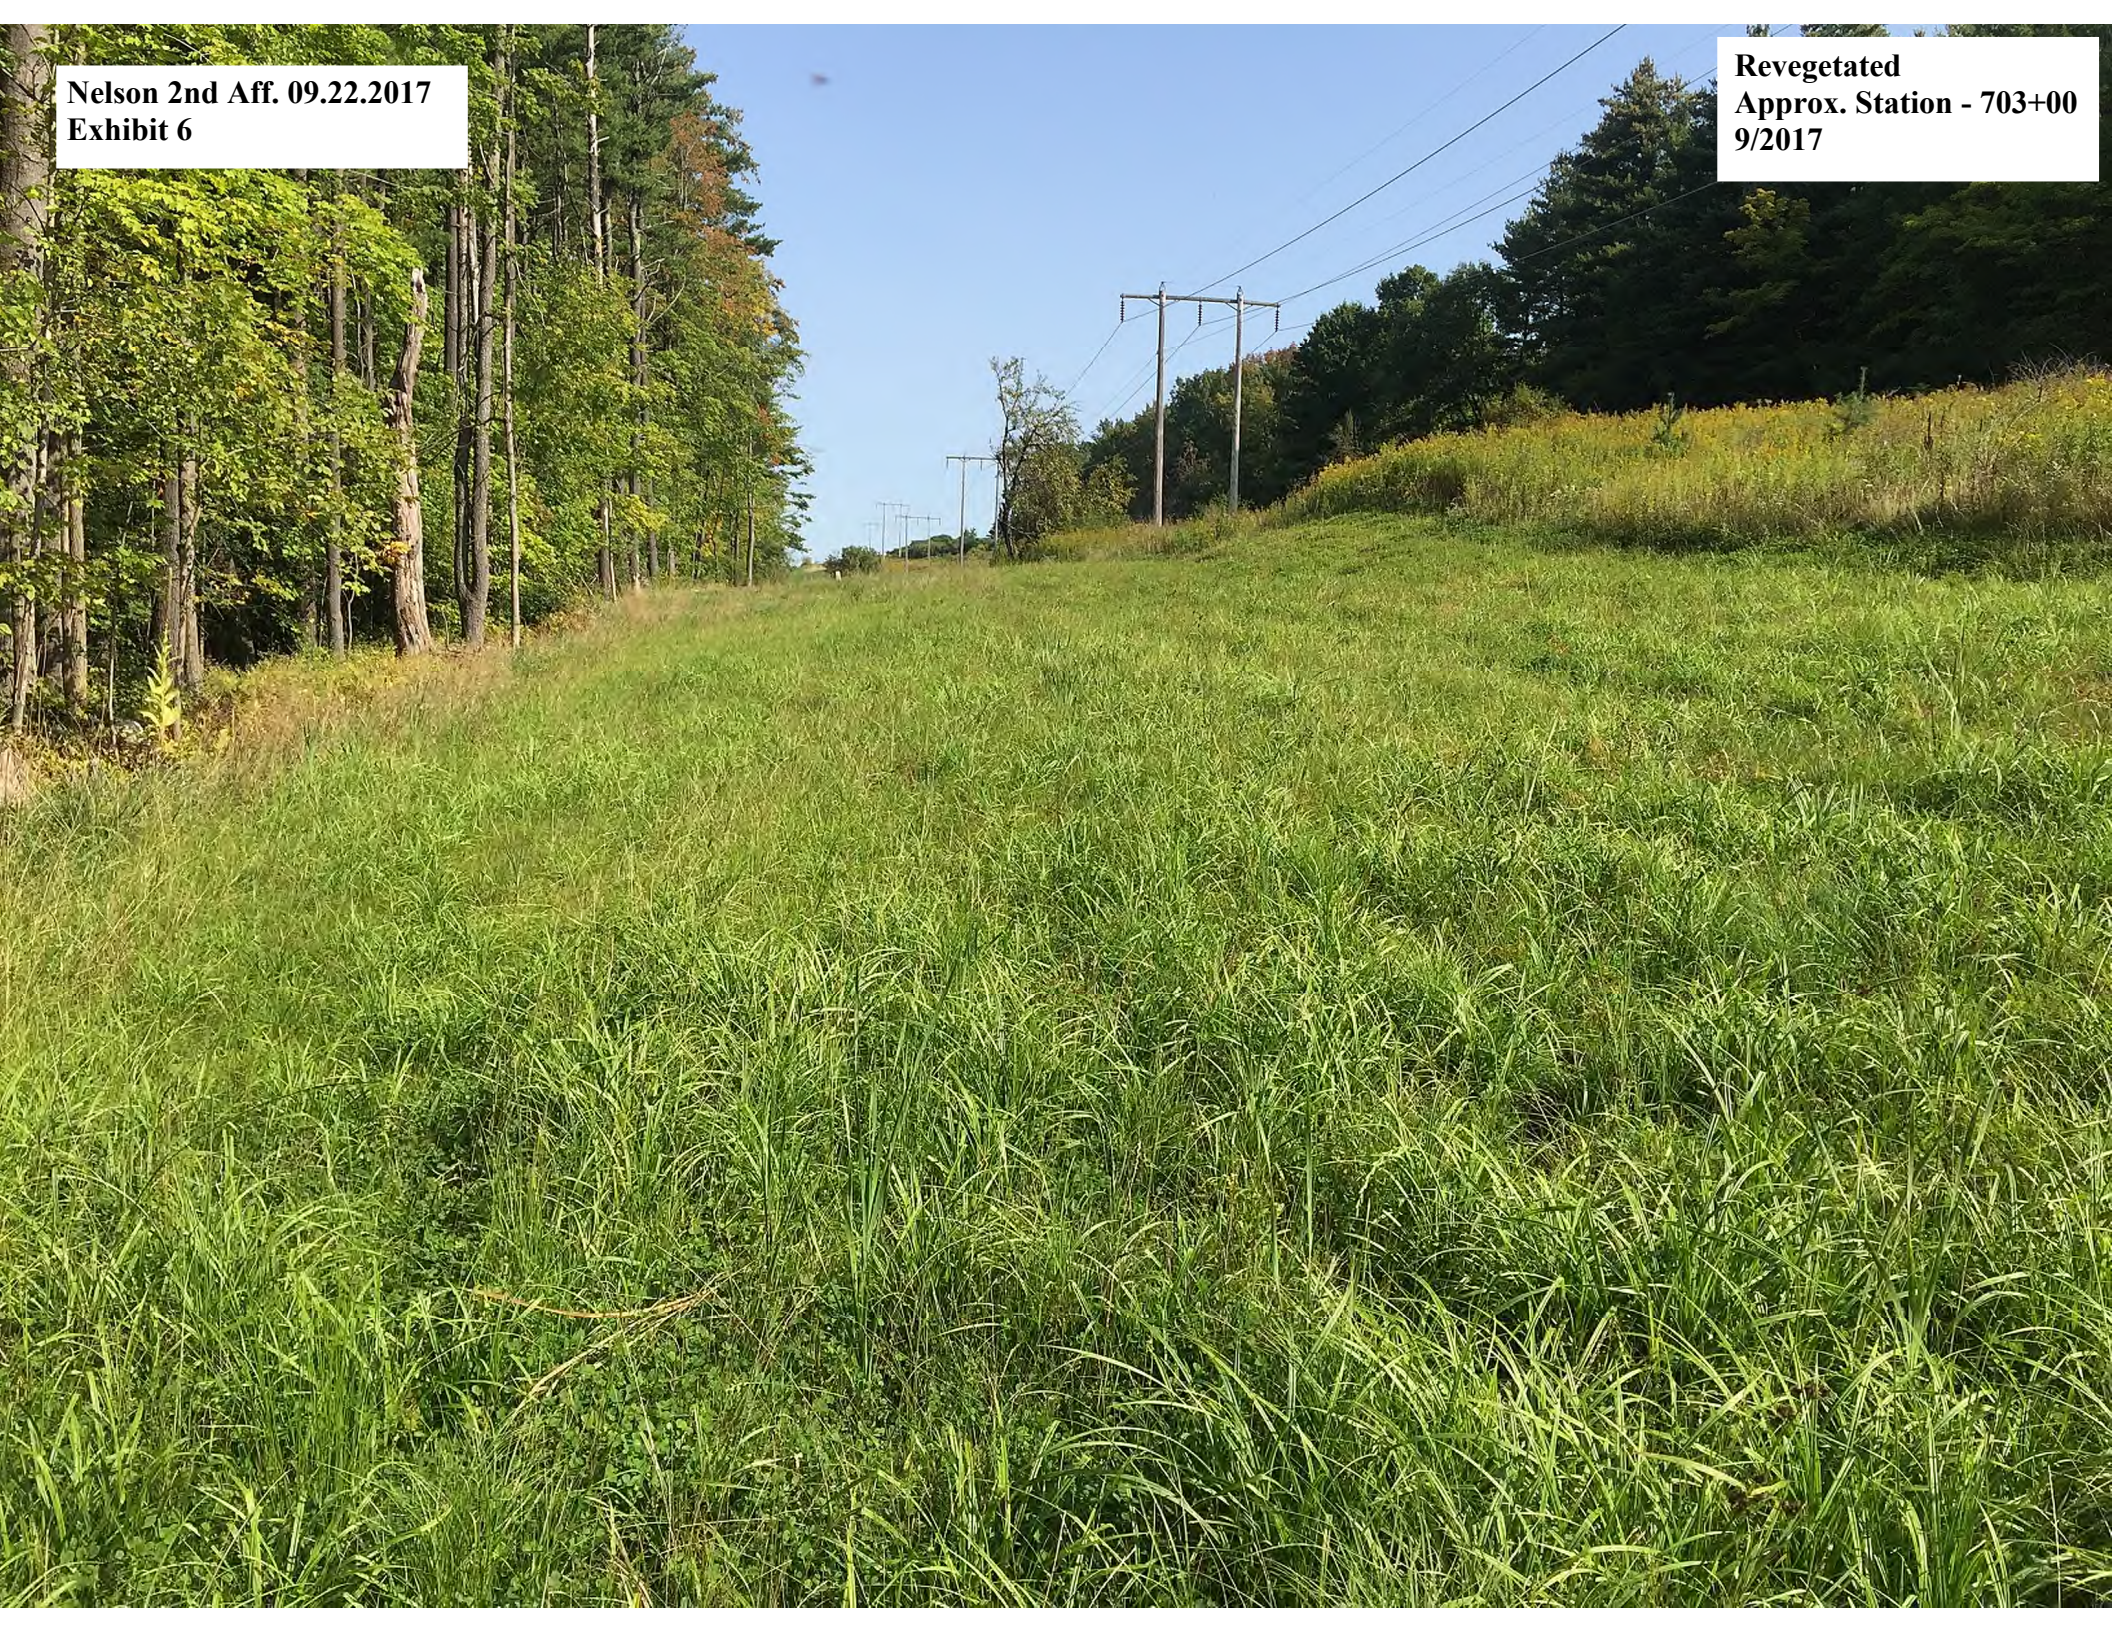
**Nelson 2nd Aff. 09.22.2017
Exhibit 6**

**Revegetated
Approx. Station - 703+00
9/2017**
