**STATE OF VERMONT
PUBLIC UTILITY COMMISSION**

Notice of Probable Violations by Vermont Gas)
Systems, Inc. for certain aspects of the) Case No. 18-0395-PET
construction of the Addison Natural Gas)
Project)

RESPONSE OF VERMONT GAS SYSTEMS, INC. TO DPS FEBRUARY 16, 2018 NOPV

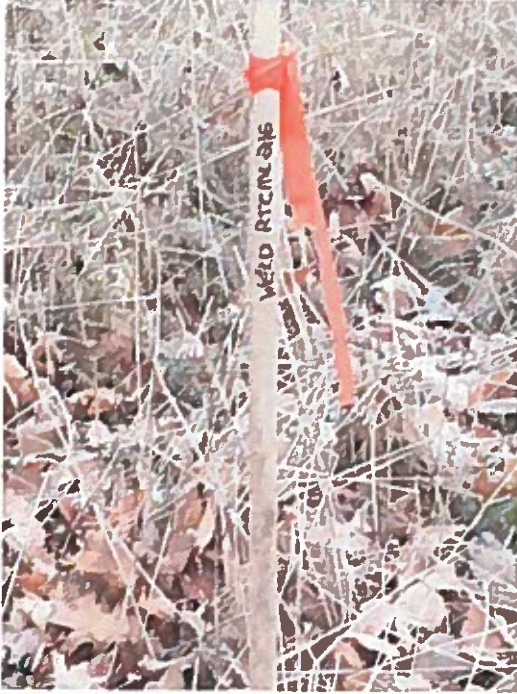
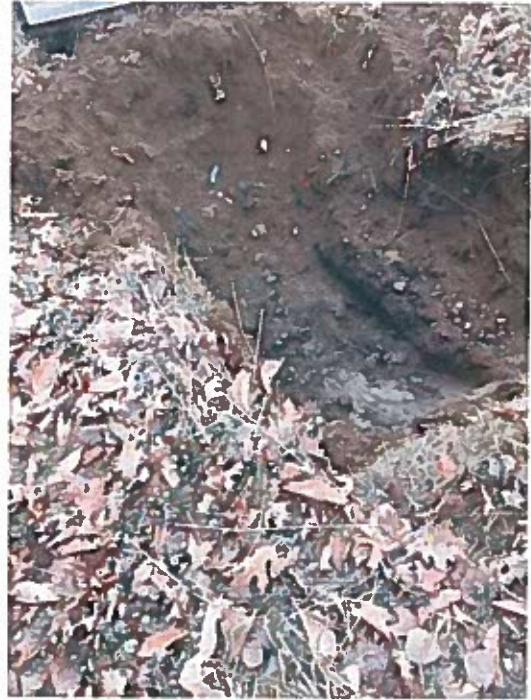
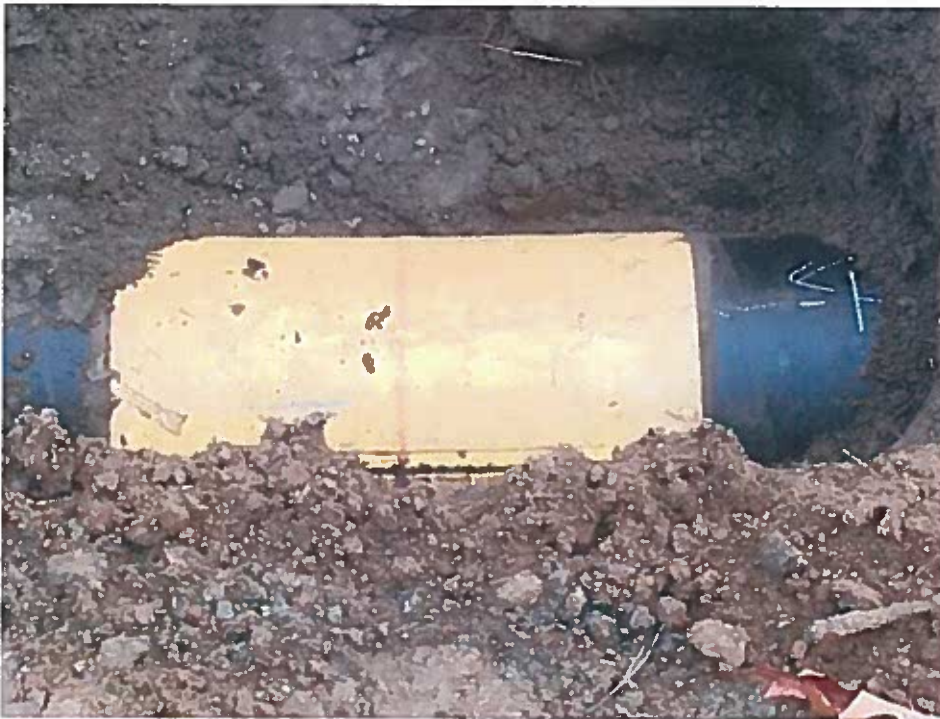
12/01/15 Dig #1

During the period of 12/1/15 to 12/8/15 a total of 8 test pits were dug in the area of concern. No trash or garbage was found in close proximity to the installed pipe. A small amount of small items was found in the very top layer of the cover, well above the pipe. No mirify fabric was found at any of the dig sites. (see attached pictures).
