Vermont Gas Systems Addison Natural Gas Project  
Road Crossing Observation Report

March 30<sup>th</sup>, 2021

ADDENDUM 1: FINAL OBSERVATIONS

June 24<sup>th</sup>, 2021

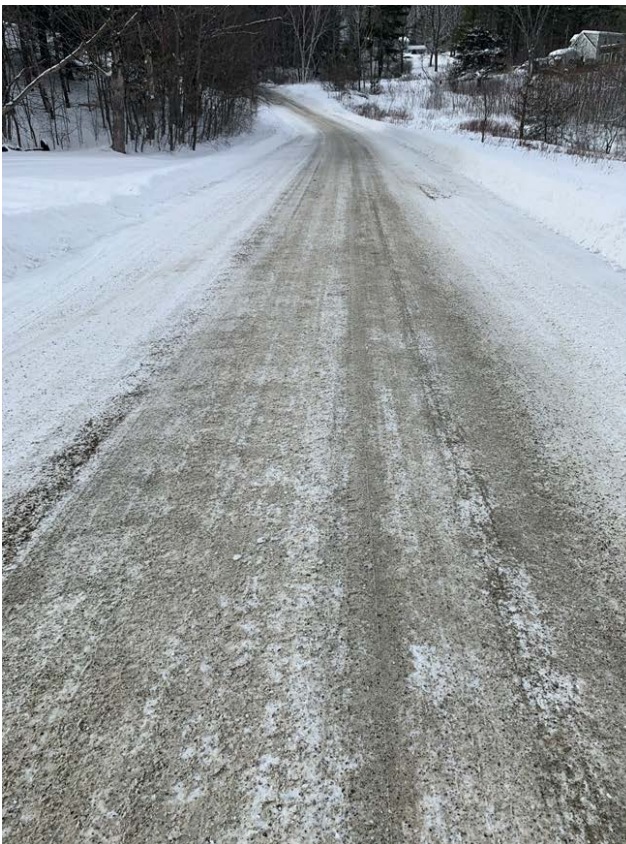
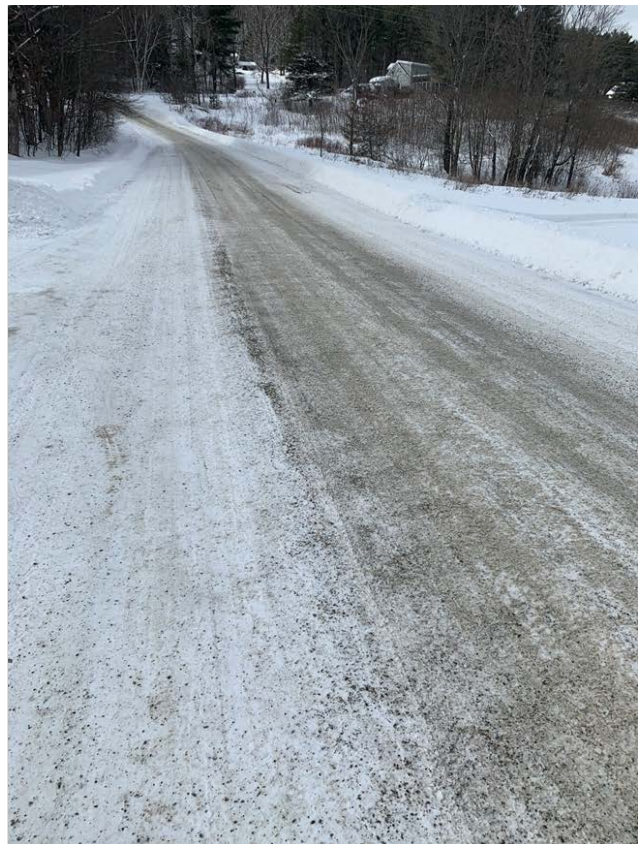
- No visible evidence of poor roadbed performance, erosion or settlement of road above gas line.
- Road was plowed with small layer of snow on top.
- No heaving evident.

- Revisit the site in the spring, after the final freeze-thaw cycle of the season.

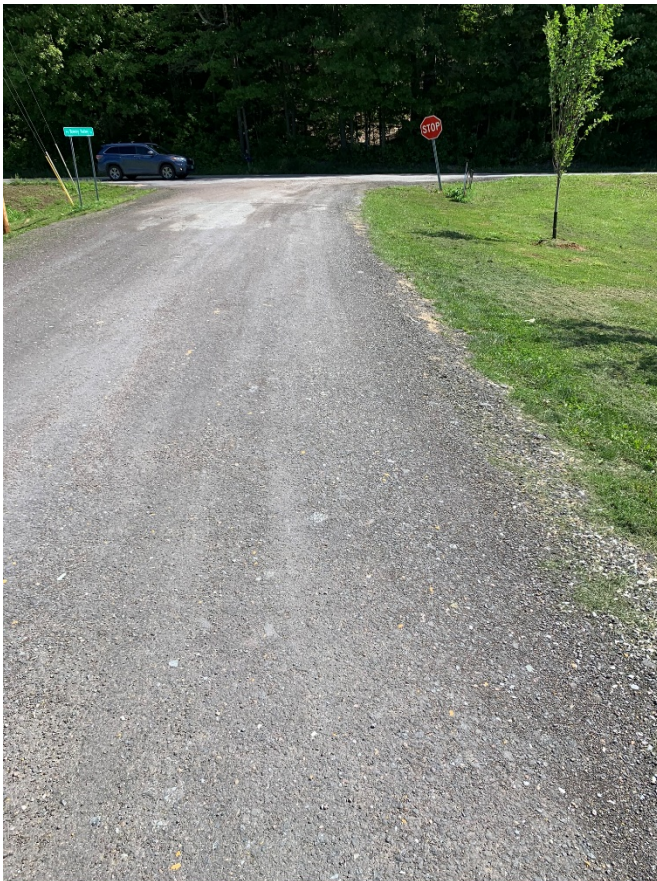
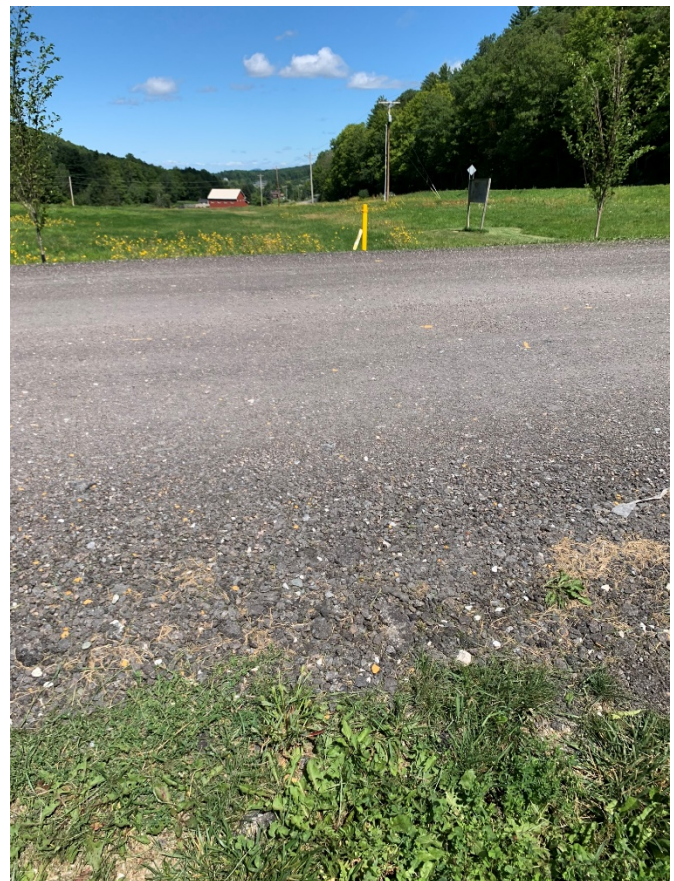
- No visible evidence of poor roadbed performance, erosion or settlement of road above gas line.

- None.

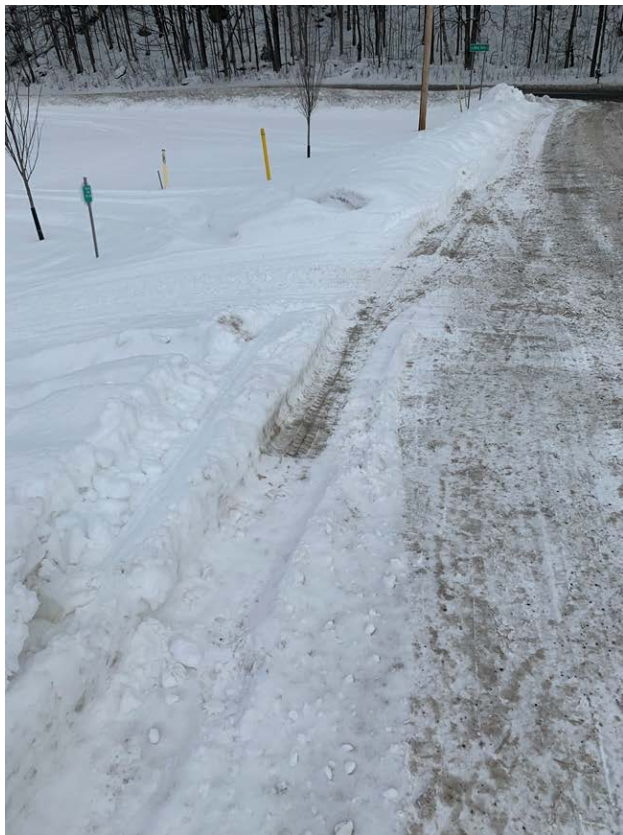
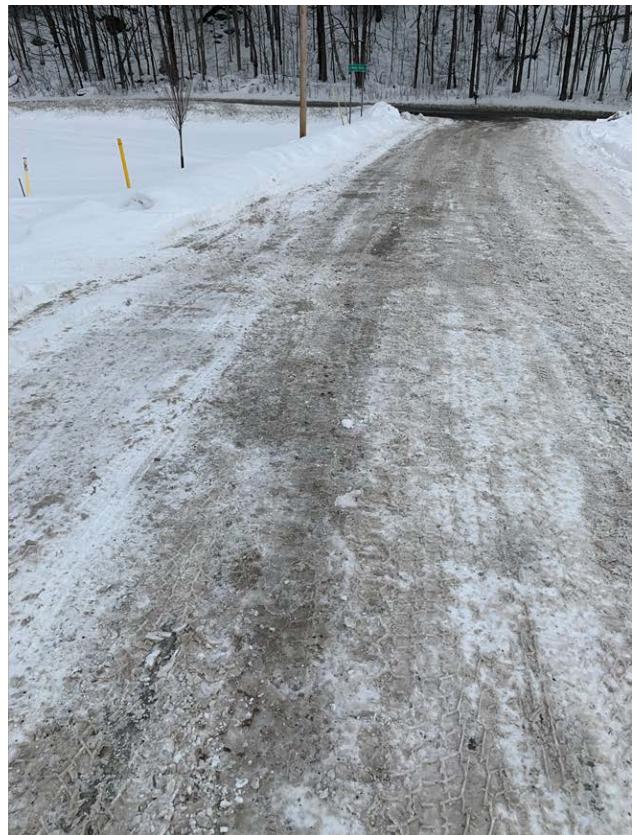
- No visible evidence of poor roadbed performance, erosion or settlement of road above gas line.
- Road was plowed with small layer of snow on top.
- No heaving evident.

- Revisit the site in the spring, after the final freeze-thaw cycle of the season.

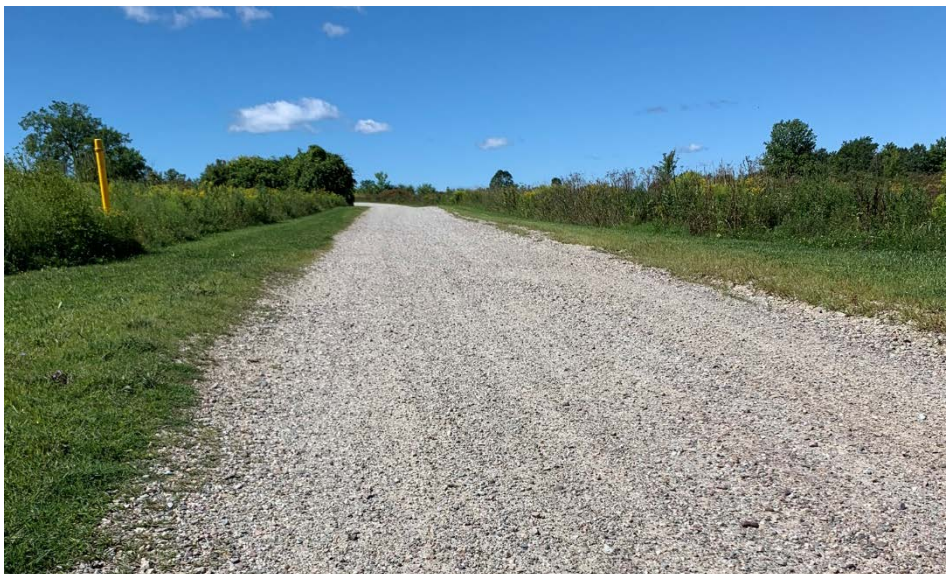
- 1"-2" of settlement in road above gas line.
- Settlement appeared to cause stormwater to channel and create erosion along the north side of the road.

- See February 2021 recommendations.

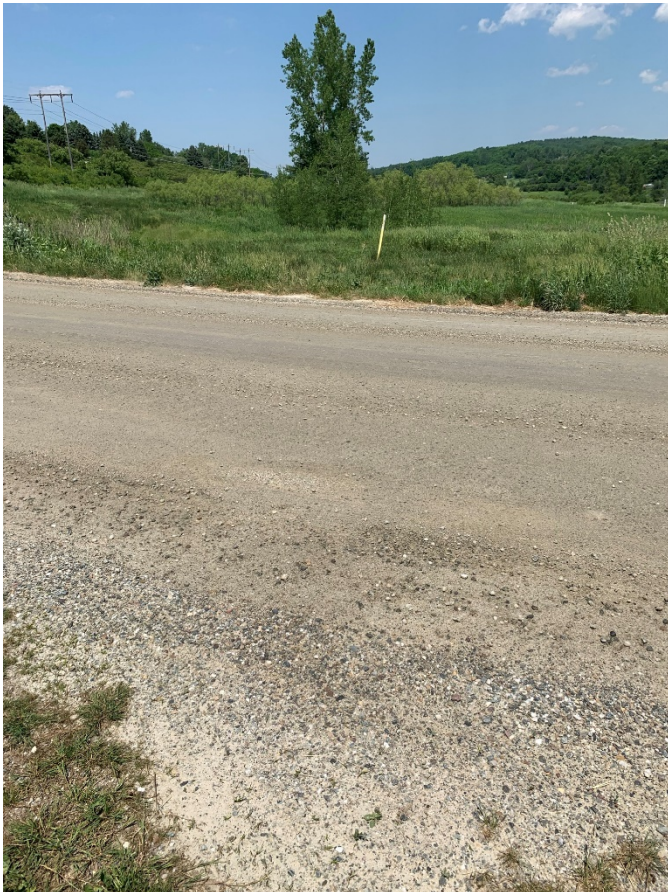
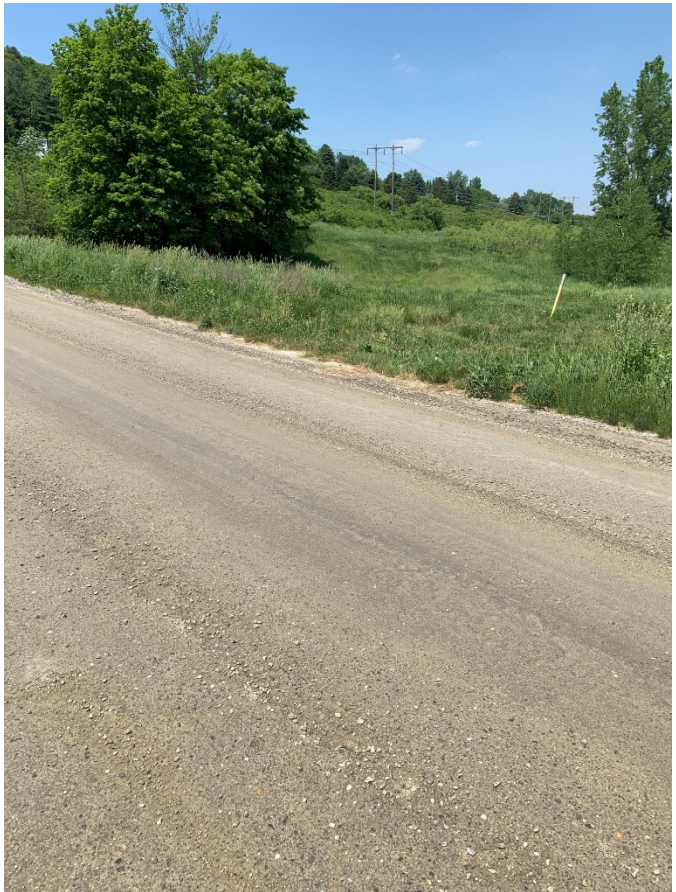
- No visible evidence of poor roadbed performance, erosion or settlement of road above gas line.

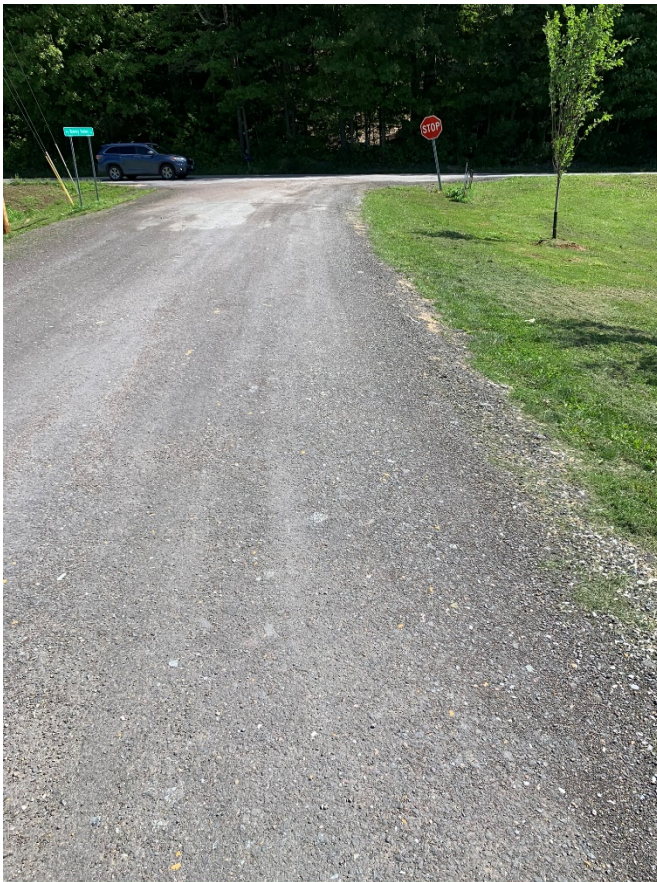
- No visible evidence of poor roadbed performance, erosion, or settlement of road above gas line.
- Road has been paved.

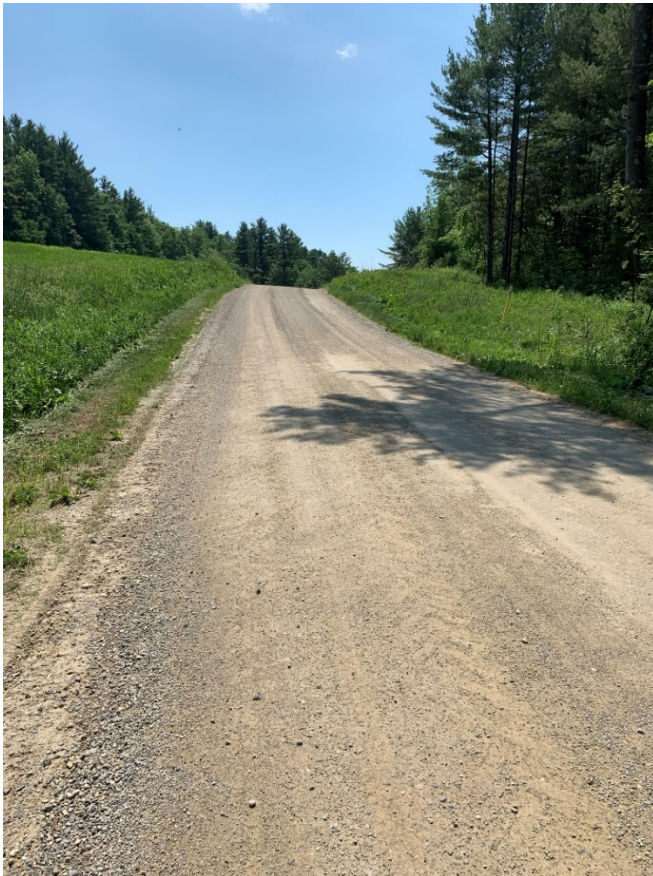
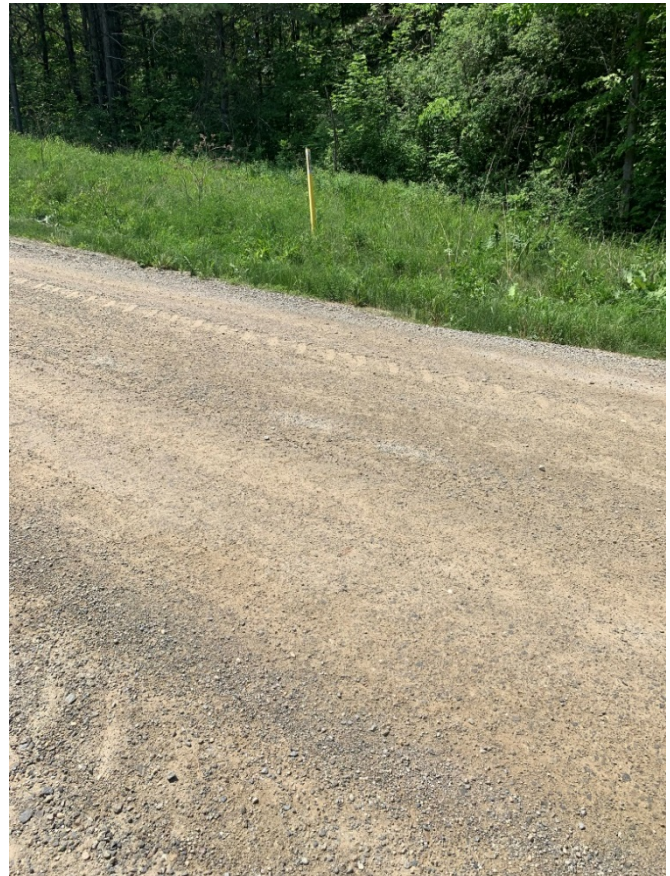
- No visible evidence of poor roadbed performance, erosion, or settlement of road above gas line.
