Vermont Gas Systems Addison Natural Gas Project
Road Crossing Observation Report

Krebs & Lansing Consulting Engineers, Inc.
164 Main Street | Colchester, Vermont 05446
(802) 878-0375

March 30th, 2021

ADDENDUM 1: FINAL OBSERVATIONS

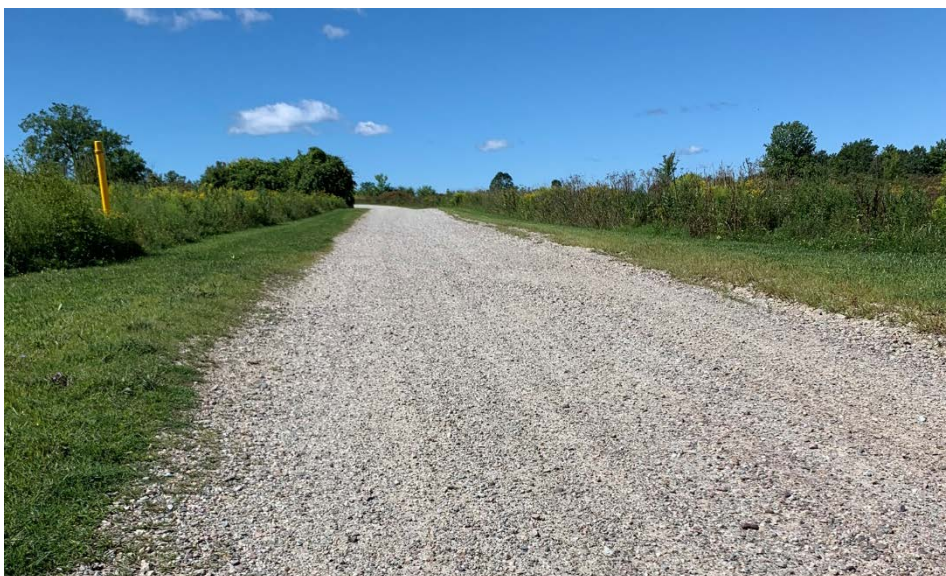
- 1"-2" of settlement in road above gas line.
- Settlement appeared to cause stormwater to channel and create erosion along the north side of the road.

- See February 2021 recommendations.
