Re: NAE-2012-0123_VT Gas Systems ARNGP Phase I Bi-weekly Report

Reporting Period: May 31, 2015 through June 13, 2015.

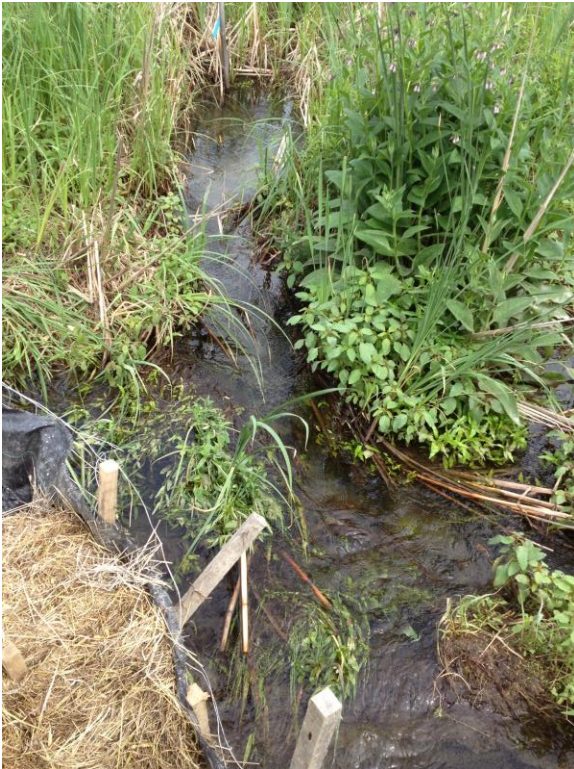
Photograph 4: High flows in wetland behind silt fence adjacent to the area shown in Photograph 3 above. Water was visibly clear and no turbid discharges were observed leaving the construction site.
