**Re: NAE-2012-0123\_VT Gas Systems ARNGP Phase I Bi-weekly Report**

**Reporting Period: May 31, 2015 through June 13, 2015.**

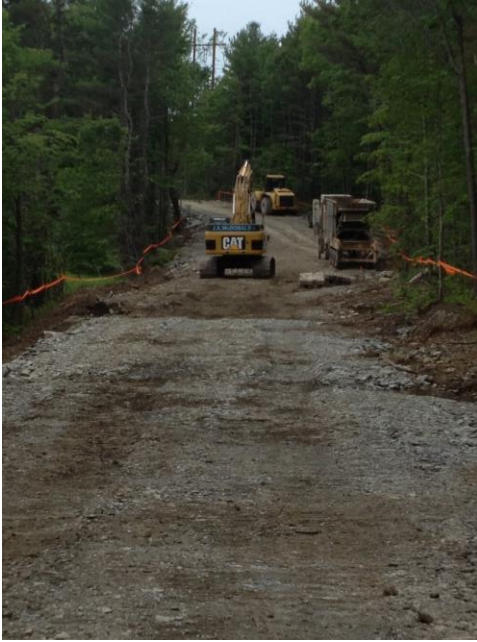
Photograph 1: J.A. McDonald, Inc. setting up their rock crushing plant to process the blasted material so that it's suitable for general pipe backfill. Plant is setup within the ROW off of 289.

1. No mainline pipe installation took place during the reporting period.
2. No site clearing took place on the project during the reporting period.
3. J.A. McDonald, Inc completed drilling and blasting for the pipeline trench along the 289 corridor from station 160+00 to 182+00. They mobilized and setup their crushing plant and the blasted trench rock is being excavated and crushed to meet the backfill requirements. The processed material is then placed back into the trench.

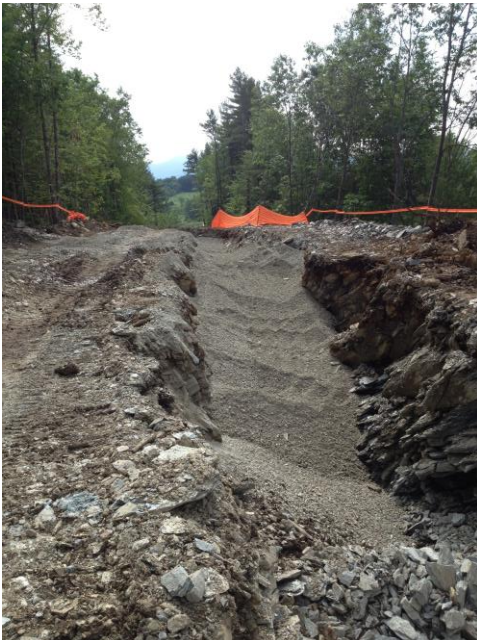
Photograph 2: Trench backfilled with processed (crushed) 1 ½" minus material.

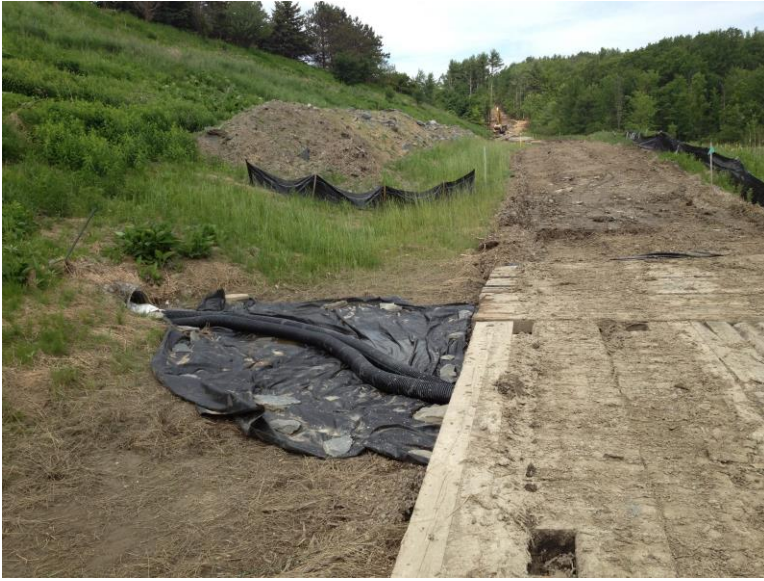
Photograph 3: Wetland mats continue to be maintained through resource areas as work continues around Indian Brook.

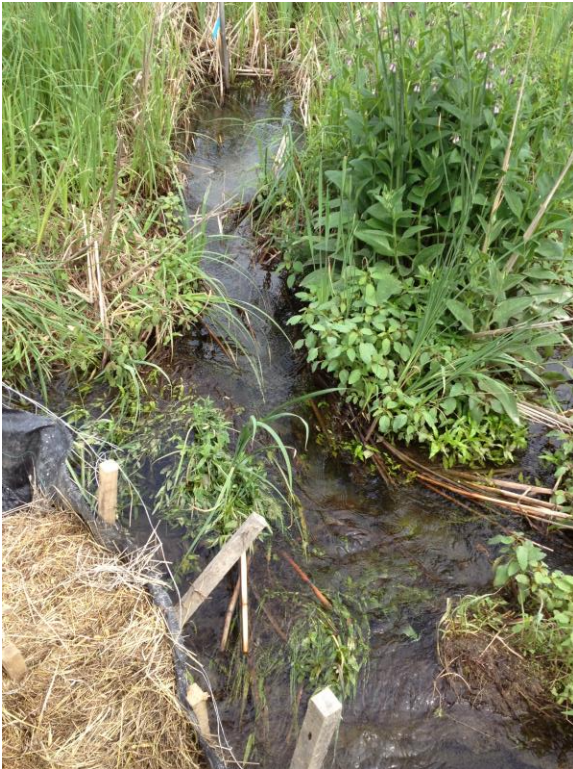
Photograph 4: High flows in wetland behind silt fence adjacent to the area shown in Photograph 3 above. Water was visibly clear and no turbid discharges were observed leaving the construction site.

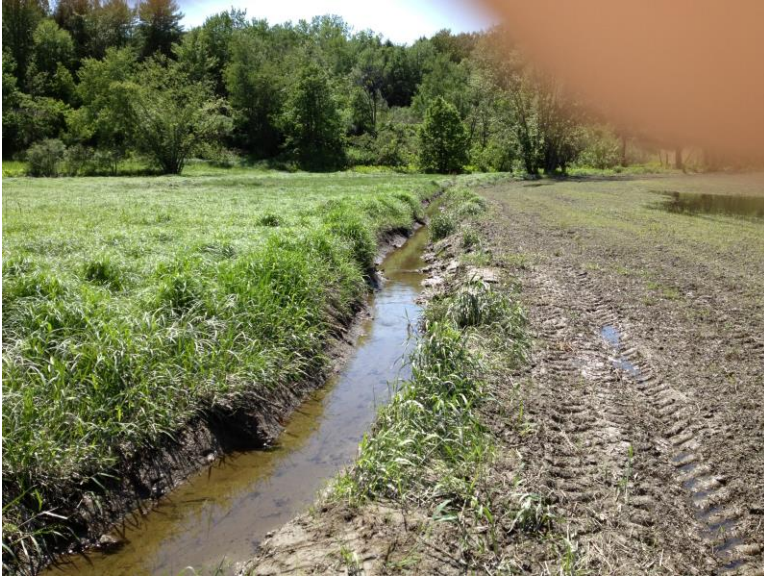
1. No work has taken place at the Gauthier parcel with respect to restoration of the wetlands that were impacted by others.
2. The farmer off of Fay Lane trenched along wetland 2012-CM-194 for field drainage. This work was not a part of the project, and VGS contractors did not perform this work.

Photograph 5: Farmers trench along wetland 2012-CM-194 off of Fay Lane.  
This work was not project related and was not performed by the project contractors.
